January 26, 2024

**Re: 2023 Annual Inspection Report for Yankee Doodle Tailings Impoundment and Corrective Action Plan for Recommendations**

The Engineer of Record (EOR) annual inspection of the Montana Resources, LLC (MR) Yankee Doodle Tailings Impoundment (YDTI) was conducted on September 28 and 29, 2023, by Mr. Daniel Fontaine, P.E., the Engineer of Record (EOR). Mr. Fontaine was accompanied during the site inspection by Mr. Mike Harvie (Manager of Engineering and Geology) of MR.

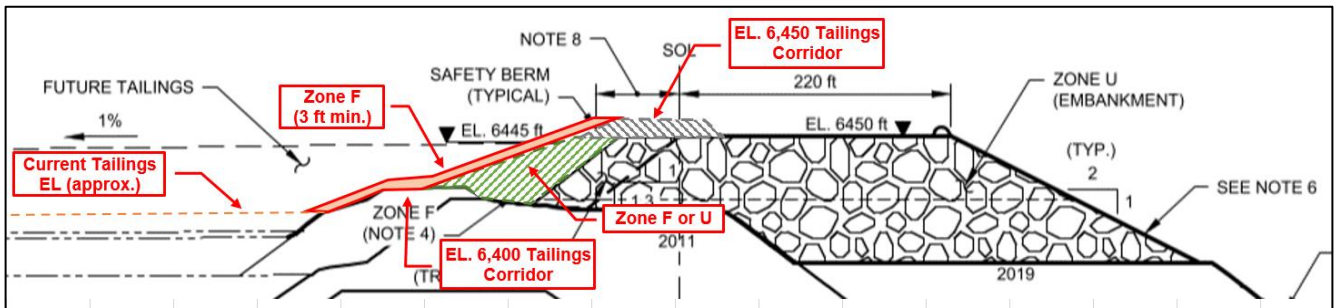
**Figure 1 Alluvium Facing Placement (MR, 2023b)**

- 2. Continue regrading the upstream slope of the North-South Embankment during construction of the tailings pipeline corridor for EL. 6,450 ft lift. Initial regrading activities were undertaken in 2023 as a result of the 2022 EOR AIR recommendations. Regrade the embankment upstream slope to cover and incorporate the tailings pipeline discharge corridor along the EL. 6,400 ft lift. Implement the alluvium facing layer between the crest of the tailings pipeline corridor along the EL. 6,450 ft lift and the upstream alluvial facing of the EL. 6,400 ft lift along the regraded upstream slope. The intent is to**

**create a continuous layer of alluvium between the EL. 6,450 tailings pipeline corridor and the alluvium facing previously placed as part of the EL. 6,400 ft lift construction. This recommendation applies to the remaining portion of the North-South Embankment between Section 28+00N and the abutment at Rampart Mountain. (continuation of 2022 recommendation).**

MR proposes to continue the upstream slope regrading of the North-South Embankment with the same construction methodology implemented along the East-West and North-South embankments as outlined in the 2022 CAP (MR, 2023b) and illustrated in Figure 1. It is anticipated that the North-South regrading activities will occur in Q1 and Q2 of 2024. The timing and completion of this work will be dependent on tailings beach conditions as the tailings discharges are used to limit and control dusting from the tailings beach to the most practical extent. Regrading activities will require the temporary disconnection of Tailings Delivery Pipeline 3 at a location between the 3-3 discharge and the 3-4 discharge. The Tailings Delivery Pipeline will be reconnected as the facing and construction of the tailings pipeline corridor advanced to the north.
