MONTANA DEPARTMENT OF ENVIRONMENTAL QUALITY
HARD ROCK MINING BUREAU
OPERATING PERMIT – FIELD INSPECTION REPORT

Operator: Montana Resources, LLP				Inspection Date: June 7, 2022			
Operating Permit #: 00030			Project: Montana Resources-Continental Mine Complex			County: Silver Bow	
Nearest City or Town(s): Butte							
DEQ Staff: Garrett Smith				Company Representative(s): Mark Thompson, Jeremy Fleege			
Agencies w/overlapping Jurisdiction:		USFS		BLM		Other	× None
Minerals: Copper, molybdenum, minor silver							
Status:		× Active		Inactive		Suspended	Other
Weather: Partly cloudy, high temp 59°F							
Type of Operation:				Purpose of Inspection:			
×	Open Pit				Initial (Pre-permitting)		
	Underground			×	Regular Compliance		
	Placer				Amendment #		
×	<i>Heap Leach- Leach pads near HSB no longer receiving solution</i>				Complaint Received		
	Vat Leach				Bond Release		
×	Mill				Other		
	Other:				NON issued

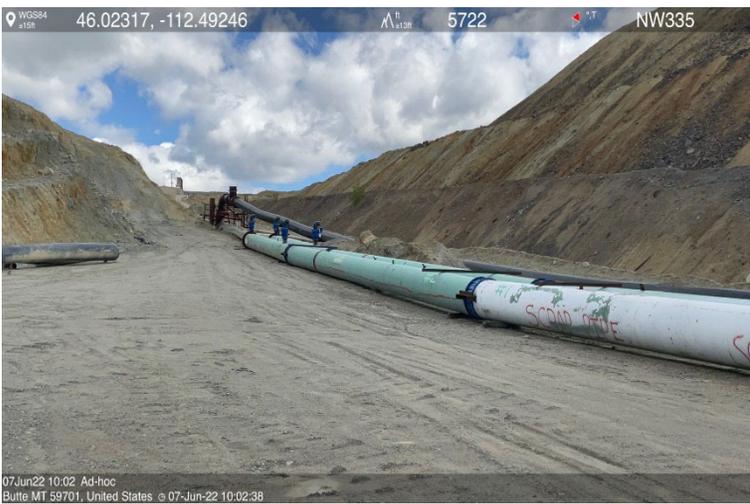
On the way to the Continental Pit, some recent upgrades to water pipelines were observed (Photo 1). Devices have been installed which release air pressure in the lines, which will improve water conveyance from YDTI to the processing facilities and reduce the need to manually relieve pressure. Mining continues in multiple locations within the Continental Pit, including D East, D North, and C block (Photos 2 and 3). Mining is occurring at elevations above groundwater within the pit, but dewatering occurs in the pit as necessary. Inflow rates are estimated at 0.5 million gallons per day (MGD) or 350 gallons per minute (GPM).

Photo 1- Devices have been installed which release air pressure in the lines, which will improve water conveyance from YDTI to the processing facilities and reduce the need to manually relieve pressure. **Photo 2-** Mining continues within the Continental Pit (as seen from the north), dewatering occurs as needed and the inflow rates are presumed to be around 0.5 MGD.

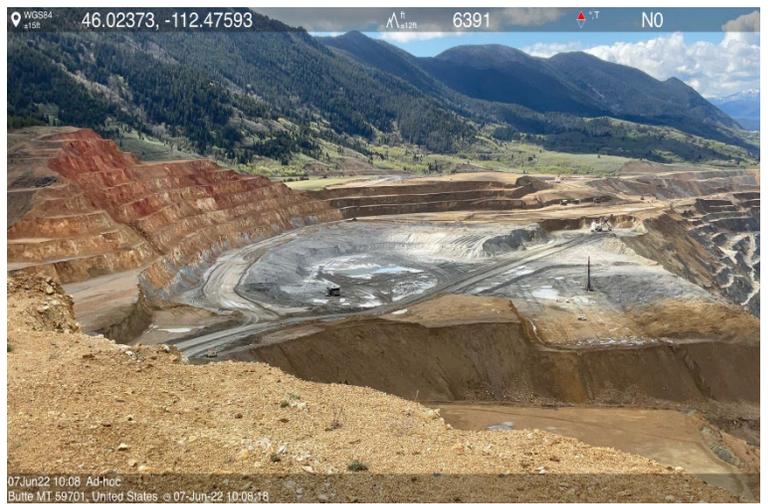
Photo 3- Mining continues within the Continental Pit (as seen from the north), dewatering occurs as needed and the inflow rates are presumed to be around 0.5 MGD. **Photo 4-** The downstream slope of the N-S Embankment (center) has been constructed in sequential lifts to support a crest elevation of 6,450 feet.

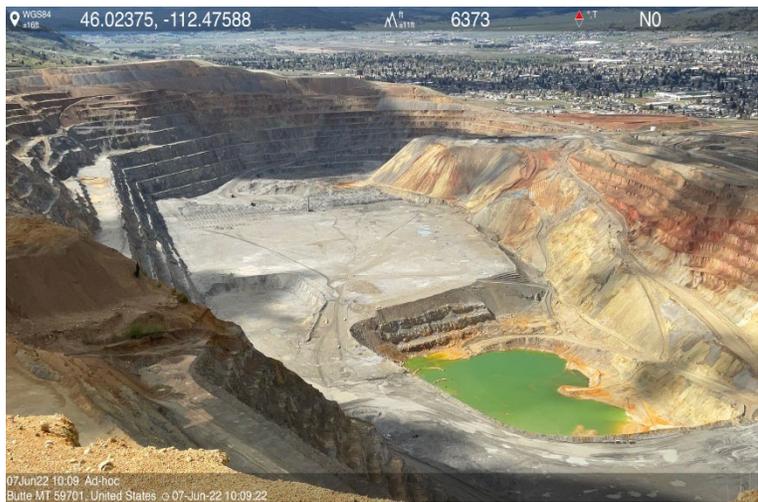
Waste rock is being used as construction material to expand the capacity of the Yankee Doodle TSF by raising the embankment crests to 6,450 feet (Amendment 010). The tailings pipeline ramp was relocated and raised to a higher elevation along the southern face of the central (E-W) embankment. The downstream (outer) face of the N-S Embankment is also being raised in 50-foot lifts. This downstream construction or "step-out" method increases the embankment footprint before building the crest upwards (Photo 4). There are still a few areas along the crest that have not yet reached the elevation of 6,450 feet (Photo 5).

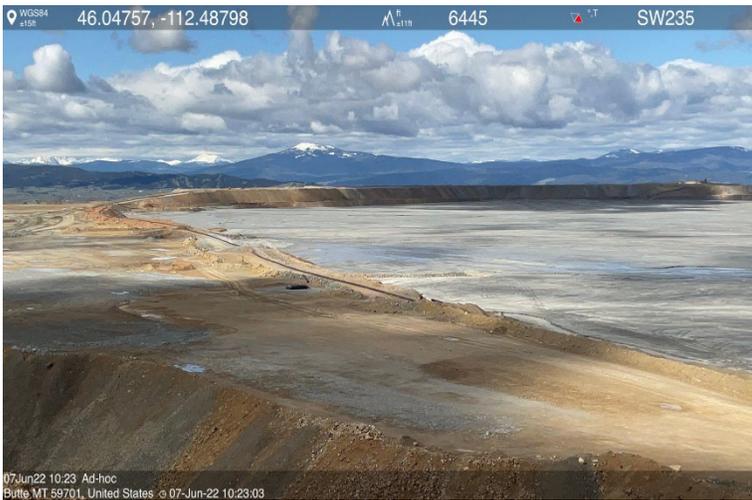
Photo 5- The crest of the N-S Embankment has been widened and construction to the 6,450 ft elevation continues. **Photo 6-** The tailings beach has been widened adjacent to the N-S Embankment and the pond is being pushed further to the northeast.

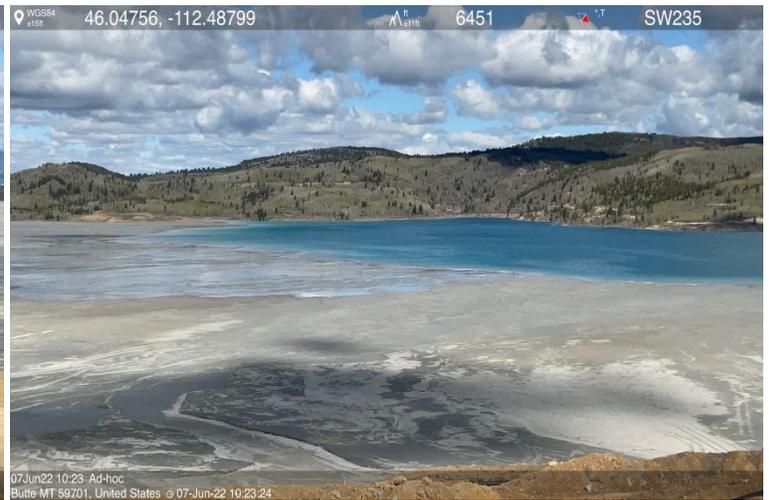
A wide beach area is important to separate the tailings pond from the embankments, thus contributing to the safety and stability of the impoundment. The beach area has increased along the N-S Embankment, with the addition of tailings discharge at this location (Photo 6). As the beach surface area increases, additional measures are needed to reduce the potential for blowing dust. MR has installed storage bladders for magnesium chloride around the YDTI, to speed up the process to deploy and refill tracked vehicles onto the beach. Some portions of the tailings beach closest to the E-W Embankment are being covered in rock as a “surcharge” or “pre-loading” step to help densify and remove pore water from the underlying tailings mass. An access road to the pond/barge has been constructed on the slope adjacent to the eastern margin of the N-S Embankment, as approved in permit revision MR20-002 (Photos 7 and 8). Segments of pipe have been placed along this route for future water conveyance, but additional road preparation will occur before the pipe is joined. Through the BMFOU water treatment pilot project, a portion of the supernatant water that is pumped out of the YDTI pond is being diverted for treatment at a “Polishing Plant” facility operated by Atlantic Richfield Co. (AR).

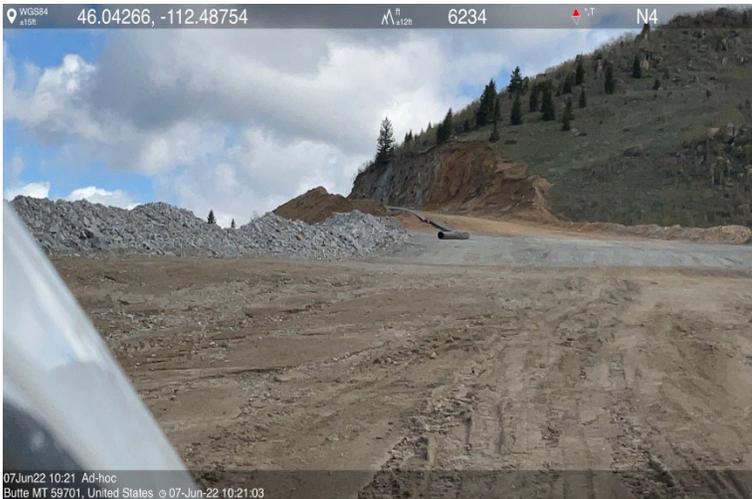
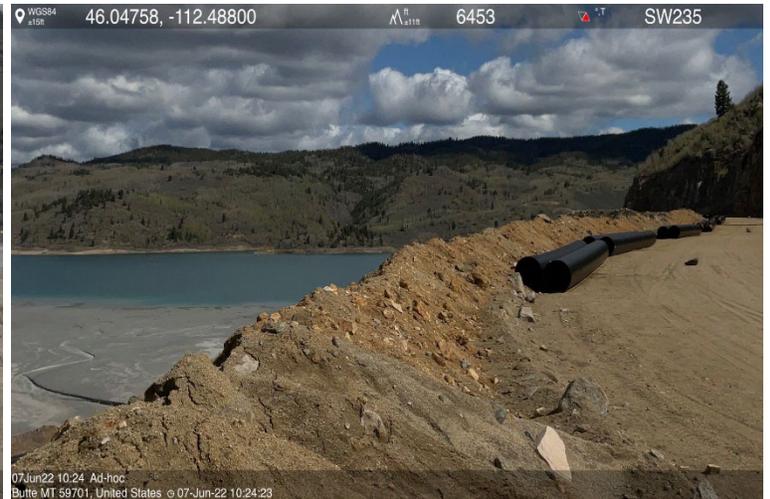
Photos 7 and 8- The new access road to the tailings bond barge (above the N-S Embankment) has been constructed. Segments of pipe have been placed along this route for future water conveyance, but additional road preparation will occur before the pipe is joined.

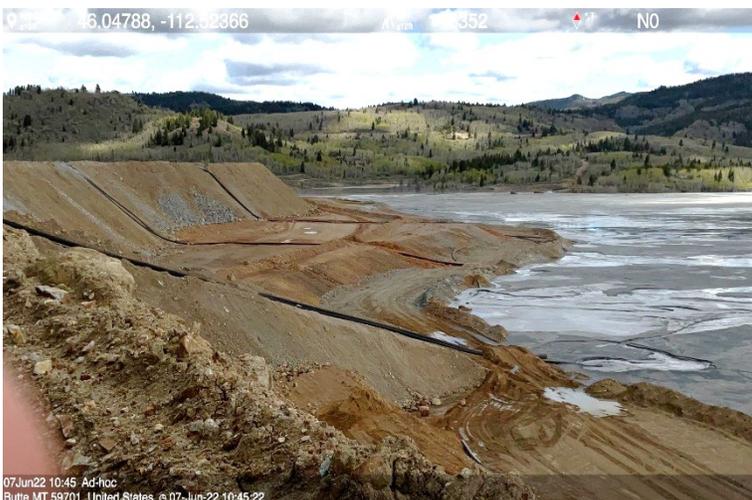
The West Embankment crest has been constructed to an elevation of 6,450 feet and tailings discharge along this side of YDTI continues to develop a wide beach between the West Embankment and the supernatant pond (Photo 9). **Based on project scheduling and material availability, the reclamation of the downstream (outer) slope of the West Embankment should proceed as approved in Amendment 010:** "The West Embankment will be constructed at its final slope of 3H:1V, with the exception of a small segment near the WED extraction pond where the final slope will be graded to 2.5H:1V. Capping will be distributed on the 3H:1V portion of the West Embankment concurrently with lift completion. Six inches of soil will be placed over 36 inches of non-acid generating alluvium (D2 Zone)."

Photo 9- The interior/upstream face of the West Embankment, with tailings discharge lines across the slope. **Photo 10-** The extraction pond at the south end of the WED, where a pump barge is used to circulate water back into the YDTI.

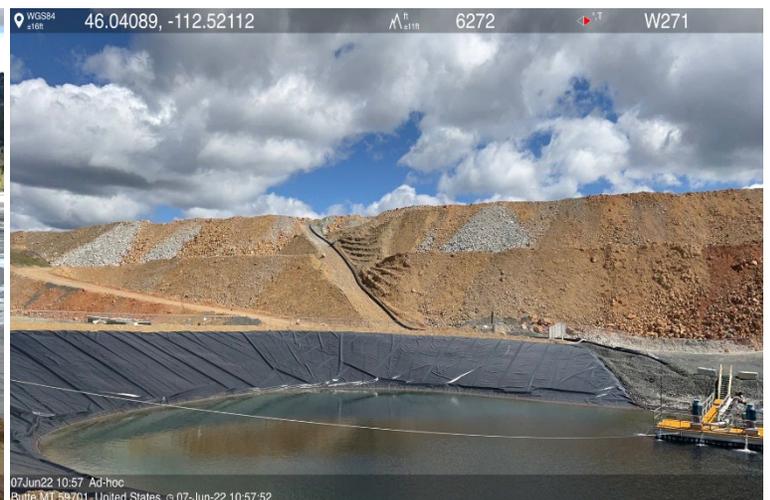
At the south end of the West Embankment, the lined extraction pond continues to receive the outflow from the West Embankment Drain (WED) installed within the embankment’s foundation. The drain also collects a lesser amount of groundwater, which generally follows topography and flows eastward from the West Ridge to the West Embankment. The flow rate into the WED extraction pond was typically between 300 and 450 GPM during 2019-2021, but the rate has increased from 450 to 575 GPM in the first quarter of 2022 (Photo 10). This increase is likely due to additional tailings discharge along the West Embankment and rapid/direct infiltration of water into the coarse tailings that are adjacent to the WED. The measured flows remain below the design capacity of the WED (4,500 GPM).

Water quality monitoring results from the extraction pond are provided in the 2021 Annual Progress Report. Although the TSF pond had an average pH of 10.3, the water reporting to the extraction pond had an average pH of 3.31 and the concentration of sulfate and some metals (Al, Cd, Cu, Fe, Mn, Pb, U, Zn) are enriched in the extraction pond as compared to the tailings pond. This indicates the current level of reactivity of the materials that are encountered by water entering the WED. **Monitoring the WED water quality and flow rates should continue as specified in the Operating Plan. The monitoring results should also be compared to the modeling assumptions that were included in Amendment 010. This information will further inform the development of future plans to expand the TSF, with respect to evaluating the performance of the WED and the potential options to manage the long-term outflow. (See stipulation for Amendment 010, due September 30, 2022).**

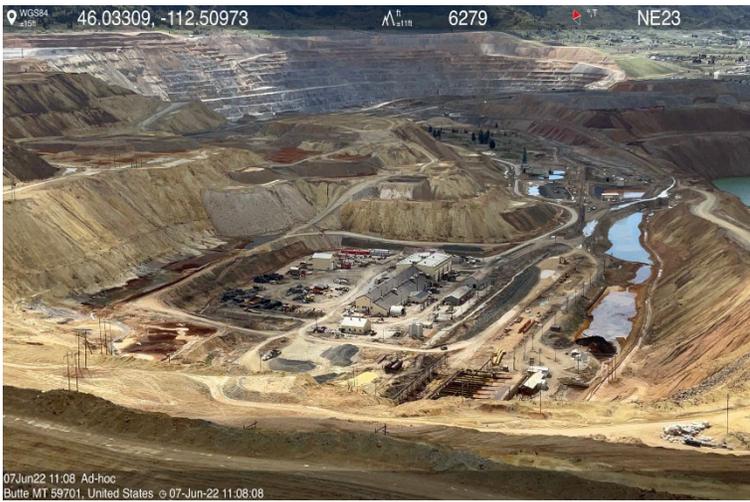
Designs have been developed to create a new rock disposal site (RDS) within the HSB area (Photo 11), as discussed in multiple meetings with the Engineer of Record (EOR) and Independent Review Panel (IRP). DEQ provided additional guidance about the options for permitting actions in a meeting with MR on January 14, 2022. The RDS would consist of rockfill at the toe of the E-W Embankment, which would provide additional foundation support for YDTI. This would require demolition of the existing Precipitation Plant facilities, containment/management of ongoing seepage, and the construction of rock drain features that can convey all future seepage and infiltration out of the current HSB footprint (from underneath the RDS). The rock drains would be constructed with similar materials and methods as the WED within the West Embankment. **MR will soon submit an application for this permit modification, which DEQ will process as a minor amendment and evaluate the potential significance of impacts through an Environmental Assessment (EA). Further agreements/authorizations may also be required from Superfund parties in order to proceed with the project.**

Photo 11- Looking south over the HSB area: copper precipitation plant in the lower center, leach pad seepage ponds to the left, mechanic shops and equipment storage in the center, HSB Water Treatment Plant in the upper/distant center, and Berkeley Pit to the distant right. **Photo 12-** Ground preparation has started for the relocated Precipitation Plant, directly to the north of the HSB Water Treatment Plant.

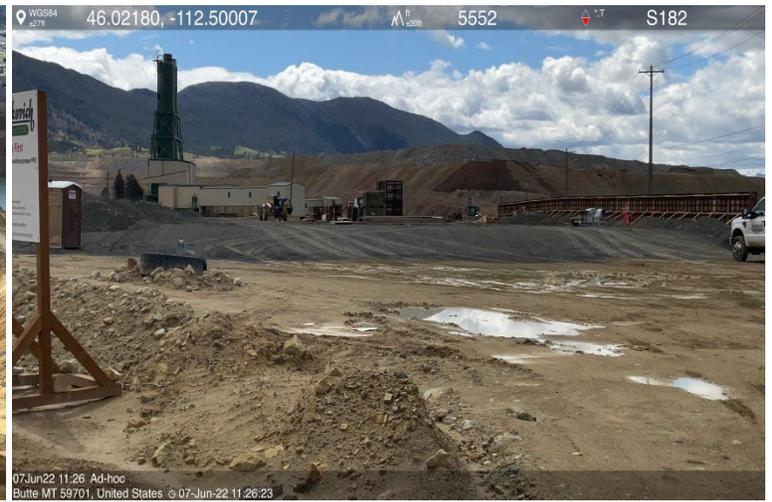
Following the guidance that was provided by DEQ, MR submitted a request for permit revision MR22-001 on April 13, 2022 to construct a new Precipitation Plant, approximately 0.5 mile to the south of the existing plant within HSB. DEQ provided a deficiency letter on May 3, 2022 with questions about the construction, operation, and reclamation of the plant, as well as the location of the plant in relation to pre-1974 disturbance areas. **MR has not responded to the deficiency comments at the time of this inspection, although early ground preparation (e.g. grading, fill/gravel placement) is taking place in an area to the north of the HSB Water Treatment Plant (Photo 12). DEQ brought this to MR's attention and advised that further construction should not proceed until the pending revision has been approved and bonded (based on the pre-1974 determination).**

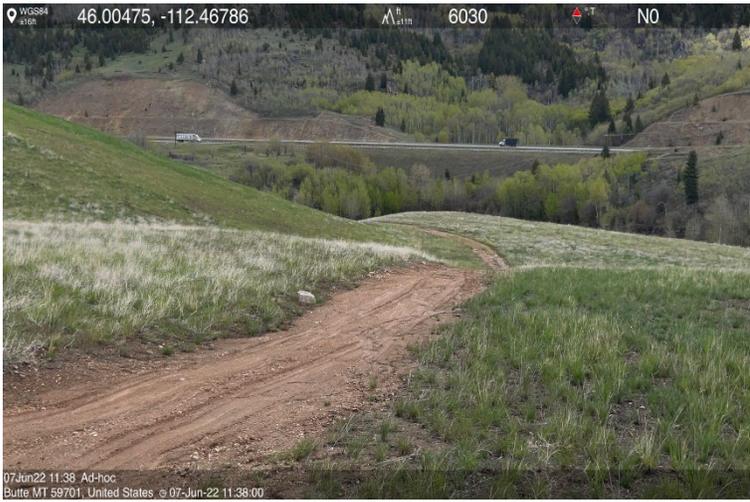
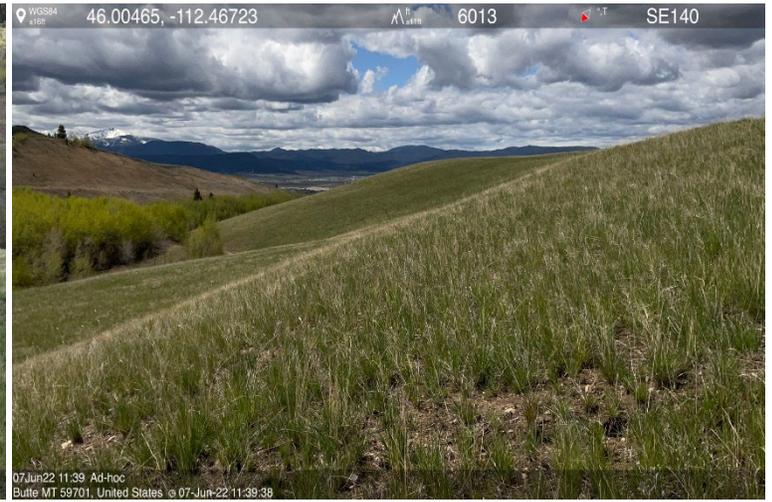
The relatively cool and wet weather during April through June 2022 has been a benefit to vegetation and the reclaimed slopes are looking very green. Some of the reclaimed slopes are showing good vegetation density and relatively little erosion (Photos 13, 14, and 16). Some of the areas that were seeded more recently are showing a few bare patches, minor rills, and tracks (presumably from the seeding equipment). The southern end of the dump complex was reclaimed in 2017-2018 and the vegetation is noticeably denser compared to areas that were seeded in 2019 or 2020 (Photos 15 and 17). **In addition to implementing the monitoring and maintenance activities in the Erosion Control Plan for these areas, DEQ recommends continued weed control in the upcoming season. Some of the noxious weed species that were observed on the East Dump Complex include knapweed, Dalmatian toadflax, and henbane.**

Photos 13 and 14: Looking across slopes on the east side of the East Dump Complex, this area was reclaimed in 2019-2020. Although not as old as the vegetation in Photos 16 and 17, the density of grass species is improving with time.

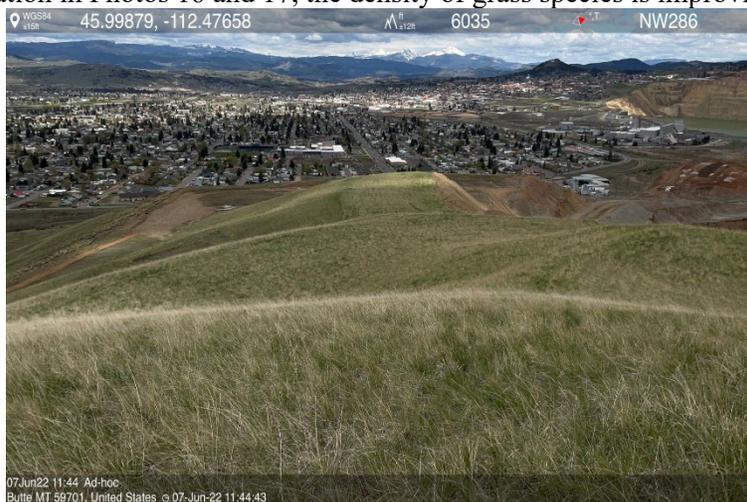
Photo 15- Looking west across the southern end of the East Dump Complex (Hillcrest RDS). This area was reclaimed in 2017-2018.

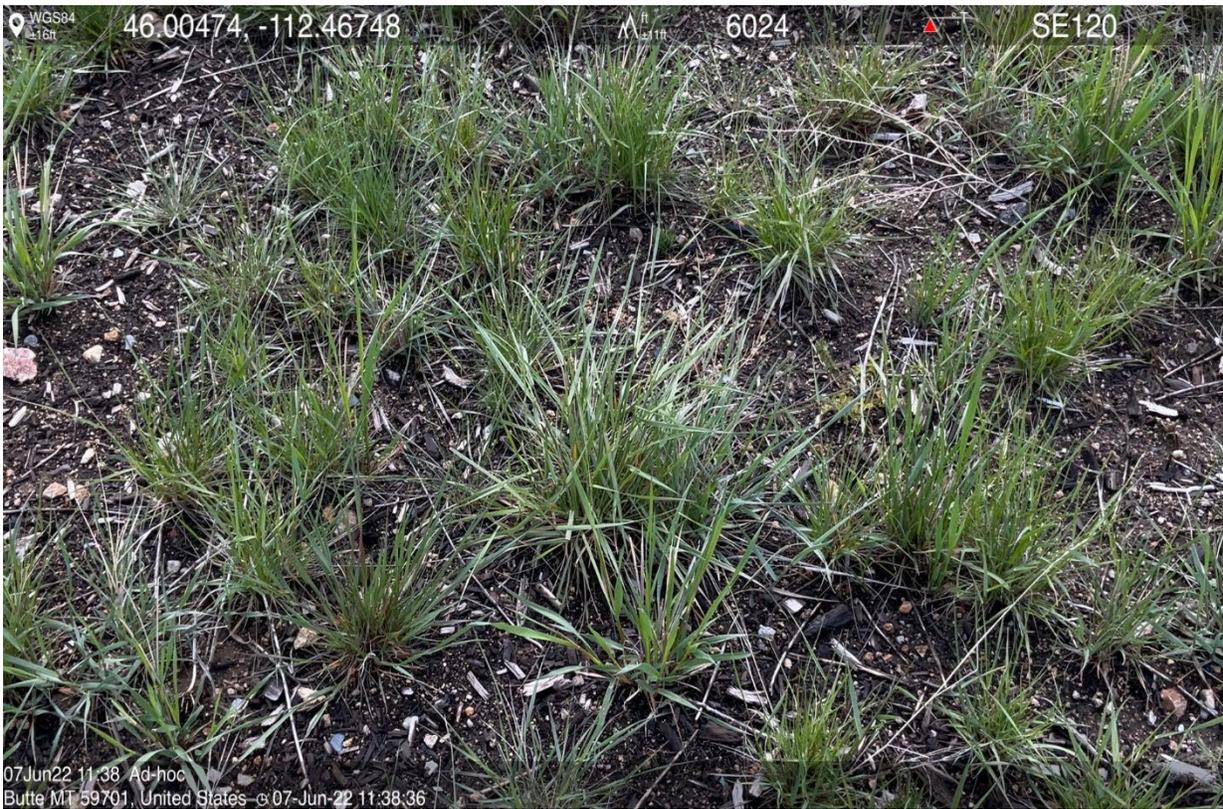
Photo 16- A closer view of the vegetation density at the location in Photo 14.

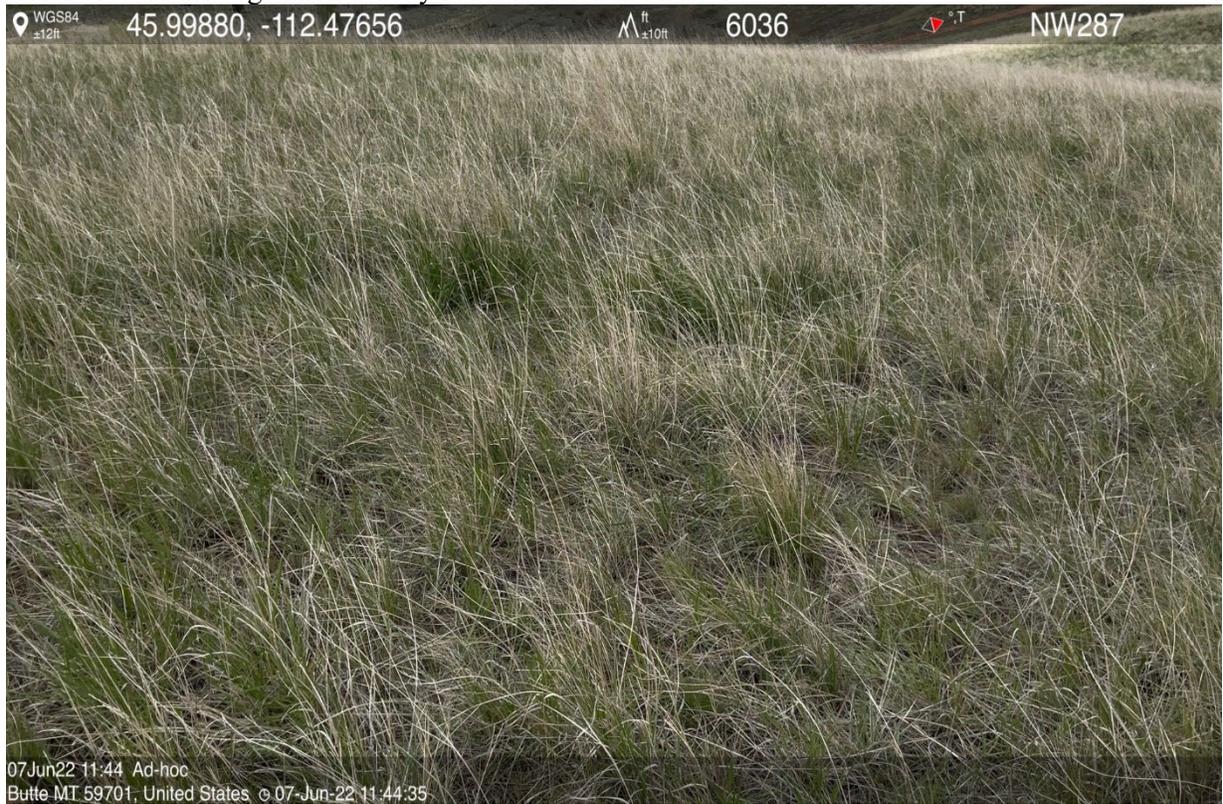
Photo 17- A closer view of the vegetation density at the location in Photo 15. Compare this location to younger growth in Photo 16.
