**June 2, 2023**

Mr. Mike Harvie  
Manager of Engineering and Geology  
Montana Resources, LLC  
600 Shields Avenue  
Butte, Montana  
USA, 59701

**Knight Piésold Ltd.**

**RE: Q1 2023 – YDTI Quarterly Piezometric and Deformation Monitoring Update**

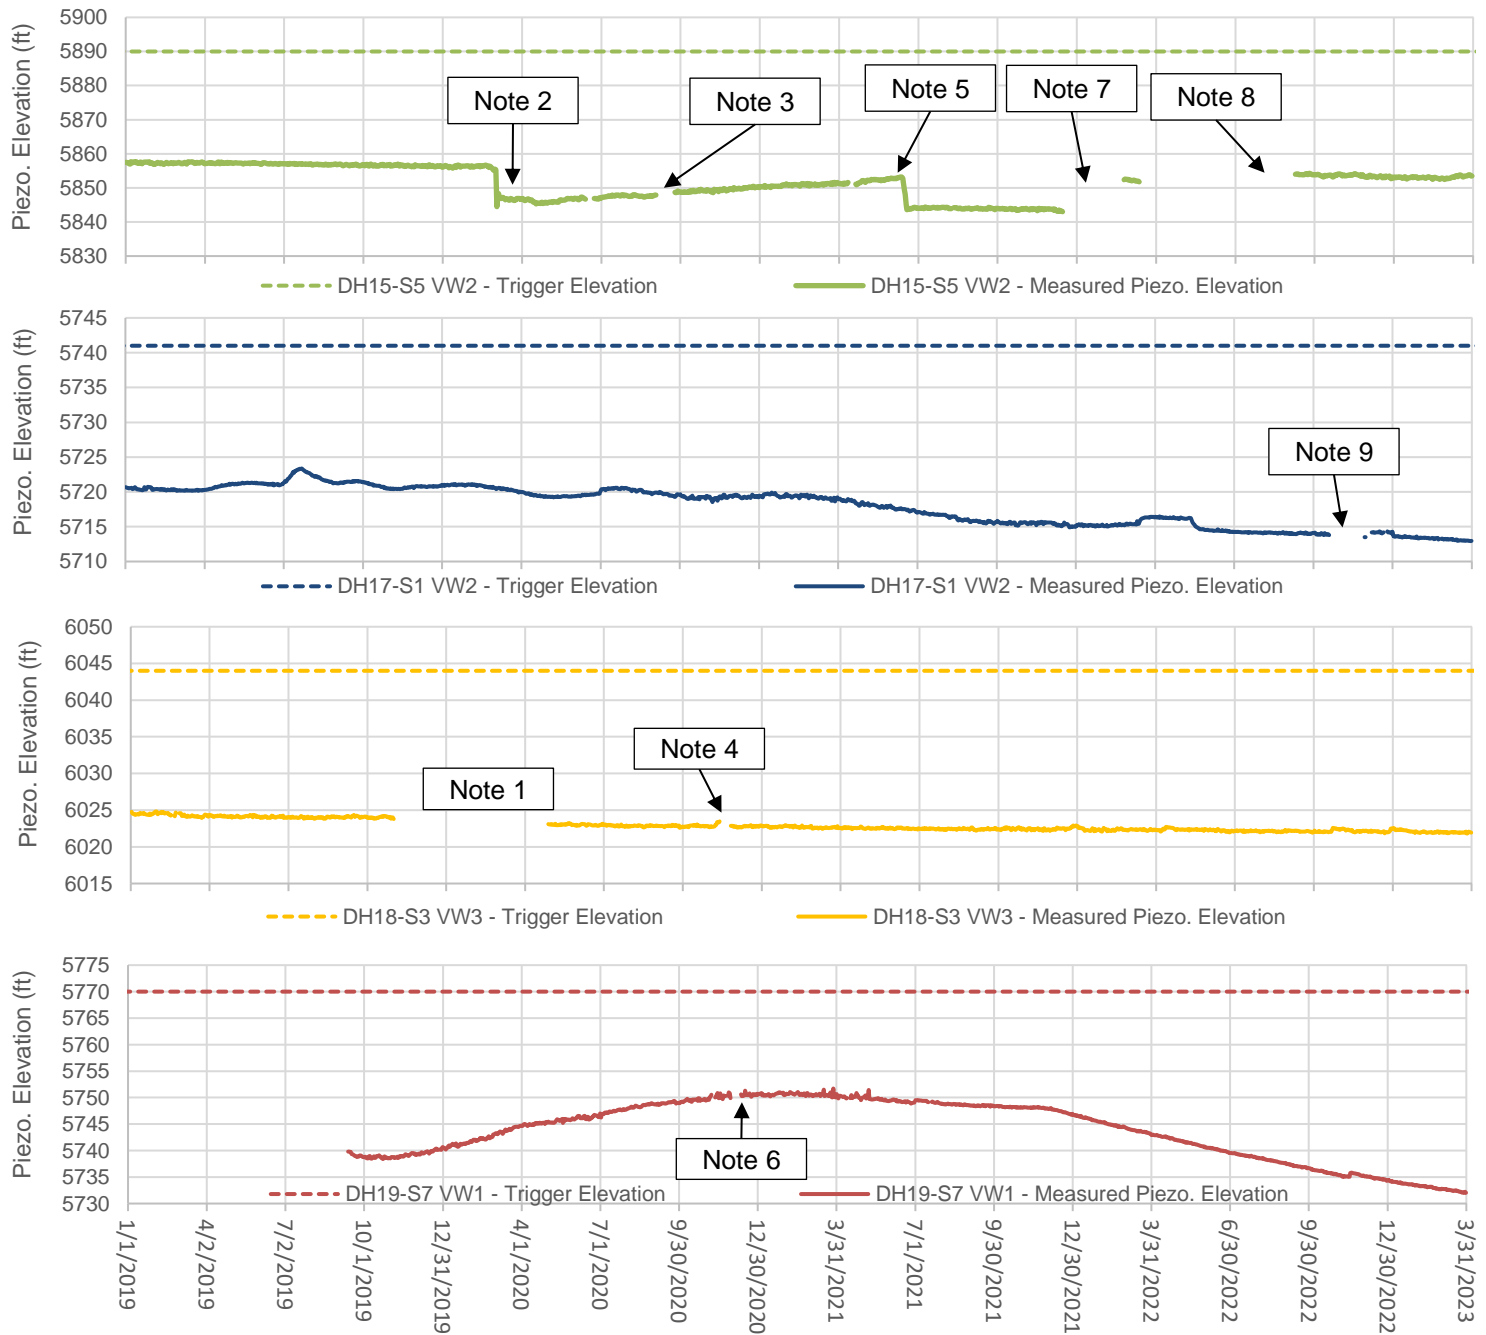
P/A NO. VA101-126/29		REF. NO. VA23-00701
	<b>FIGURE 3</b>		REV 0

- QPP monitoring sites MW94-8, MW94-11, and DH15-S3 VW1 observed minor pore water pressure decreases (approximately -0.1 ft in magnitude) during Q1 2023.
- QPP sensor DH17-S1 VW2 monitored slightly decreasing pore water pressure (approximately 0.6 ft decrease) during Q1 2023.

- QPP SENSOR DH15-S5 VW1 WAS DAMAGED DURING EL. 6450 ft LIFT CONSTRUCTION AND HAS BEEN ABANDONED. KP HAVE ELECTED SENSOR DH15-S5 VW2 AS A REPLACEMENT QPP. THE DATA LOGGER AT DH17-S1 WAS DAMAGED AND NO DATA WERE RECORDED BETWEEN OCTOBER 18, 2022 AND DECEMBER 9, 2022. FUNCTIONALITY HAS SUBSEQUENTLY BEEN RESTORED.

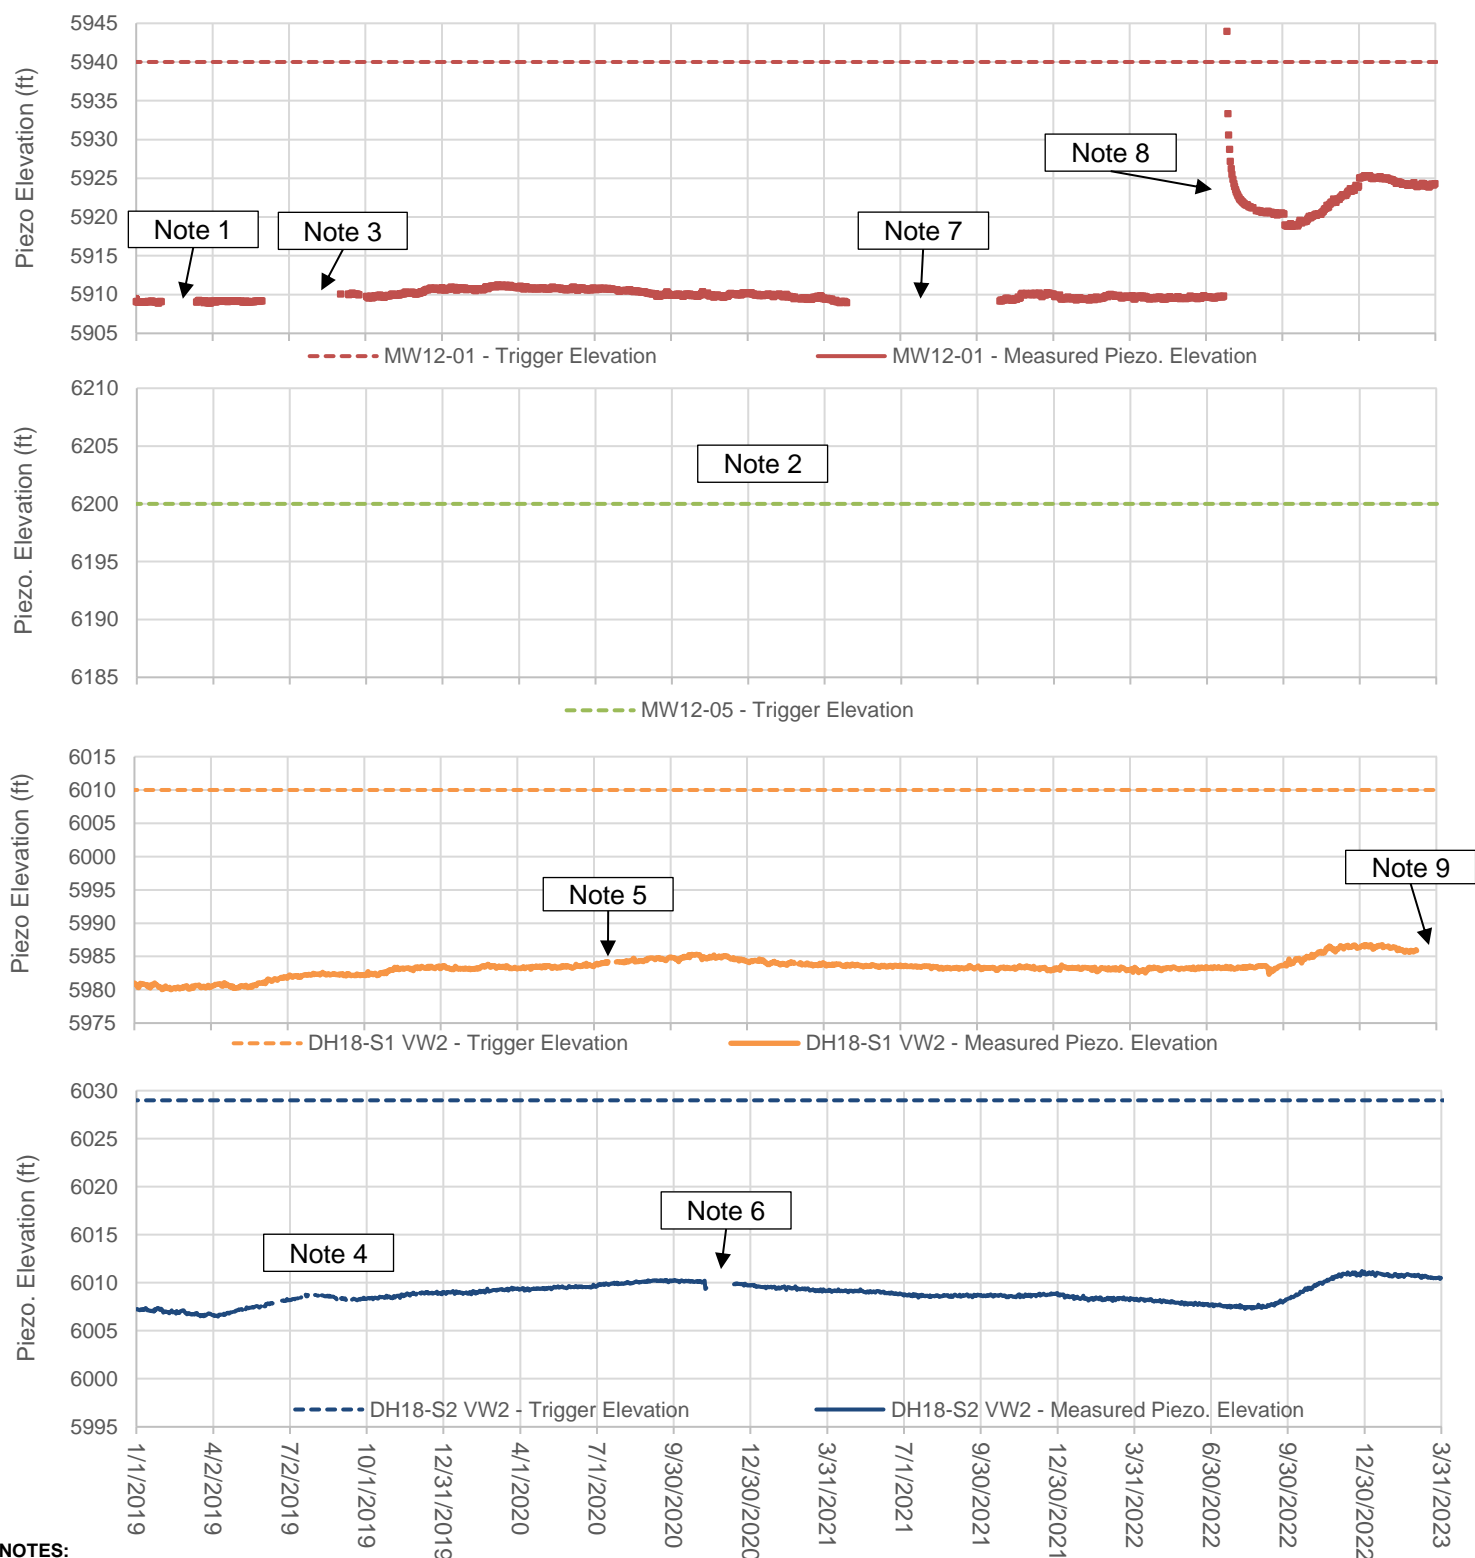
MONTANA RESOURCES, LLC	
YANKEE DOODLE TAILINGS IMPOUNDMENT	
SUMMARY OF MEASURED VS. QPP TRIGGER PIEZOMETRIC ELEVATIONS NORTH-SOUTH EMBANKMENT	
	P/A NO. VA101-126/29
	REF. NO. VA23-00701
FIGURE 4	
REV 0

- Monitoring well MW12-01 was inundated (tailings flowed into the well riser) by the rising tailings beach during September 2022 and subsequent water levels have been notably elevated (by approximately 10 ft) since. Slightly decreasing water levels were observed during Q1 2023 (approximately 0.8 ft decrease), and current elevations remain approximately 15 ft below the QPP threshold elevation.

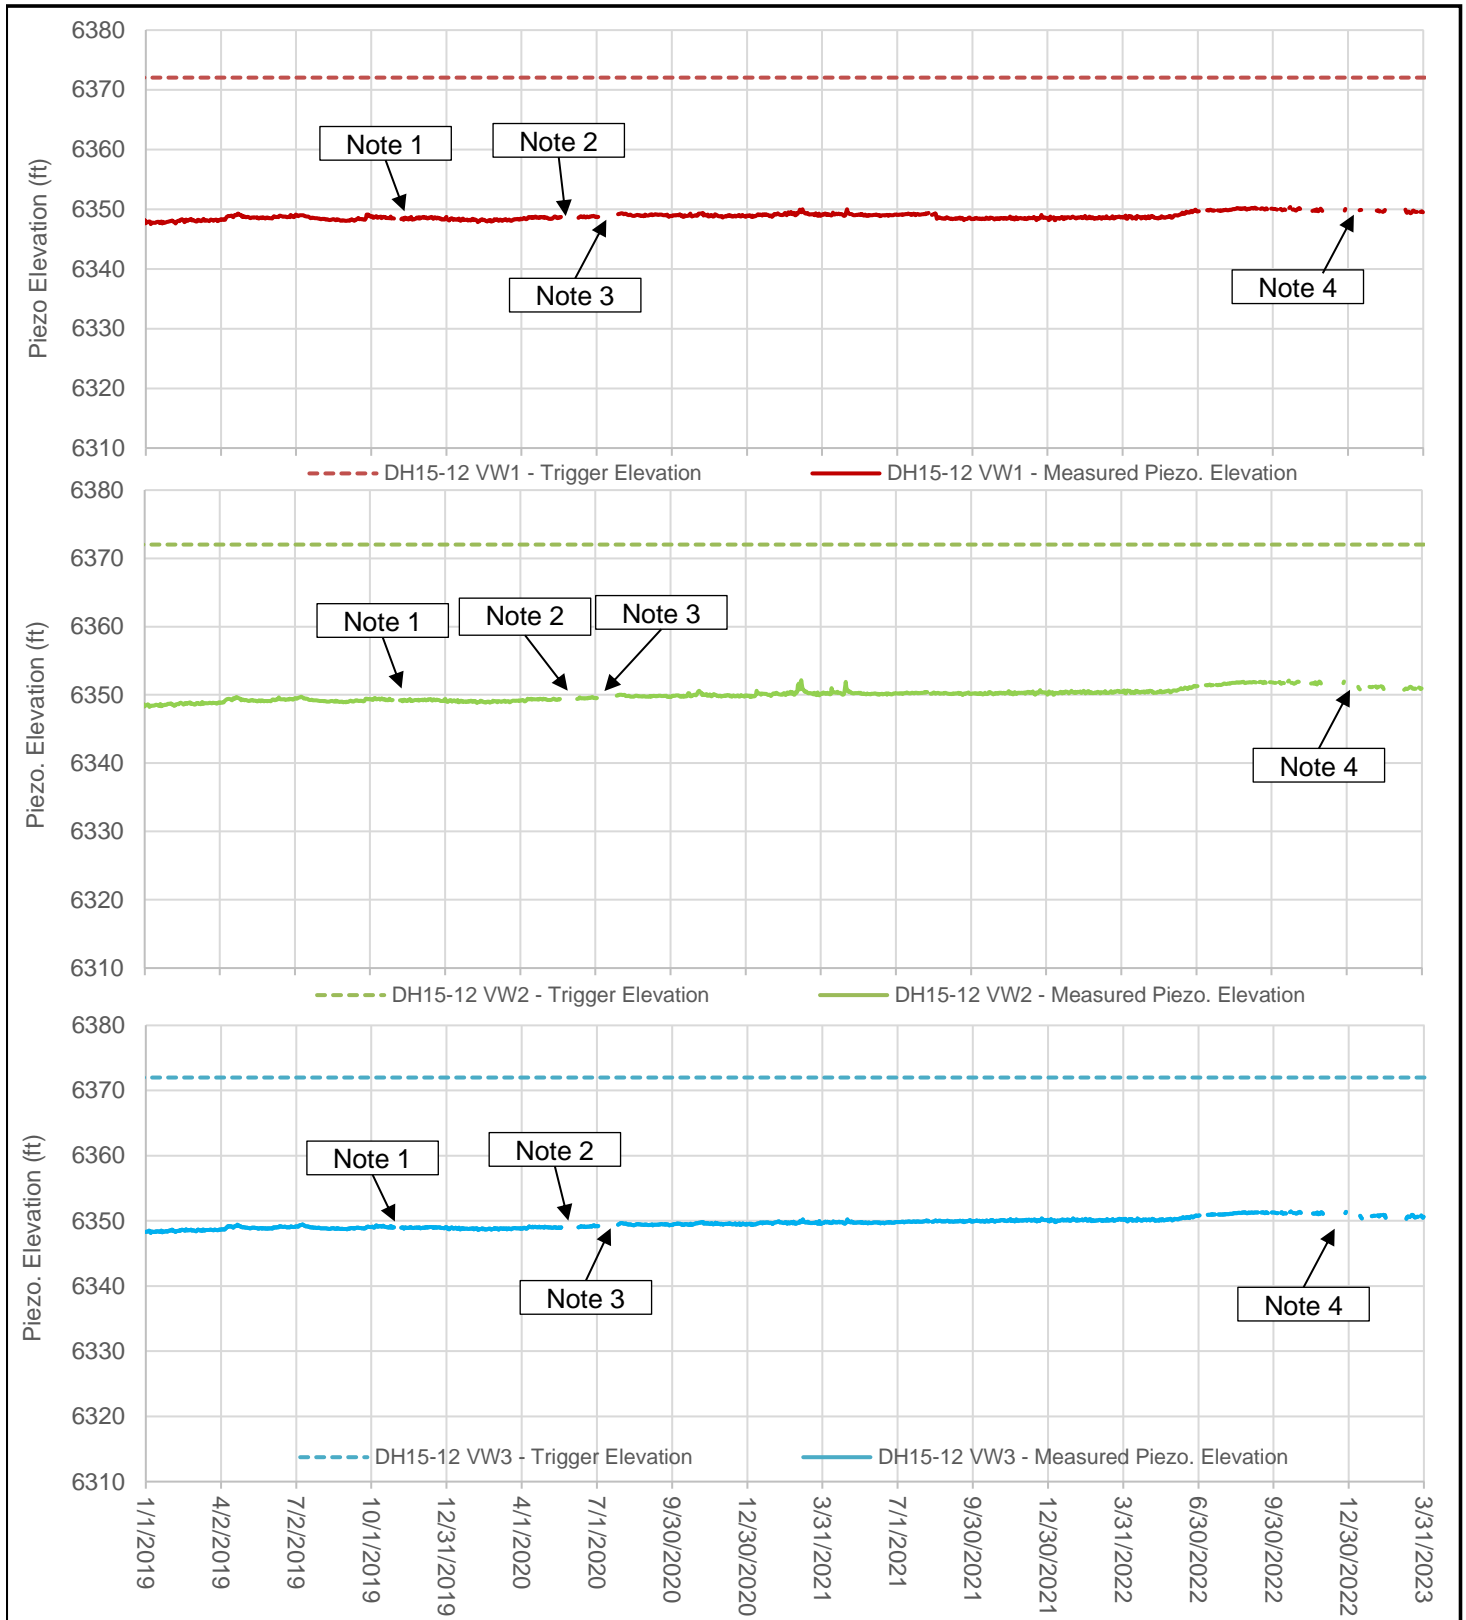
<b>Knight Piésold</b> CONSULTING	P/A NO. VA101-126/29		REF. NO. VA23-00701
	<b>FIGURE 5</b>		REV 0

- QPP sensors in drillhole DH15-12 (VW1, VW2, and VW3) are installed within the West Embankment foundation and monitored slightly decreasing pore pressures during Q1 2023 (less than approximately 0.5 ft). Data from the nested VW1 through VW3 sensors continue to indicate an upward gradient towards the drain.
- Pore water pressures monitored by QPP sensors installed in WED Drain Pods 1 and 2 (VWP-DP1 and VWP-DP2, respectively) monitored relatively stable pore water pressures during Q1 2023.
- The piezometric elevation monitored by the non-QPP sensor in the WED Extraction Basin (VWP-EB1) monitored relatively stable pore water pressures during Q1 2023.

QPP sensors installed in drillhole DH15-12 are presently more than 20 ft below the TOMS QPP trigger elevations. Sensors installed in Drain Pods 1 and 2 remain more than 25 ft below the trigger elevations. The recent pore pressure increases within the WED are likely attributed to continuous tailings deposition along the West Embankment during 2022, particularly from location RK-1 and the 12-inch discharges. Tailings discharge in this area likely contributed higher seepage flows to the WED and Extraction Pond, via slurry water infiltration into the tailings beach and embankment rockfill when the tailings slurry flows along the beach adjacent to the upstream side of the embankment.

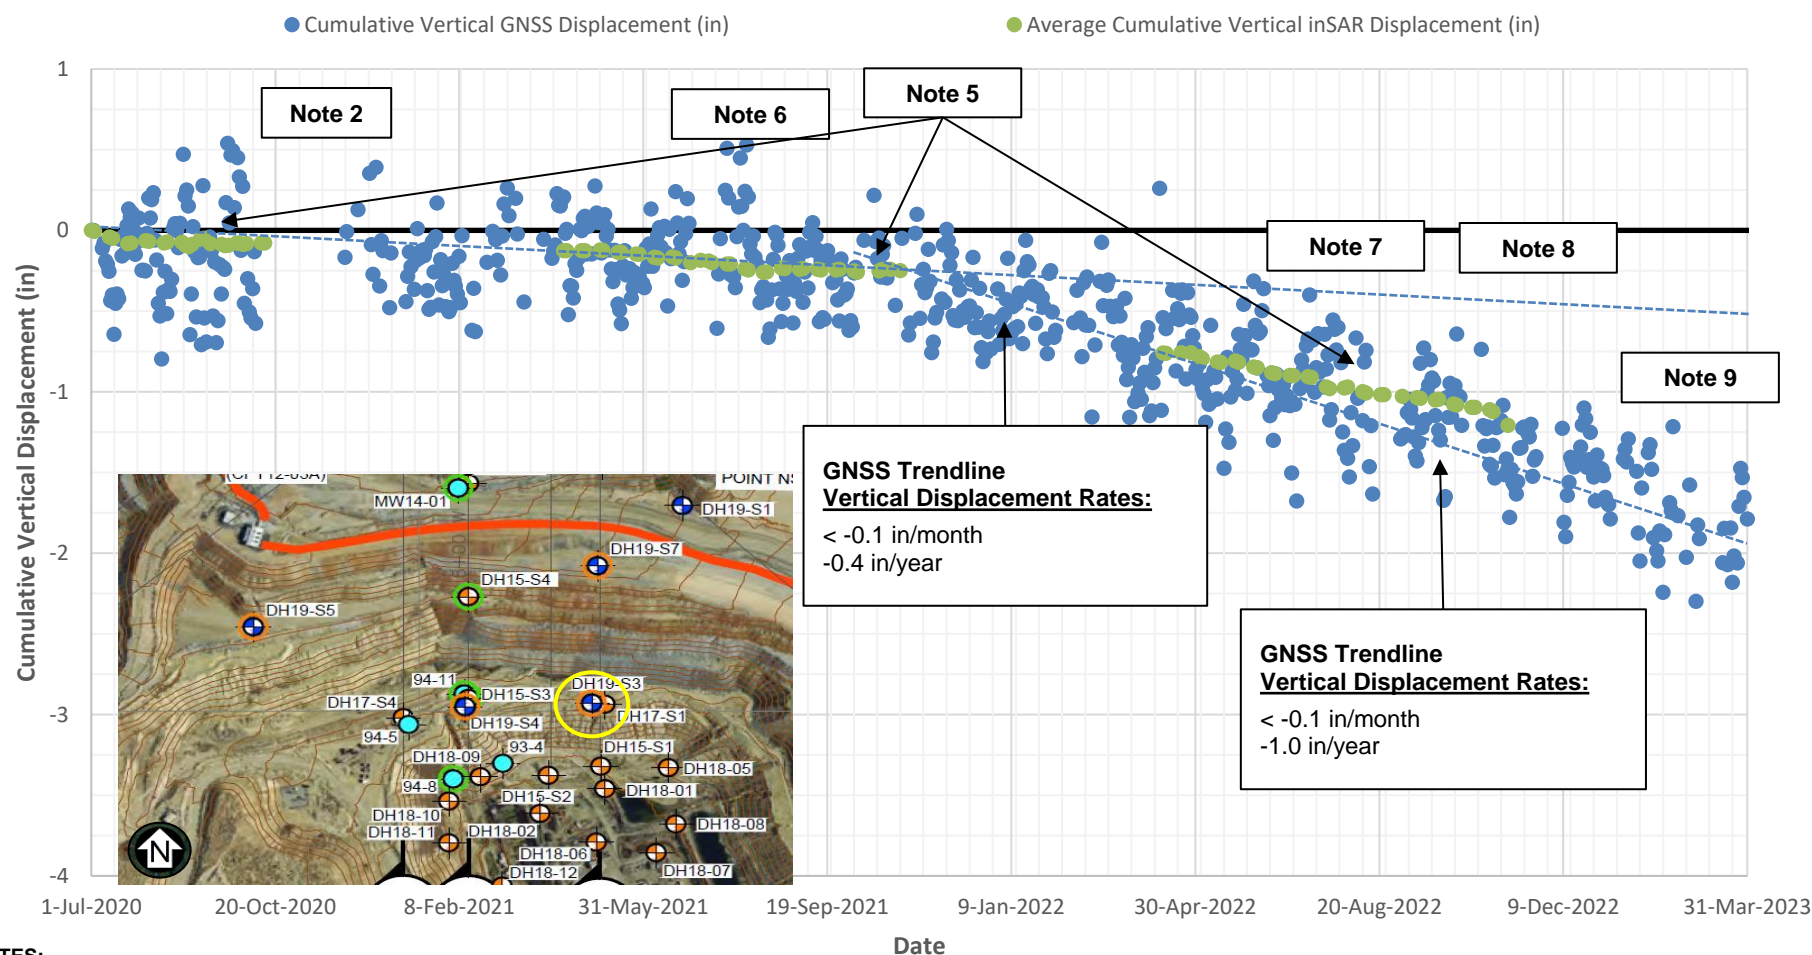
MONTANA RESOURCES LLC.			
YANKEE DOODLE TAILINGS IMPOUNDMENT			
CUMULATIVE VERTICAL DISPLACEMENTS MONITORED AT DH19-S3 (JULY 1, 2020 THROUGH MARCH 31, 2023)			
	P/A NO. VA101-00126/29		REF. NO. VA23-00701
	FIGURE A.1		REV 0

- Survey-monuments (GNSS DH19-S3, GNSS DH19-S4, SB-1, SB-2, and SB-3) installed along the Seep 10 Bench have previously observed slightly elevated surface deformation rates interpreted to signify influence from construction. Monitoring during Q1 2023 continued to indicate slightly slowing deformation rates.

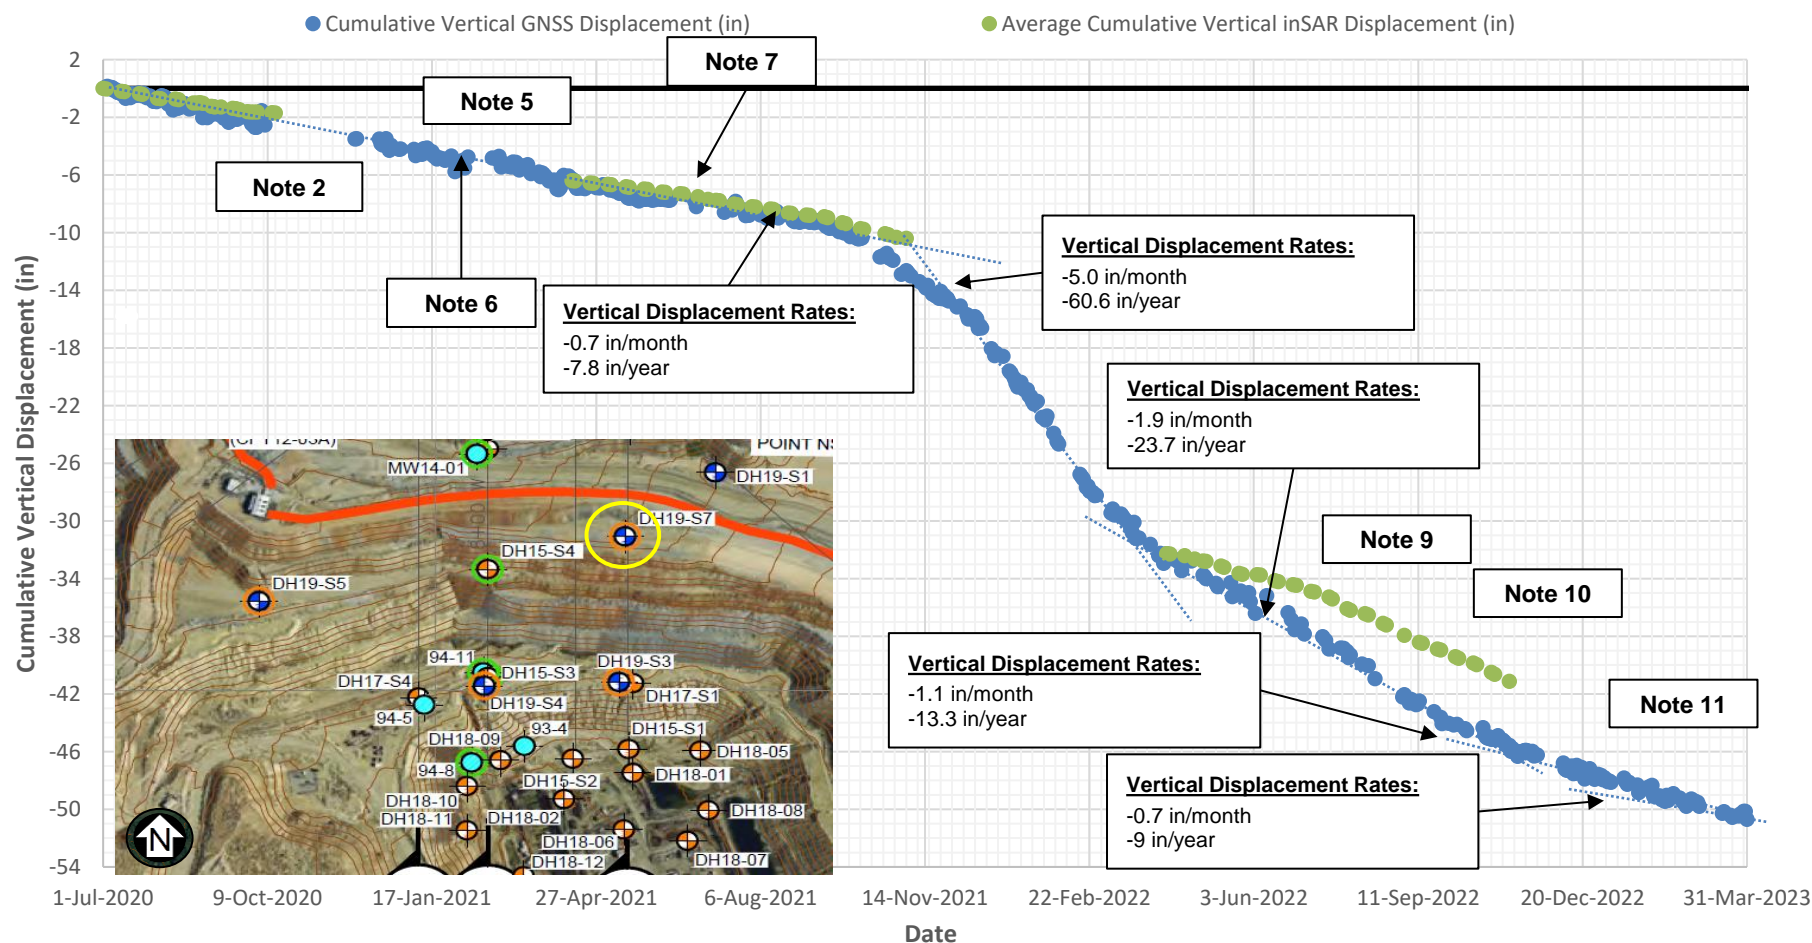
MONTANA RESOURCES LLC.			
YANKEE DOODLE TAILINGS IMPOUNDMENT			
CUMULATIVE VERTICAL DISPLACEMENTS MONITORED AT DH19-S7 (JULY 1, 2020 THROUGH MARCH 31, 2023)			
	P/A NO. VA101-00126/29		REF. NO. VA23-00701
	FIGURE A.7		REV 0

- QPP sensor DH19-S7 VW1 (Section 0+00) continued to monitor decreasing pore water pressures (approximately 2.4 ft) within the basal saturated zone during Q1 2023. No discernable influence from recent El. 6,450 ft central embankment lift construction is apparent within the basal system at this site. More significant influence has been observed by sensors DH19-S7 VW5 and VW7, within inferred perched saturated zones higher up within the embankment:
