**April 29, 2024**

**Knight Piésold Ltd.**  
Suite 1400 - 750 West Pender Street  
Vancouver, British Columbia  
Canada, V6C 2T8  
T +1 604 685 0543  
E [vancouver@knightpiesold.com](mailto:vancouver@knightpiesold.com)  
[www.knightpiesold.com](http://www.knightpiesold.com)

## **RE: Q4 2023 – YDTI Quarterly Piezometric and Deformation Monitoring Update**

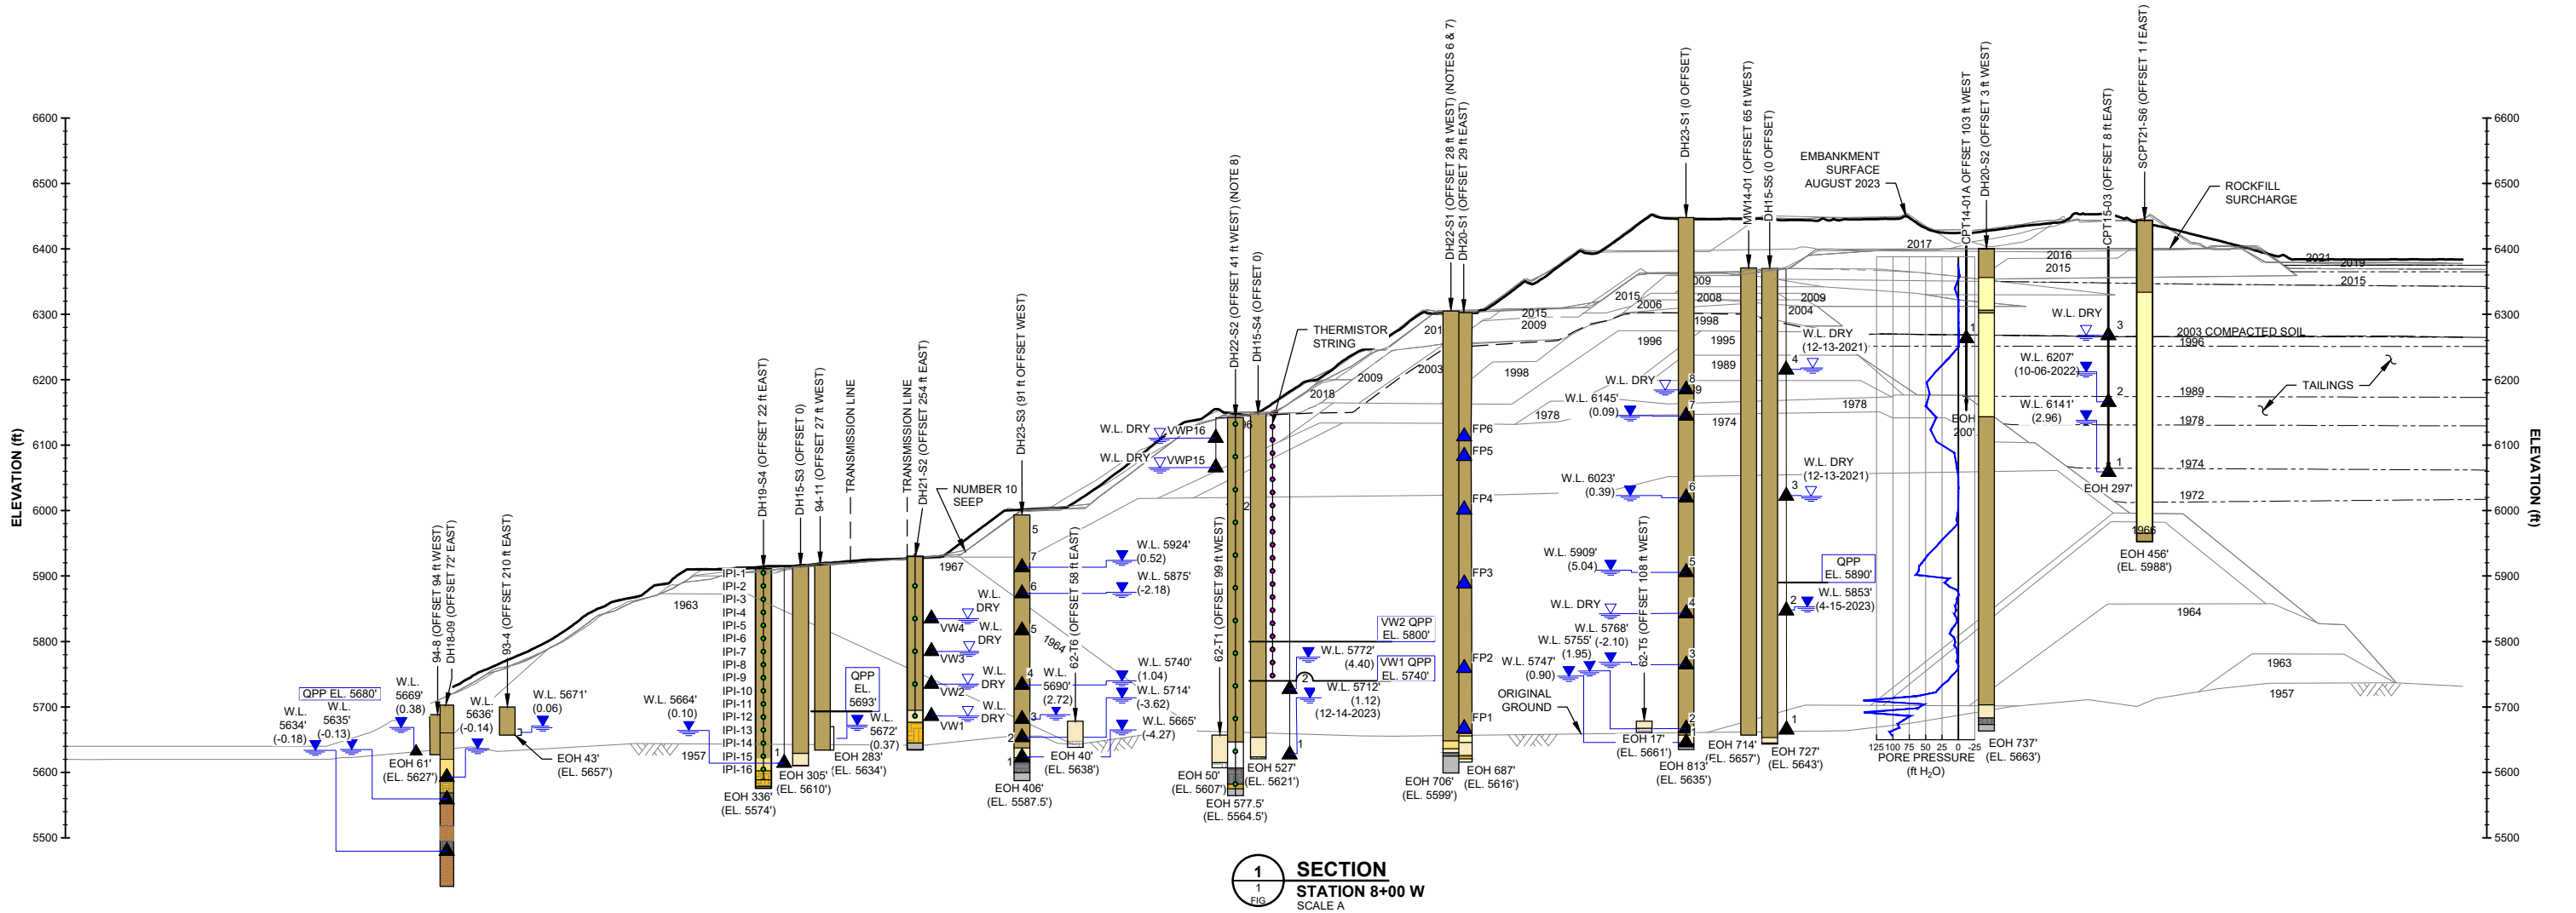
Piezometric monitoring within the East-West Embankment during Q4 2023 generally observed slightly increasing pore water pressures along Section 8+00W, with decreasing piezometric elevations observed on Section 0+00. Notable piezometric trends observed within the East-West Embankment are summarized below. No data are available from QPP and non-QPP sensors within DH15-S5 and DH17-S2 beneath the Central Pedestal Area East-West Embankment crest during Q4 2023. These sensors were damaged by construction; however, replacement sensors were installed in the general vicinity of the damaged instruments as part of the 2023 Site Investigation Program. Data from these sites will be incorporated into subsequent quarterly monitoring letters.

- QPP monitoring site DH15-S3 observed relatively stable pore water pressures (approximately 0.1 ft increase) during Q4 2023.
- QPP monitoring sites MW94-11 and MW94-08 monitored slightly increasing pore water pressures (approximately 0.4 ft at both sites).
- QPP sensor DH15-S4 VW2 (Section 8+00W) observed steadily increasing pore water pressure (approximately 4.4 ft) during Q4 2023 but remains below 28 ft below the trigger elevation.
- Non-QPP sensor DH23-S3 VW3 (installed downstream of DH15-S4) monitored a 2.5 ft pore water pressure increase between November 7<sup>th</sup> and December 21<sup>st</sup>, 2024.

- Non-QPP Geo4Sight instrumentation within drillhole DH20-S2 within the upstream embankment slope and foundation on Section 8+00W, monitored relatively stable pore pressures during Q4 2023.

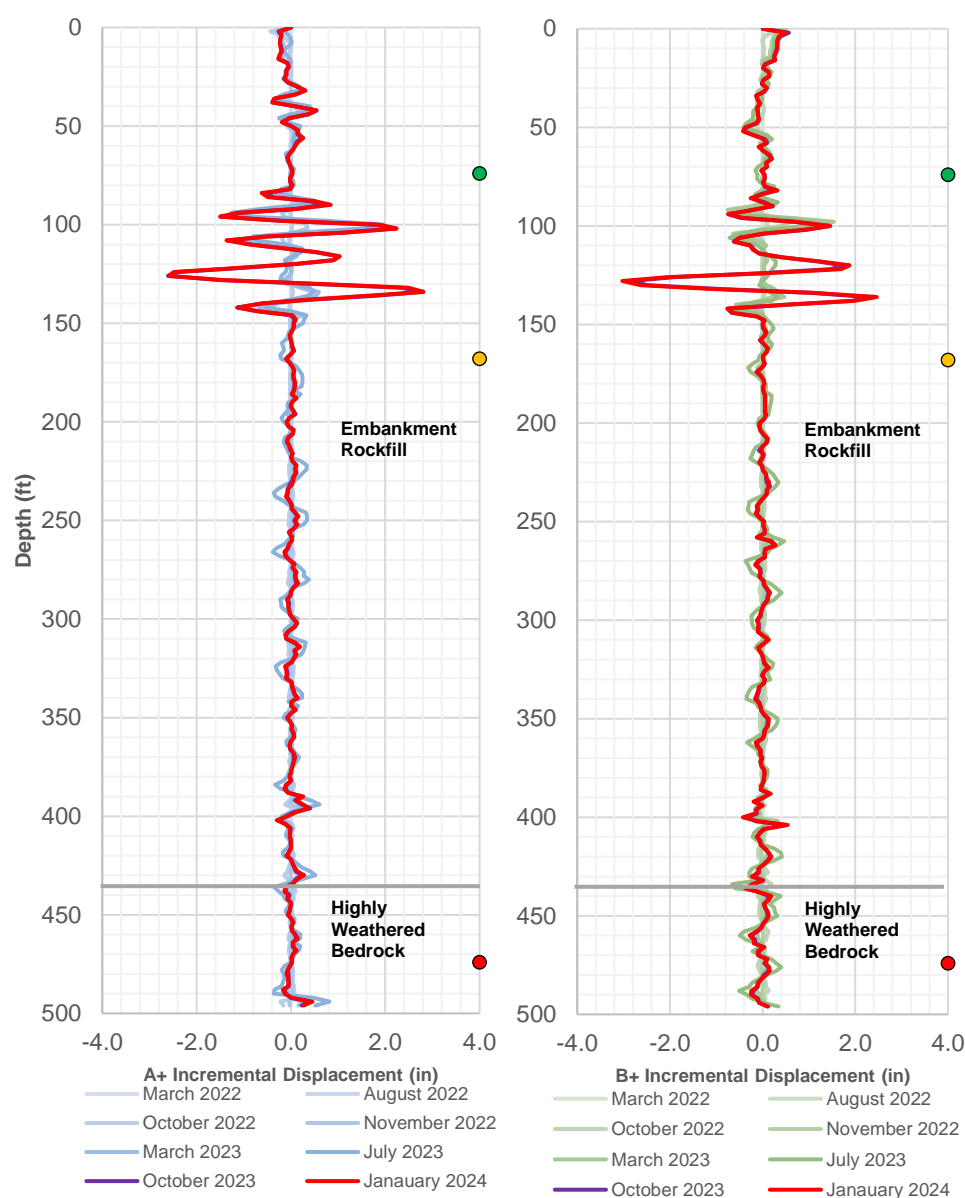
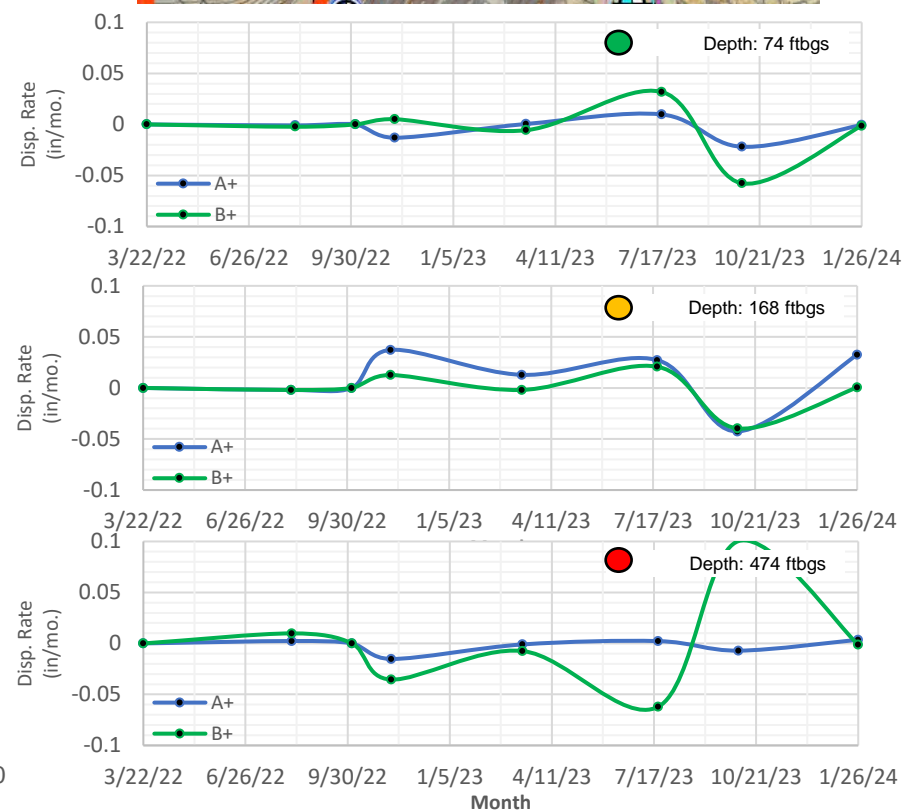
MONTANA RESOURCES, LLC		
MONTANA RESOURCES		
INCREMENTAL SUBSURFACE DEFORMATION DRILLHOLE AT DH21-S3 (MARCH 2022 THROUGH DECEMBER 2023)		
	P/A NO. VA101-126/29	REF. NO. VA24-00030
	<b>FIGURE B.13</b>	
		REV 0

- Inclinator DH21-S3, installed within the North-South Embankment and foundation near Section 28+00N, has monitored relatively minor downslope displacement and settlement since March 2022. Observed displacement rates are influenced by noise from ongoing settlement but do not indicate sustained increasing rates. More substantial settlement influence is present between approximately 100 and 150 ftbgs, in proximity to the interface between older rockfill (2009) and more recent (2018 and 2019) downstream step-out lifts.
