**Report of the Independent Review Panel**  
**Periodic Review No. 2 of Yankee Doodle Tailings Impoundment**  
**Montana Resources, LLC**  
**Butte Montana**

September 08, 2025

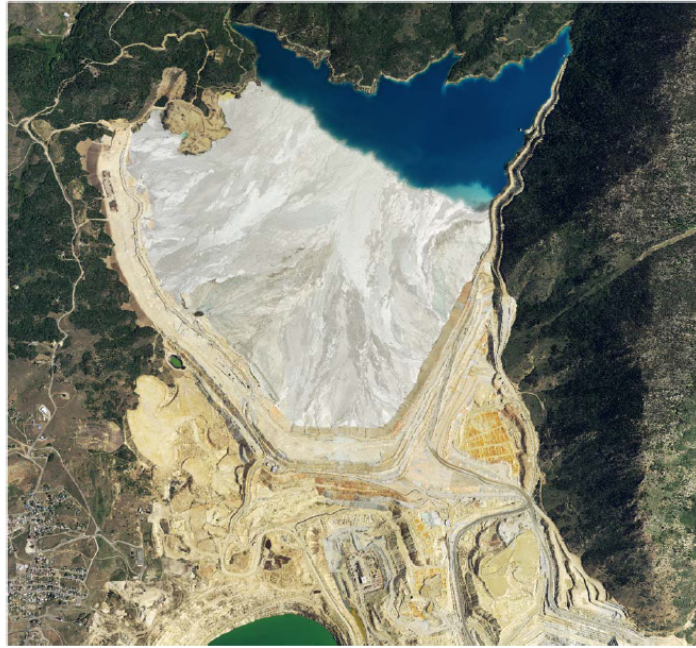
Figure 1 – YDTI as operated in 2024

Two major aspects of operations are tailings deposition and water management. There have been ongoing improvements in beach development since the change from a single point discharge to multiple spigots. Under normal operations, this has pushed the supernatant pond against natural ground at the north end of the facility, well away from the TSF embankments (Figure 1).
