## RE: Q2 2023 – YDTI Quarterly Water Data Summary

# Q2 2023 – YDTI QUARTERLY WATER DATA SUMMARY PHOTO LOG

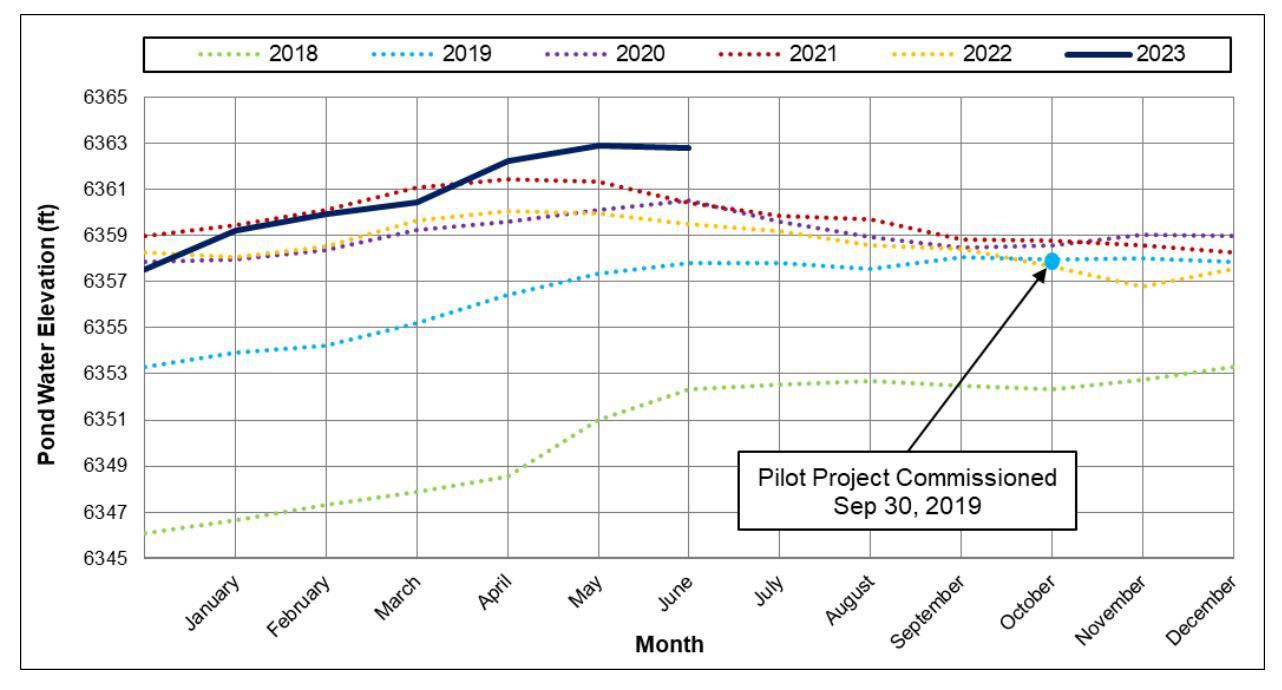
Figure 2.1 Monthly YDTI Pond Water Elevation

MR manually measures the YDTI supernatant pond elevation on a weekly basis. Monthly pond water elevations from 2018 through Q2 2023 are presented on Figure 2.1. The final pond water elevation recorded during the Q2 monitoring period was 6362.8 ft on June 21, which equates to a pond elevation increase of approximately 2.4 ft during Q2 2023. This contrasts the pond elevation decreases that occurred in Q2 of the previous two years and is mainly attributed to greater-than-normal precipitation events and melt of a larger-than-normal snowpack occurring throughout Q2 2023. The total precipitation measured in Q2 2023 was approximately 90% more than the average total in Q2 over the past decade.

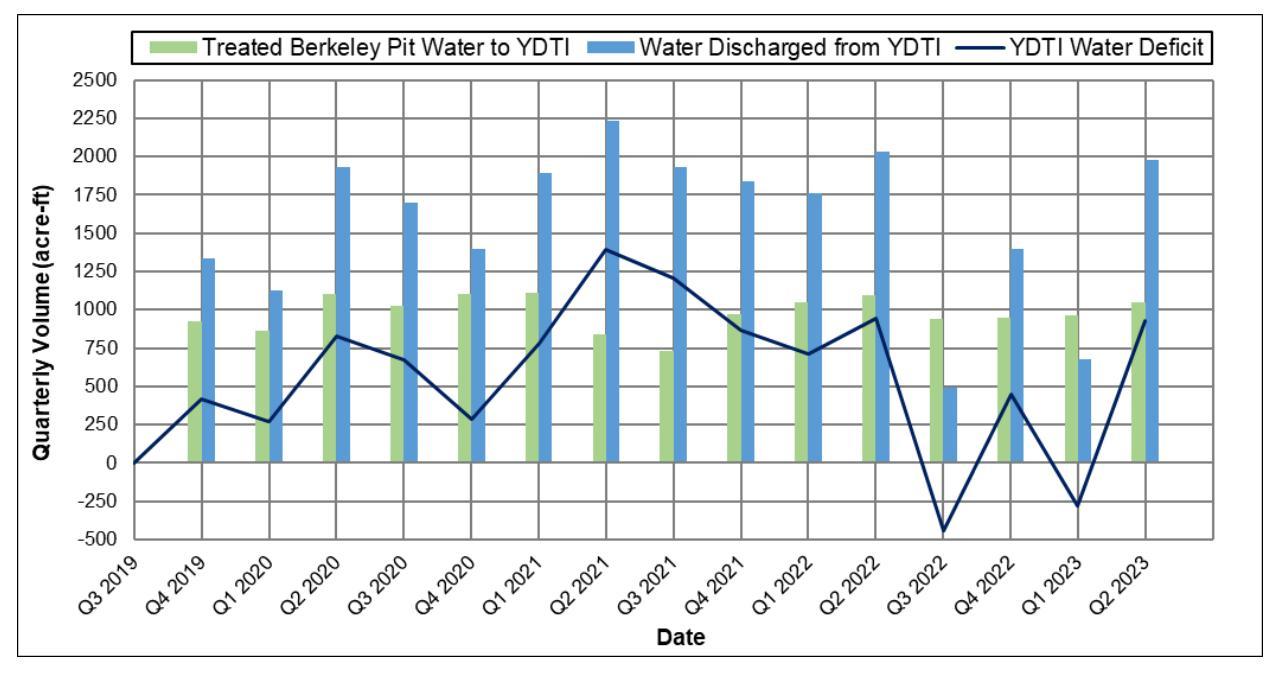
The YDTI supernatant pond had a net volume deficit of approximately 302 million gallons (927 acre-ft) of water in Q2. Approximately 342 million gallons (1,050 acre-ft) of treated Berkeley Pit water was discharged into the YDTI and 644 million gallons (1,976 acre-ft) of YDTI water was discharged off-site during Q2. The quarterly flow records for the Berkeley Pit Pumping System, Polishing Plant discharge, and YDTI quarterly balance since the Pilot Project commissioning in 2019 are shown on Figure 2.2.

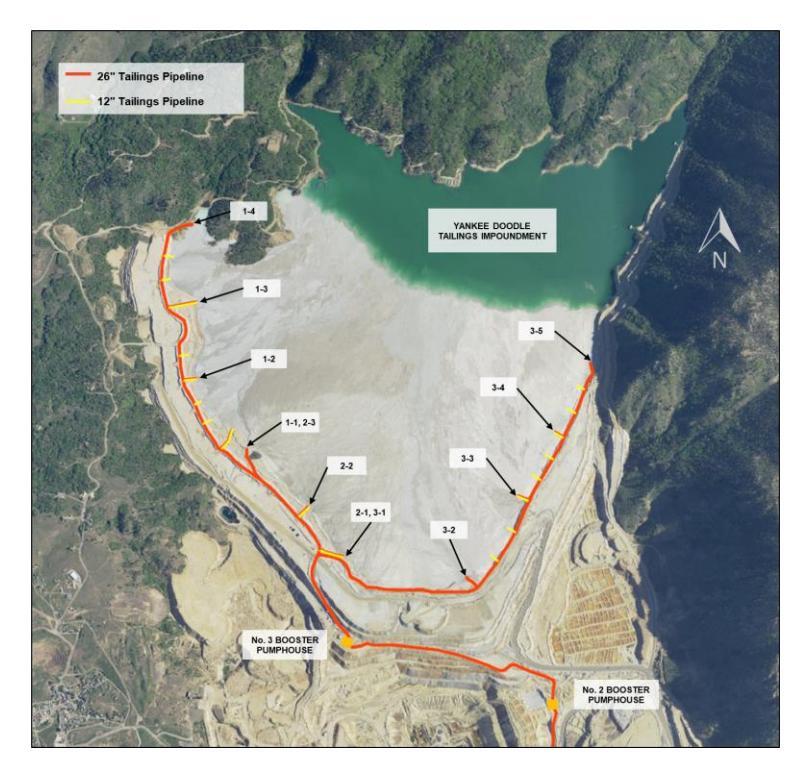
Figure 3.1 YDTI Tailings Discharge Locations

Tailings discharge records indicate that tailings were distributed from all three YDTI embankments during Q2 2023, with four of the ten 26-inch discharge locations and two of the 12-inch discharge lines being used. The tailings discharge locations are shown on Figure 3.1, and the quarterly tailings beach elevations at each of the discharge locations are shown on Figure 3.2.

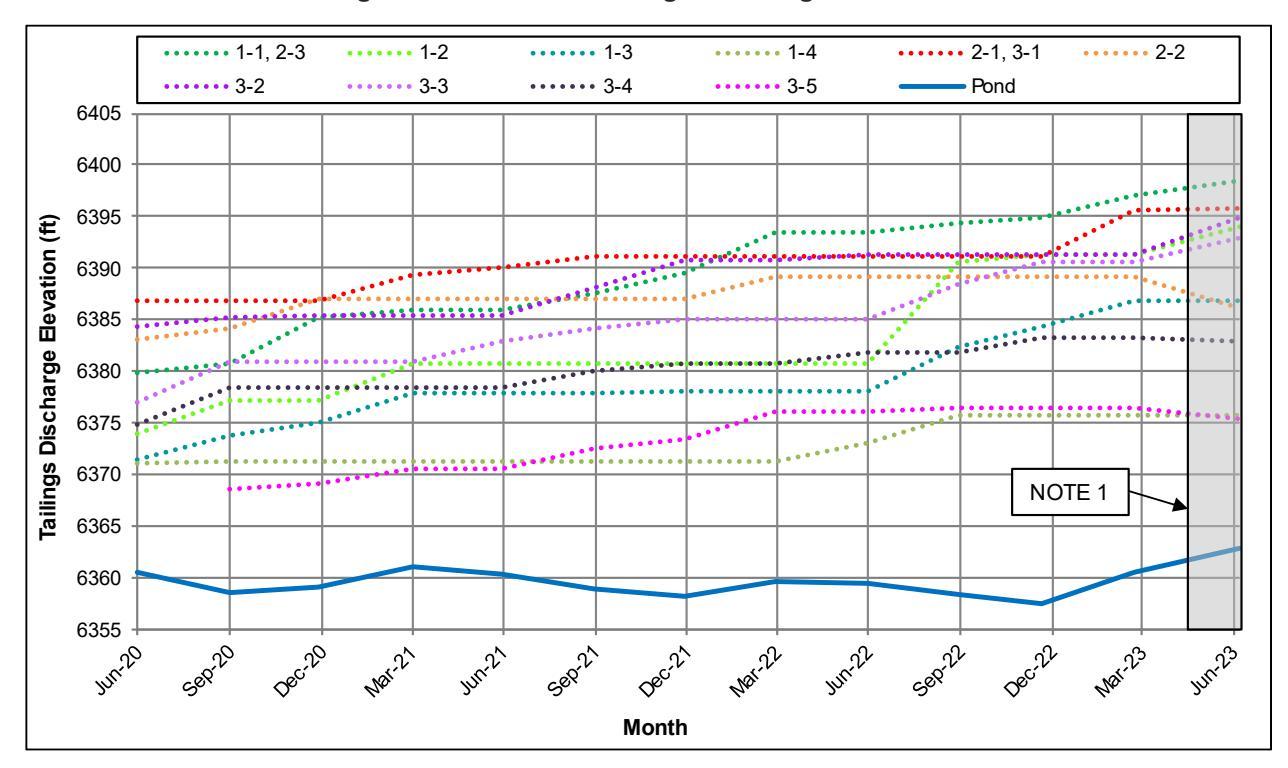
The discharge spigot with the lowest beach elevation was 3-5 at the end of Q2 2023. The elevation difference between 3-5 and the supernatant pond surface was approximately 12.6 ft at the end of Q2 2023. The location of the lowest discharge point identifies the general area of the facility where the pond may initially contact the embankment in the event the pond elevation rises due to an increase in pond volume (e.g., flooding). MR has completed discharge elevation surveys manually up to June 14, 2023. The last set of discharge elevations shown on Figure 3.2 was obtained by a drone flyover survey conducted on July 12, 2023. MR sent KP the resulting aerial image and surface file, and KP used these files to determine the approximate elevations of the discharge pipe ends at each location. Note that location 1-4 was out of the drone survey bounds.

1. Last survey in Q2 completed via drone flyover. Tailings discharge locations were estimated from the drone photo and may differ from previous survey locations.

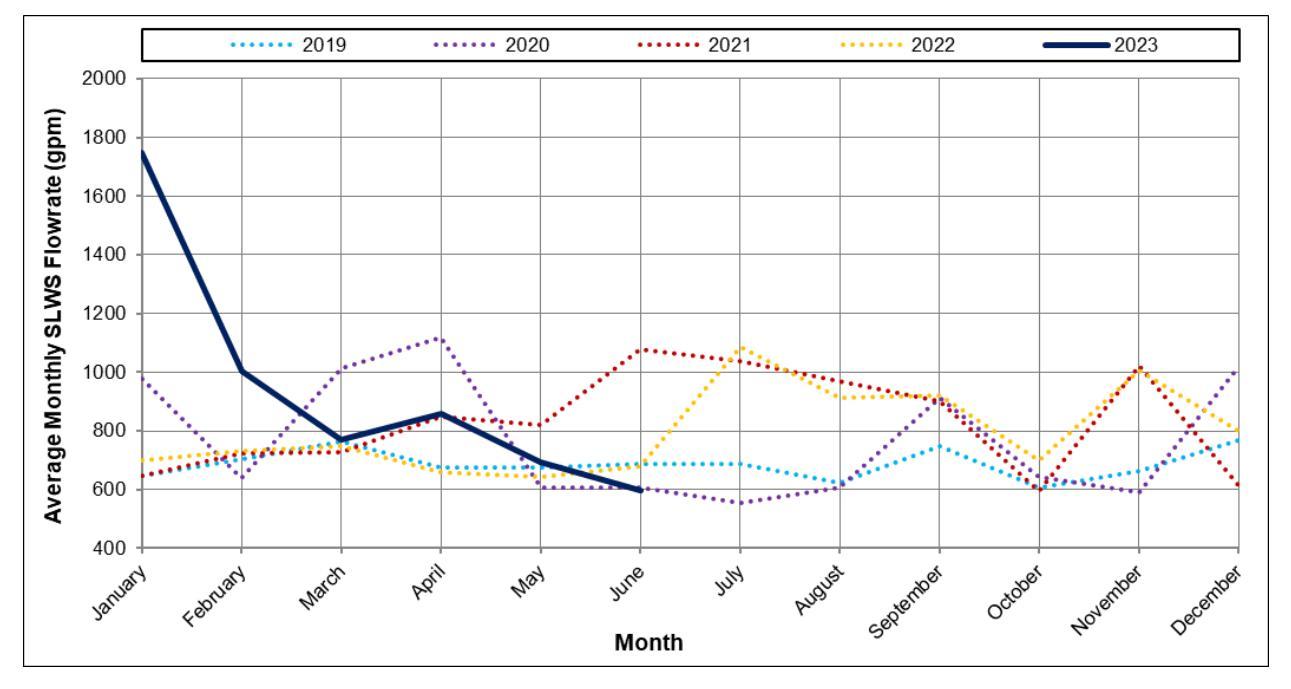
Figure 4.1 Average Monthly SLWS Flowrate

Water from the Silver Lake Water System (SLWS) is used to meet both the operational freshwater and make-up water requirements. SLWS flows in Q2 2023 averaged 716 gpm (1.0 Mgpd), which is similar to the average Q2 flowrate over the past five years. Average monthly SLWS flowrates from 2019 through Q2 2023 are shown on Figure 4.1.

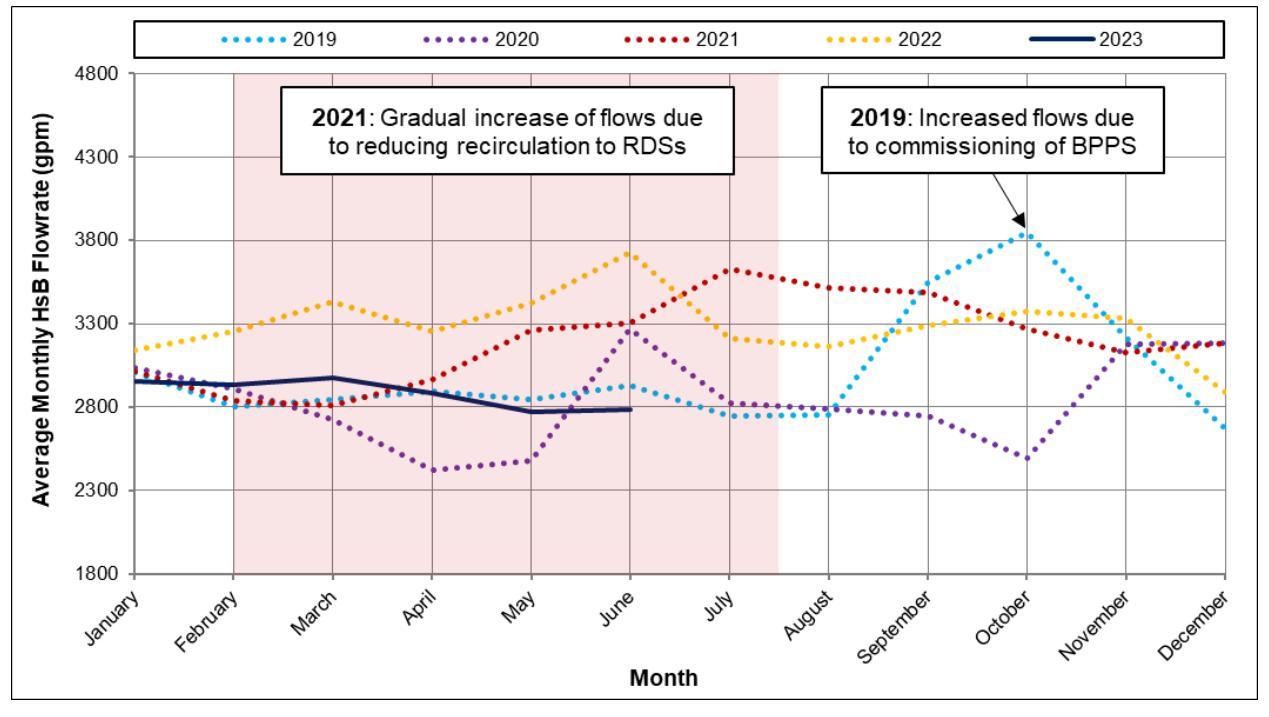
Figure 5.1 Average Monthly HsB Weir Flowrate

The average flowrate during Q2 2023 was approximately 2,810 gpm, which is approximately 510 gpm (15%) lower than the average Q2 flowrate over the past two years. The Q2 2023 average is also similar to the Q1 2023 and Q2 2019 averages; the HsB Weir flowrates may be returning to a steady state since recirculation of leach solutions to the rock disposal sites (RDSs) ceased in Q3 2021. A longer period of data is required before this can be confirmed. Average monthly HsB Weir flowrates are presented on Figure 5.1.

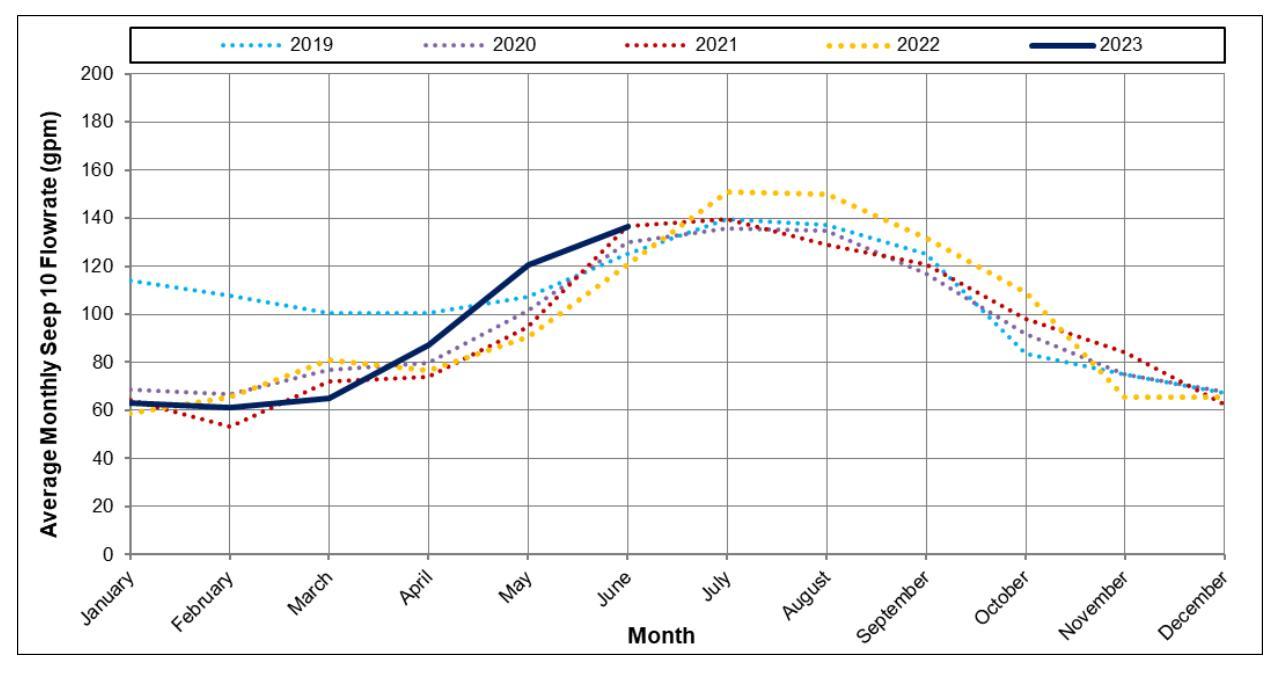
Figure 6.1 Average Monthly Seep 10 Weir Flowrate

The average monthly Seep 10 flowrates from 2019 through Q2 2023 are presented on Figure 6.1. The flowrates during Q2 2023 were on average approximately 16% (16 gpm) higher compared to Q2 over the past three years. This increase is attributed to the greater-than-normal precipitation and snowmelt events. The seasonal trend remains consistent with the trend observed over the past three years.

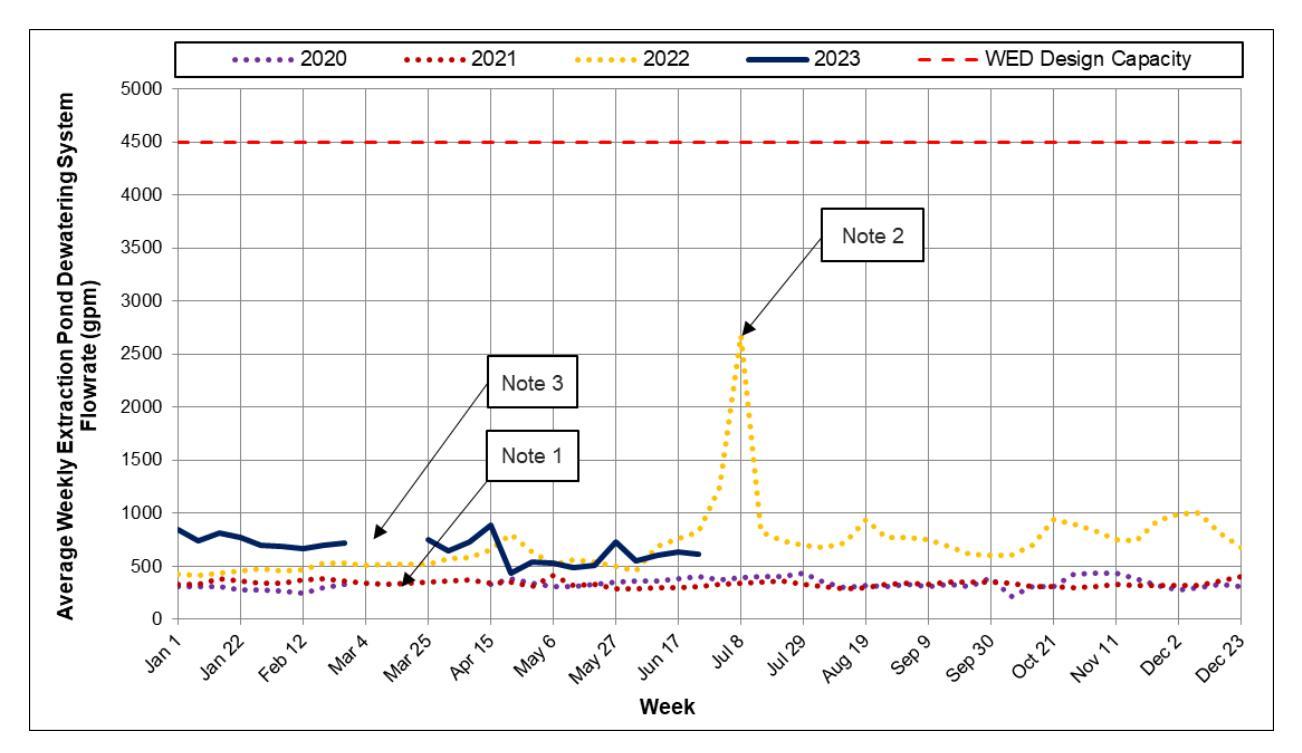
#### Figure 7.1 Average Weekly Extraction Pond Dewatering System Flowrate

The average weekly flowrates for the Extraction Pond Dewatering System since it began operating on November 20, 2019 are presented Figure 7.1. The WED average weekly pumping rates ranged between 300 to 500 gpm for the first two years and increased in early 2022 to range between 500 to 1,000 gpm. The increased flowrates recorded since early to mid-2022 are attributed to the discharge of tailings overtop of the historical tailings pipeline corridor for the EL. 6,400 ft lift of the West Embankment causing increased infiltration of tailings water into the WED.

- 1. Erroneous data caused by pump cycling from March to April 2020 were removed.
- The average weekly Extraction Pond Dewatering System flowrate peaked July 9 to 15, 2022. This high flowrate is attributed to a single event on July 9 associated with power outages and subsequent increase in pumping rate to reduce the WED pond elevation.
- 3. Erroneous data suspected to be due to a flowmeter error from March 4 to 18, 2023 were removed.

MR and KP anticipate the WED pumping rates will vary throughout the year depending on tailings discharge practices and may slowly decrease over time as the tailings beach thickness increases above the EL. 6,400 ft pipeline corridor bench. MR have been closely monitoring the daily pump data records and conducting regular visual inspections of the tailings beach adjacent to the West Embankment. No adverse conditions have been observed to date. MR will continue to regularly monitor the tailings discharges in this area and associated changes in pumping rates required to maintain dewatering of the Extraction Pond.

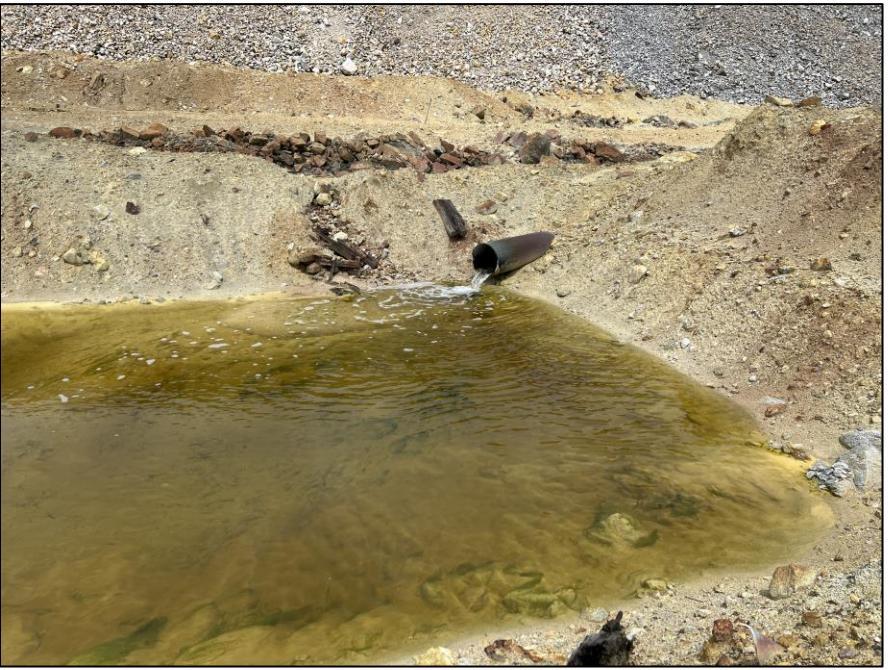
The Number 10 Seeps (Seep 10) daylight on the EL. 5,900 ft bench above the HsB seepage collection area. The seepage is collected in a small pond on the top of the EL. 5,900 ft bench and is routed to the HsB seepage collection area via a pipe. The Seep 10 flows are measured using an ultrasonic lookdown level sensor that automatically measures the stilling pond level near the weir. Images of the Seep 10 stilling pond taken on June 12, 2023 are presented in Appendix A – Photos 1 and 2.

PHOTO 1 – June 12, 2023 – Seep 10 Stilling Pond.

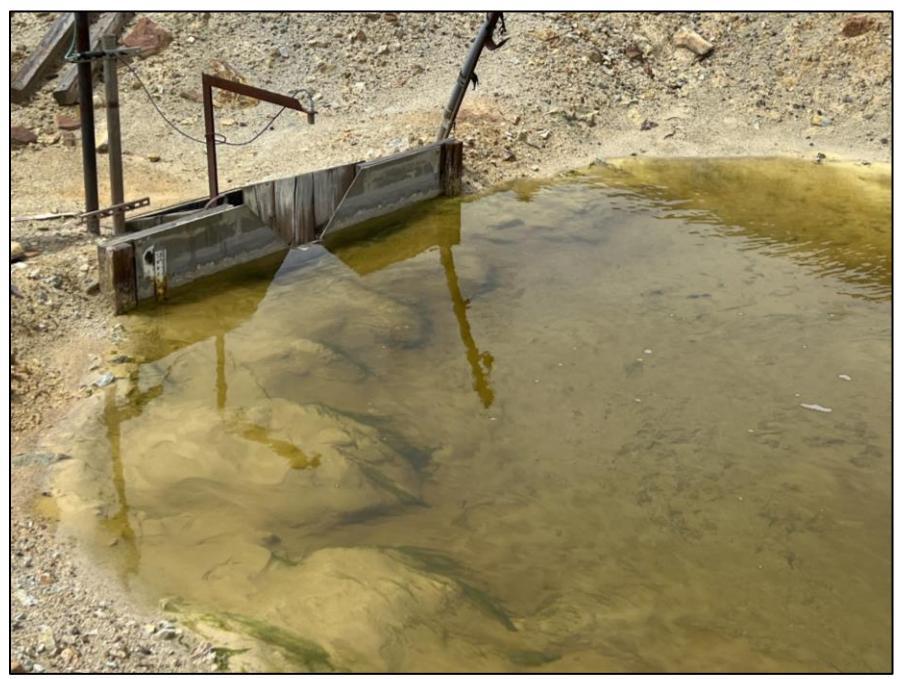
PHOTO 2 – June 12, 2023 – Seep 10 Weir and Staff Gauge reading slightly below 0.4.

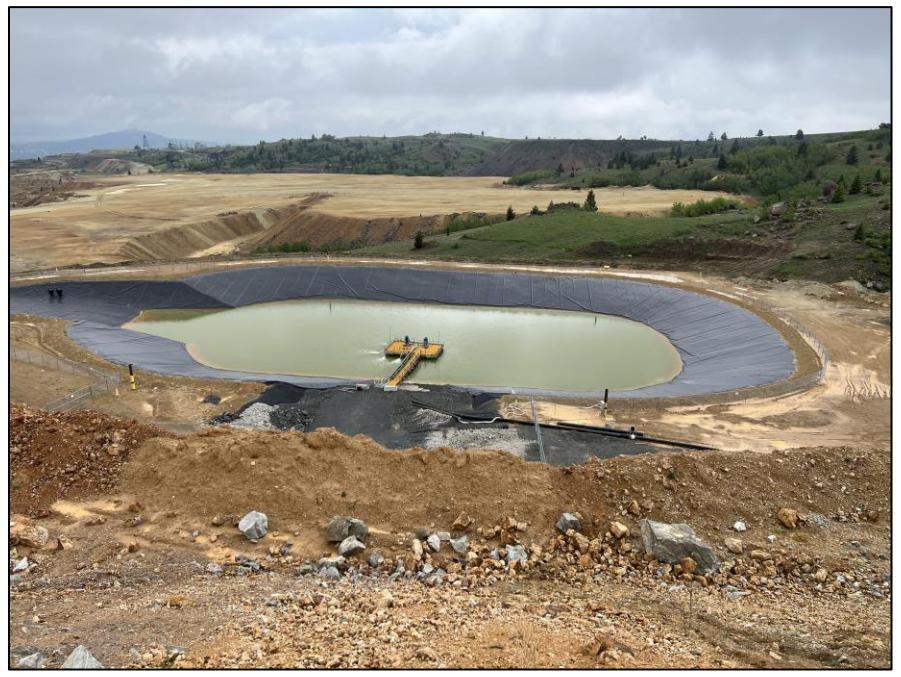
Water collected in the WED flows by gravity into the Extraction Pond and is pumped to the YDTI via the Extraction Pond Dewatering System. The flows are measured using an inline totalizing flowmeter. An image of the WED Extraction Pond and Dewatering System taken on June 12, 2023 is presented in Appendix A – Photo 3.

PHOTO 3 – June 12, 2023 – WED Extraction Pond and Dewatering System.

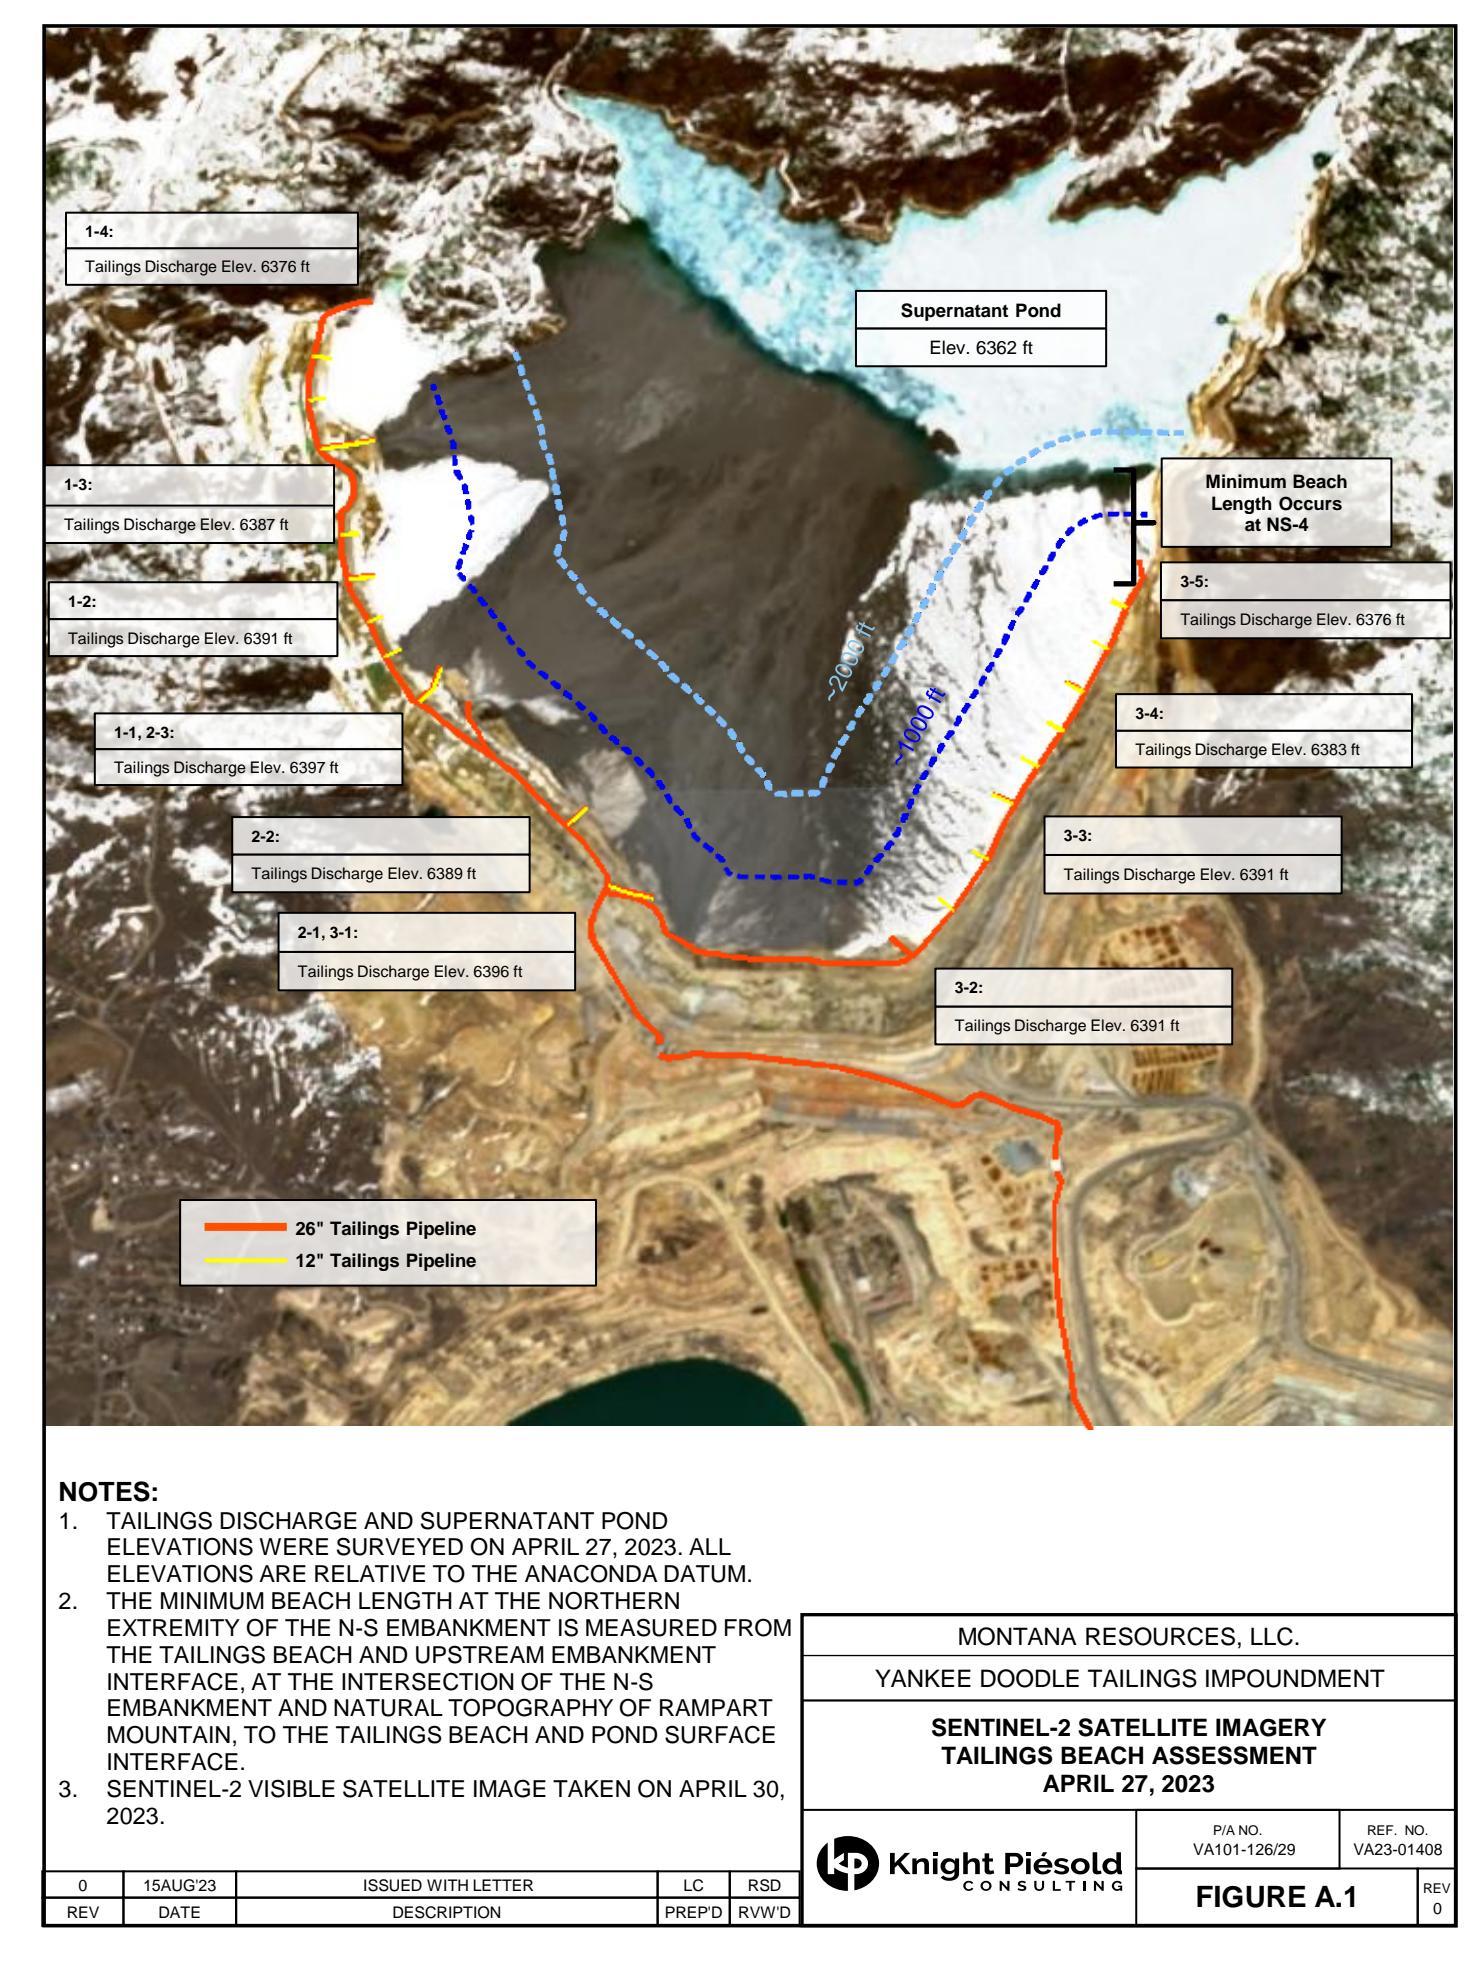
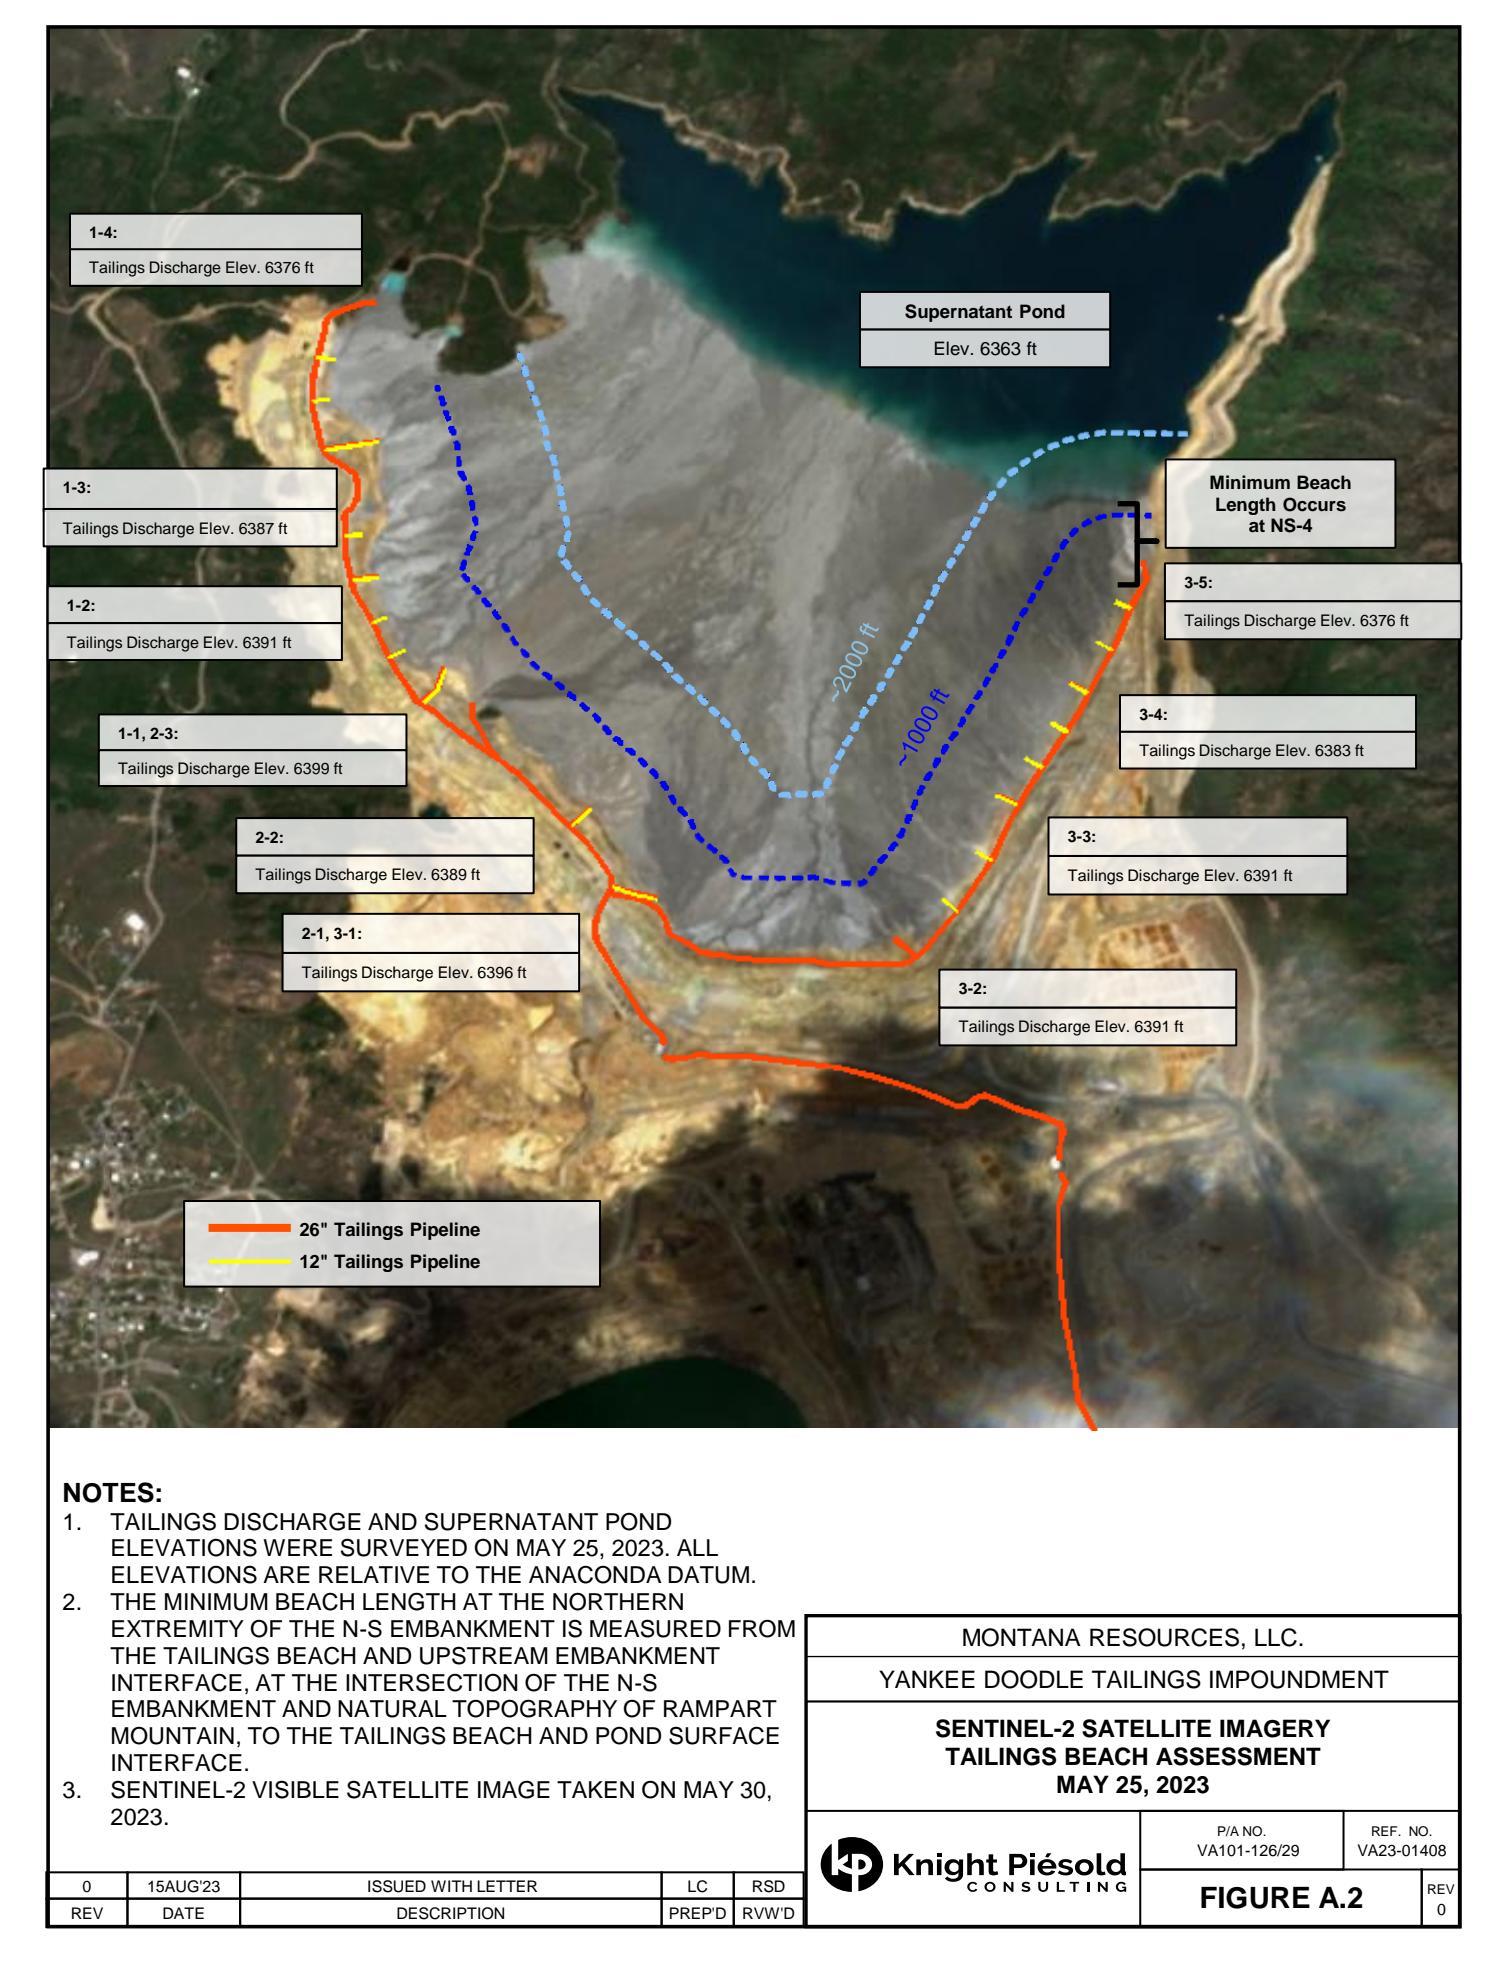
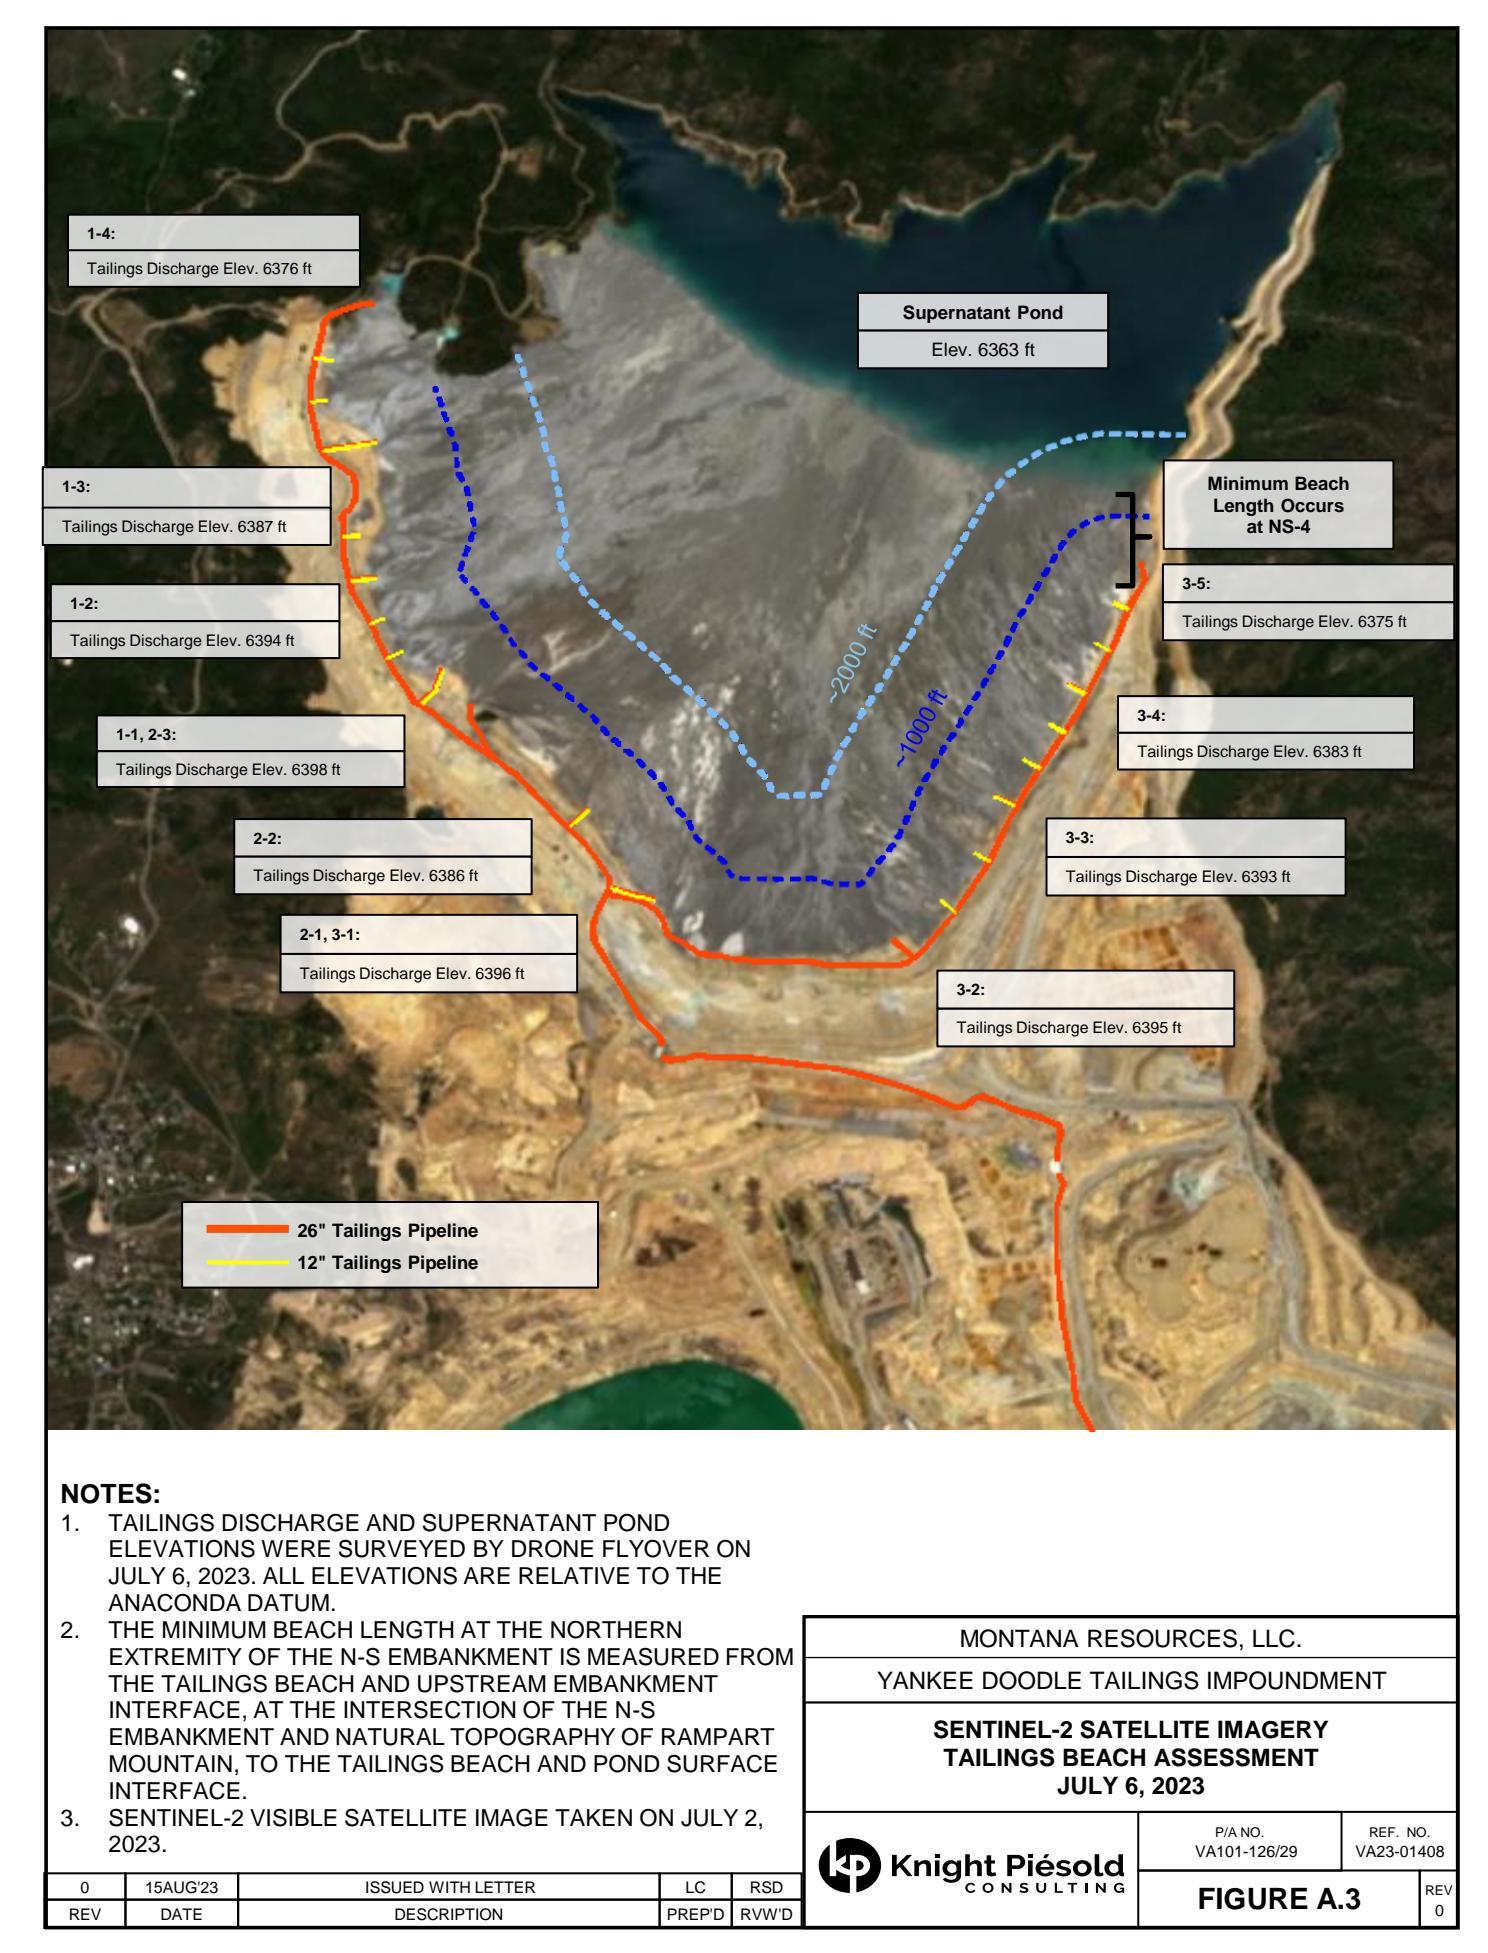
Images captured by the Sentinel-2 satellite are reviewed twice per month to remotely observe the shape of the tailings beach and position of the supernatant pond relative to the embankments. The shortest beach length was observed at the northern end of the North-South Embankment and estimated to be approximately 1,050 ft at the end of Q2, which is approximately 400 ft shorter than the end-of-Q1 2023 beach length. This decrease in beach length is attributed to the greater-than-normal precipitation and snowmelt events, which contributed to the pond water elevation increasing and less beach being exposed as the beach/pond interface extends southward. The minimum beach length however still exceeds the 200 ft minimum beach length Quantitative Performance Parameter (QPP) outlined in the YDTI Tailings, Operation, Maintenance and Surveillance Manual (TOMS) (MR/KP, 2022).

An overview of the facility observed from the Sentinel-2 satellite images near the end of April, May, and June 2023 are presented in the attached figures. The elevations indicated on the end-of-June 2023 image were obtained from the drone survey discussed in the previous section. MR plans to conduct a drone flyover survey on a quarterly basis starting Q3 2023. KP will estimate the discharge locations and elevations based on the aerial image and surface data from MR.
