February 6, 2024

Mr. Mark Thompson Vice President - Environmental Affairs Montana Resources, LLC 600 Shields Avenue Butte, Montana USA, 59701

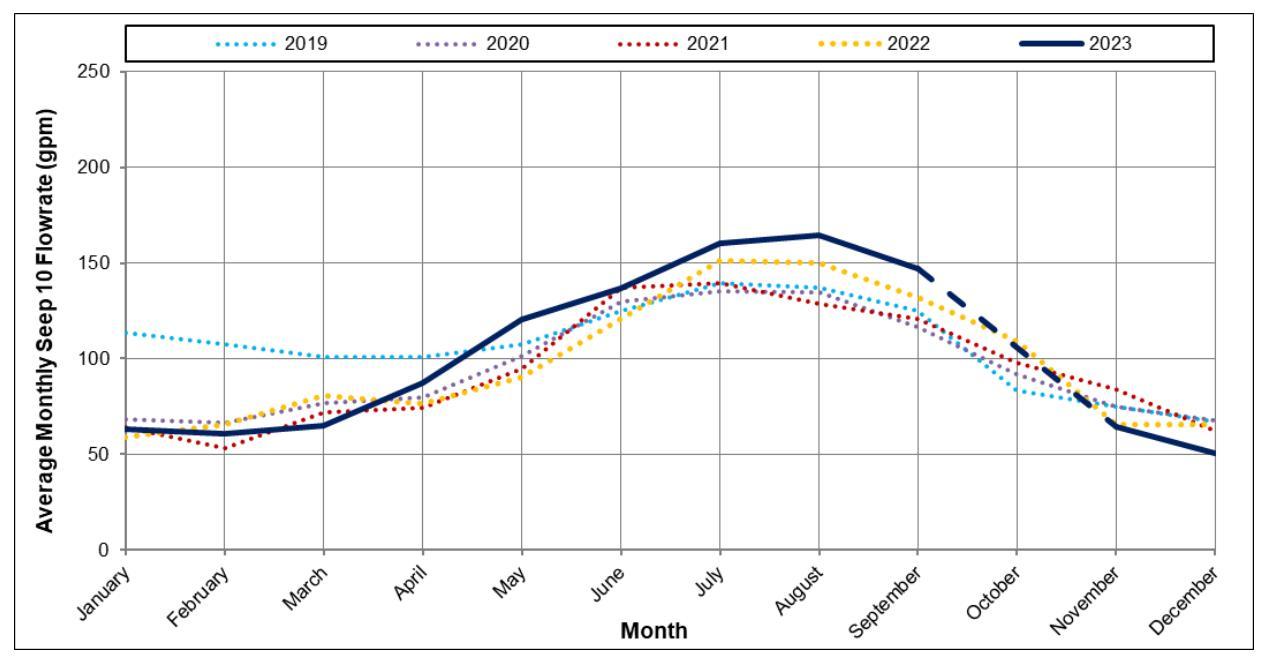
Figure 6.1 Average Monthly Seep 10 Weir Flowrate
