**VA101-126/24-9**

# **MONTANA RESOURCES**

## **YANKEE DOODLE TAILINGS IMPOUNDMENT - FAILURE MODES AND EFFECTS ASSESSMENT FOR 6,560 AMENDMENT DESIGN DOCUMENT**

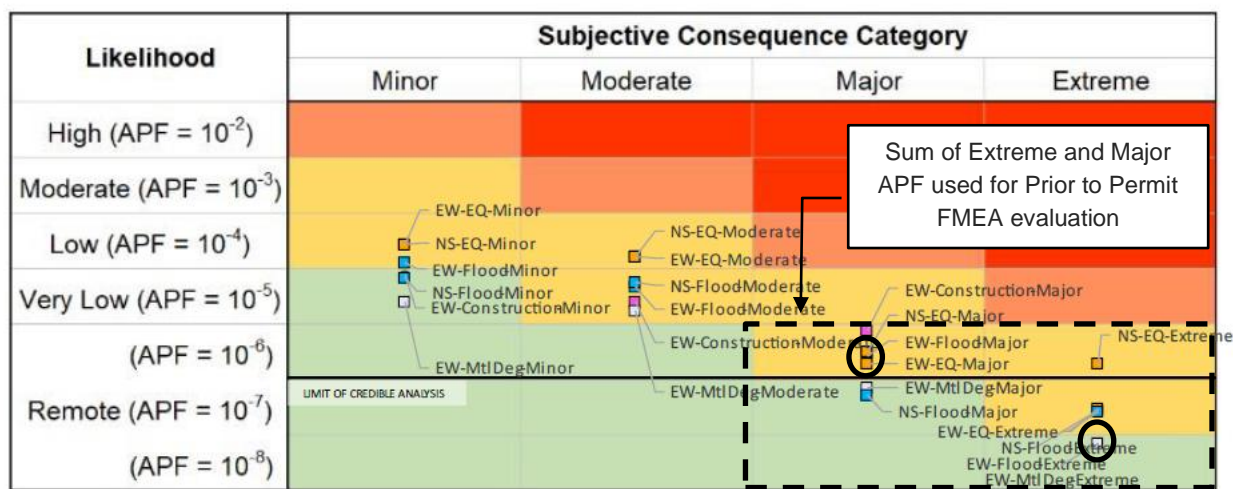
**Figure 3.1 2022 Risk Assessment Report: Results – Risk Summary by Major Hazards (adapted from Figure 3.4 of KP, 2023)**

For example, Figure 3.1 shows the 2022 Risk Assessment event tree analysis results by major hazards. The cumulative APF estimated for global instability of the East-West Embankment due to severe flooding was estimated to be 2.6E-07 for Extreme consequences and 2.5E-06 for Major consequences for the EL. 6,450 ft arrangement. The sum of these two categories results in an estimated cumulative APF of 2.8E-06. This equated to a likelihood rating of 5 for this PFM using the Table 2.2 mapping scheme. The potential consequences of failure were then rated using Table 2.3, which in this example was conservatively rated as a 4 (Extreme). The overall FMEA rating for this PFM is shown as point '1-EW' on Figure 3.2.

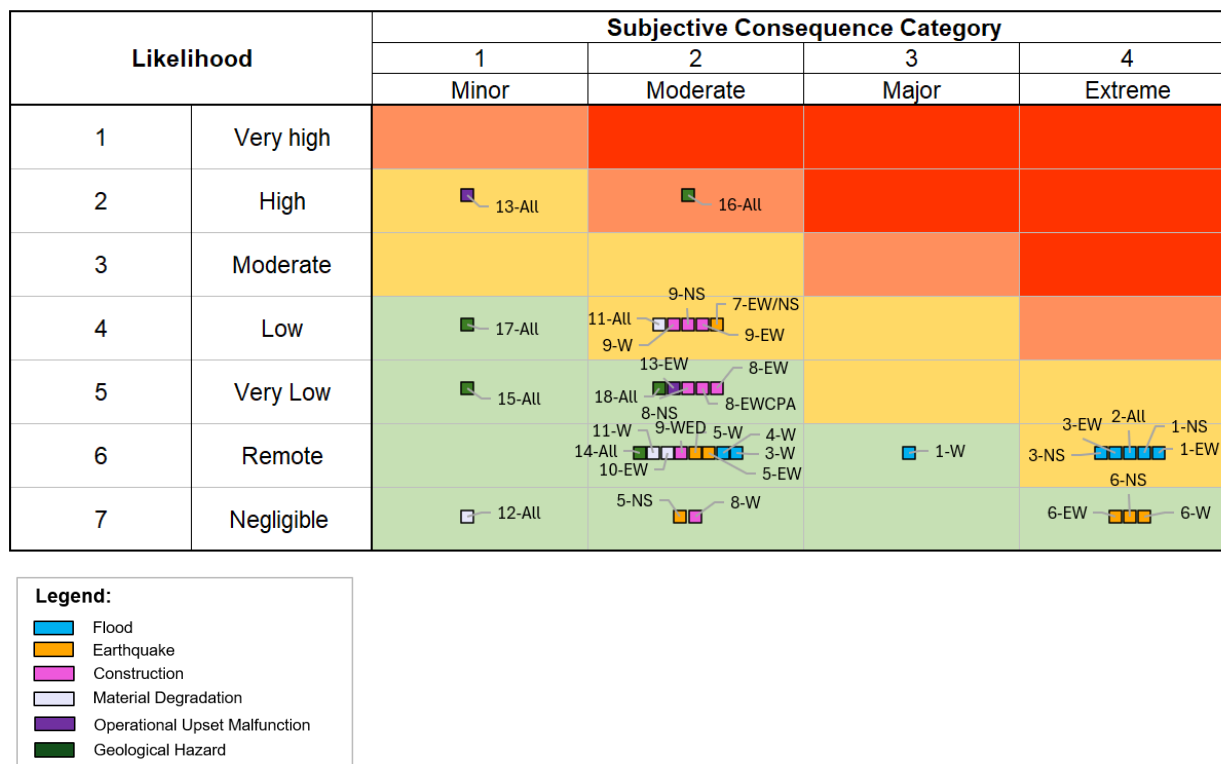
**Figure 3.3 Life of Mine Arrangement – FMEA Risk Ratings**

For example, the inferred reduction in likelihood from Category 5 to 6 for the flood-induced instability along the East-West Embankment is based on improved resistance against global instability (FS increases from 1.5 to > 2.0 for Normal Operating (peak undrained strength) condition and FS increase from 1.2 to > 1.5 for Post Earthquake (residual undrained strength) condition. These improvements combined with the reasonable expectation of a smaller remnant pond and spillway to manage beach inundation at closure support the lower likelihood rating.

A summary of the risk ratings for the Life of Mine arrangement are presented on Figure 3.3.
