ANNUAL PROGRESS REPORT FOR OPERATING PERMITS

Name and Address of Permittee		Legal Description and Location of Permitted Area
Montana Resources, LLC 600 Shields Avenue Butte, Montana		Section(s): See Attachment 1 County: Silver Bow Directions, in miles, from the nearest town: 1-2 miles east of Butte, Montana
Primary Contact Name: Mark Thompson Title: Vice President of Environmental Affairs Phone Number: 406.496.3211 Email Address: MThompson@montanaresources.com	Secondary Contact Name: Jeremy Fleege Title: Environmental Engineer Phone Number: 406.496.3205 Email Address: JFleege@	See Attachment 1 for additional description
Include any other activity-specific contacts (bonding, compliance, etc.) on an attached sheet and specify contact title/responsibilities

Montana Resources, LLC Continental Mine

2022 Reclamation Monitoring Report

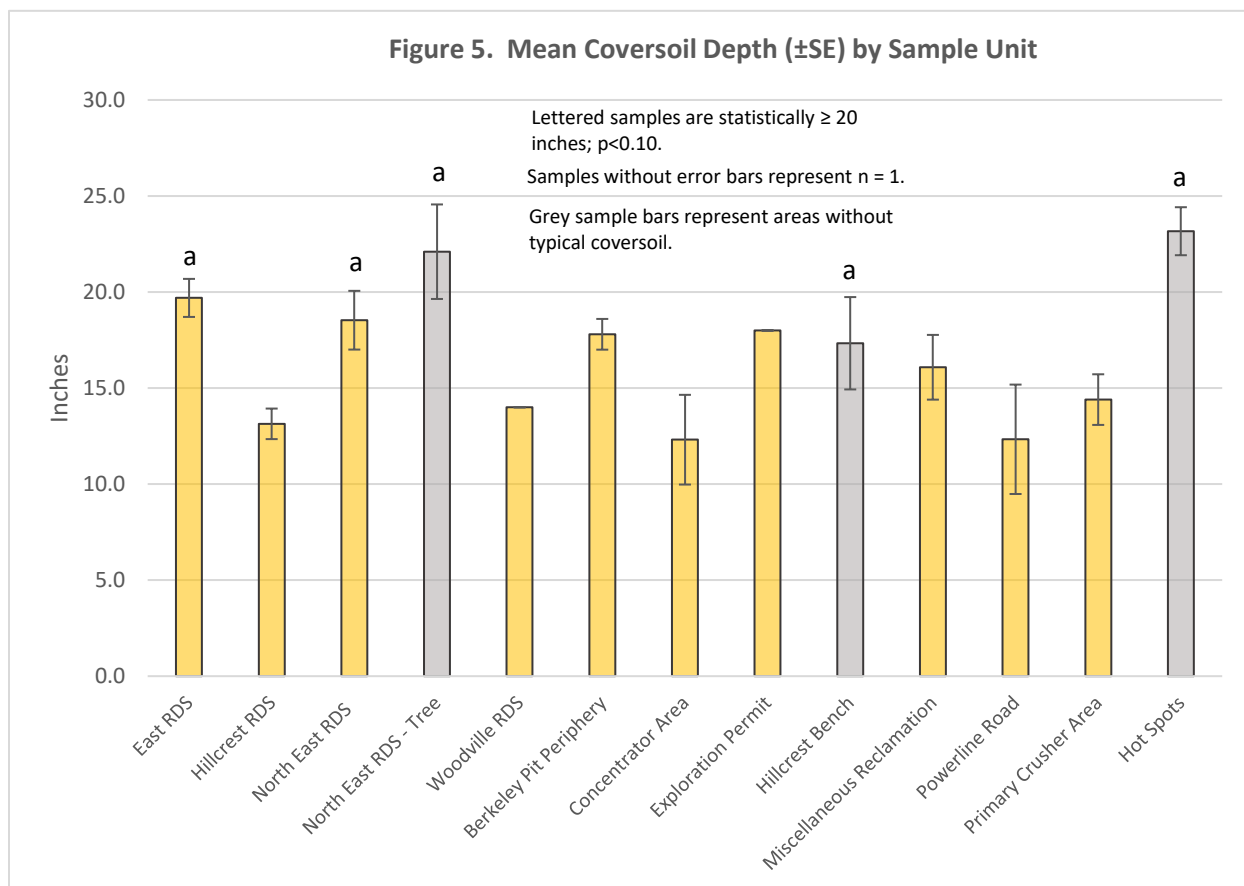
During sampling, coversoil was identified as all soil horizons that could be extracted above the point of shovel refusal. Areas below coversoil are either coarse waste rock, indurate alluvium, or a mix of the two. Note that in the case of Hot Spots and the Hillcrest Bench, there was no clear “coversoil”; rather, there is the less consolidated soil material that was excavated to the point of refusal. Mean measured coversoil depths are presented by sample unit in Figure 5.

Figure 5 shows that most acreage reclaimed since 2002 (i.e., the East and North East RDS) has a mean coversoil of approximately 20 inches.

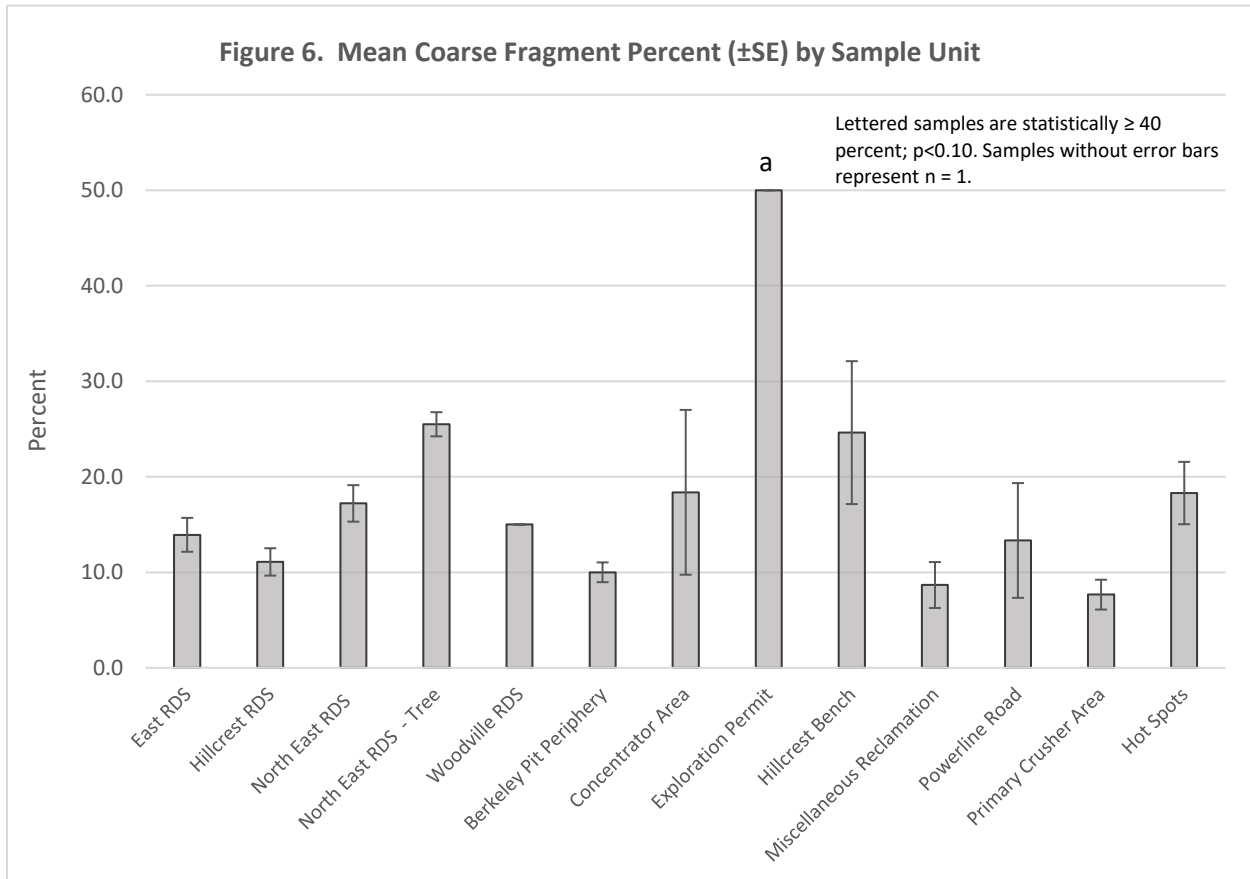
The Reclamation Plan specifies a criterion of no more than 40 percent coarse fragment (>2 mm diameter) in coversoil. Coarse fragments are composed of gravels, cobbles, and stones. Gravels are defined as coarse fragment material between 2 mm and 7.6 cm, cobbles between approximately 7.6 cm and 25 cm, and stones greater than approximately 25 cm (USDA 2015). The percent of gravels, cobbles, and stones was estimated within each soil pit and summed to determine mean coarse fragment content by sample unit as shown in Figure 6.

The only unit with greater than 40 percent coarse fragment is the small Exploration Permit site where there are a substantial number of large cobbles and boulders. All other units average much less than 40 percent coarse fragment content.

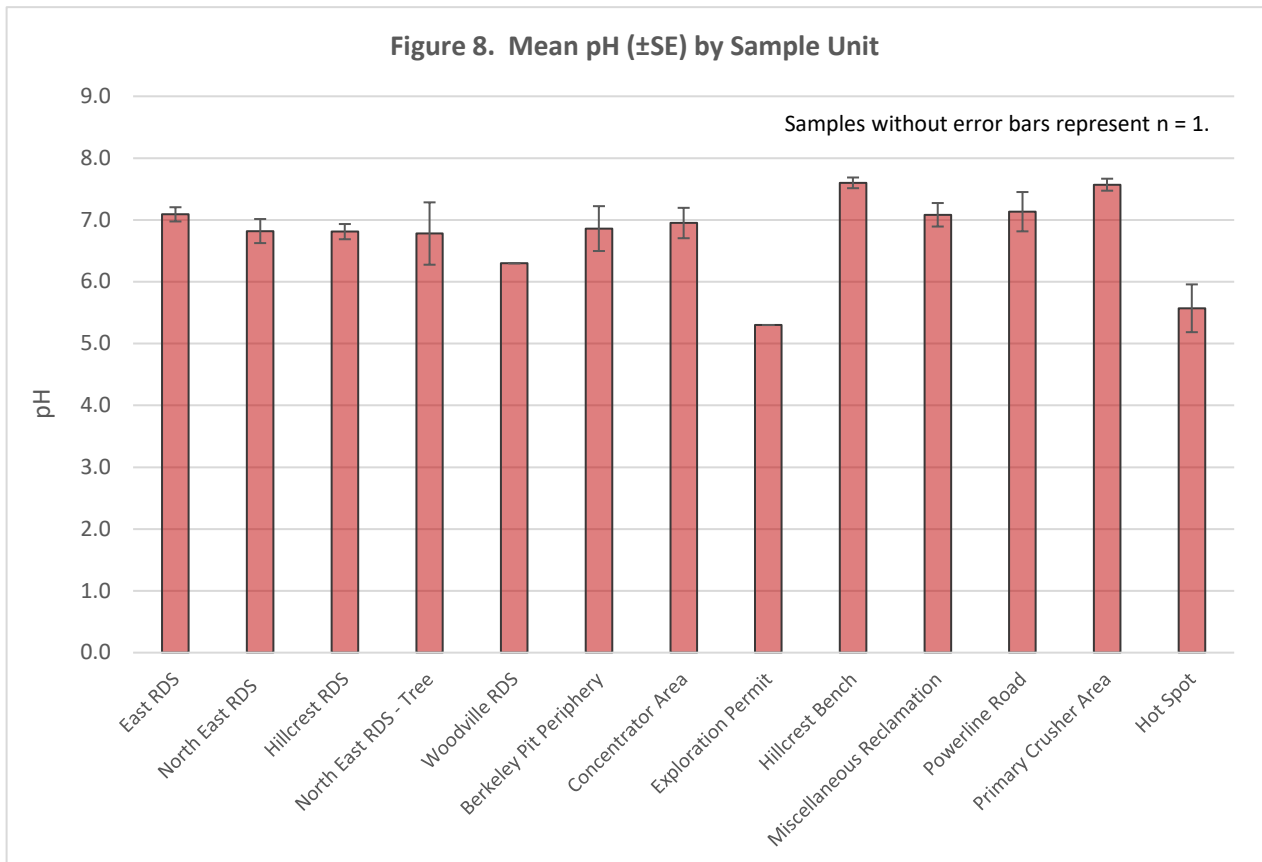
The Reclamation Plan criterion for pH coversoil suitability is between 5.5 and 8.5. Figure 8 depicts mean pH for coversoil by sample unit. Separate data for upper and lower soil horizons are not depicted in this figure since 2021 data indicated that, with the exception of Hot Spots, soil pH was similar between the first and second horizons.

Mean soil pH is between 5.5 and 8.5 in all sample units except the Exploration Permit; however, only one sample was collected in the Exploration Permit and this may not be representative of all coversoil in this small sample unit. Montana Resources' recent annual reports indicate that average pH of alluvium prior to redistribution as coversoil was ≥ 6.5 (Montana Resources 2017, 2018, 2019, 2020). It is unlikely that coversoil was applied in the Hot Spots unit; or, conversely, coversoil may have eroded out of these sites or was perhaps removed during previous remediation attempts.

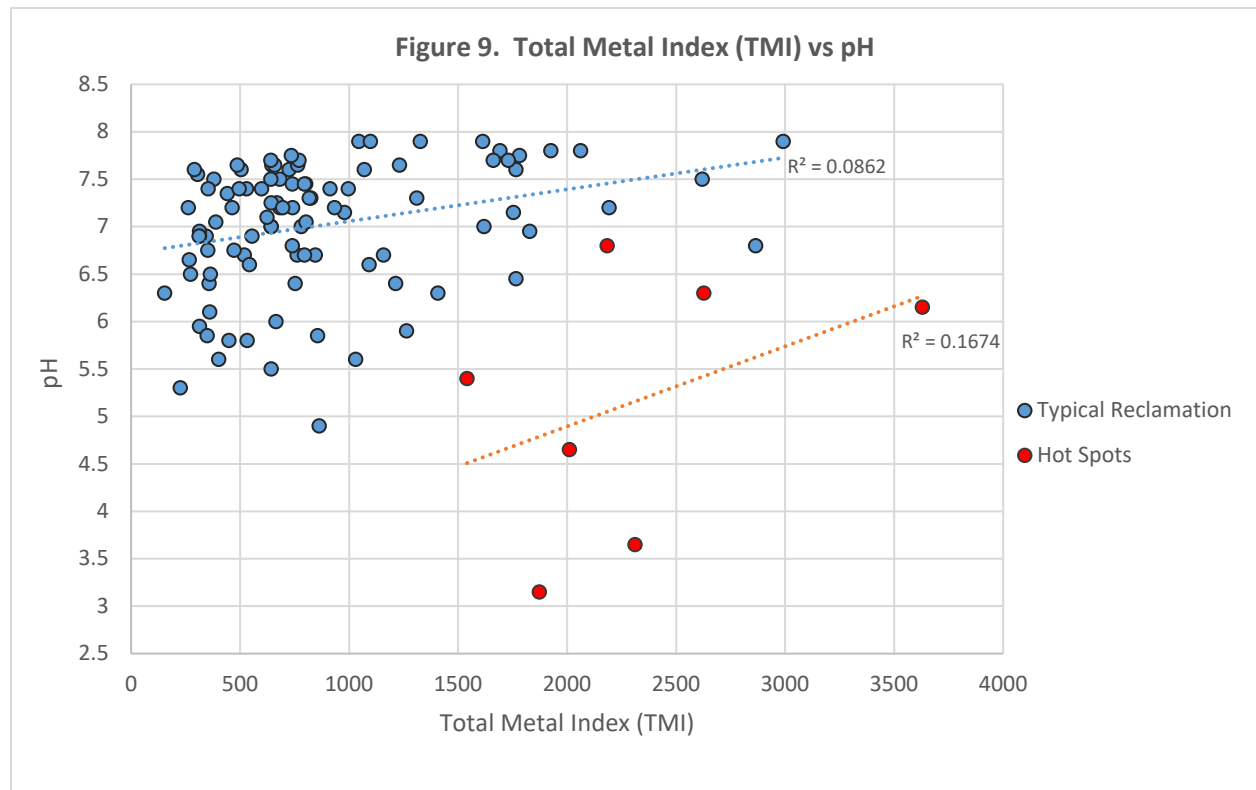
Figure 9 shows the relationship between TMI and pH. Surprisingly, this figure shows a slightly positive relationship between pH and TMI. There is no clear reason to conclude that higher pH directly correlates with greater TMI; this may be a spurious correlation. Metals are typically more mobile and available for plant uptake at lower pH (Munshower 1994, Kicinska et al. 2021). The potential negative effect of low pH and high metal concentrations is evaluated in Section 3.3.

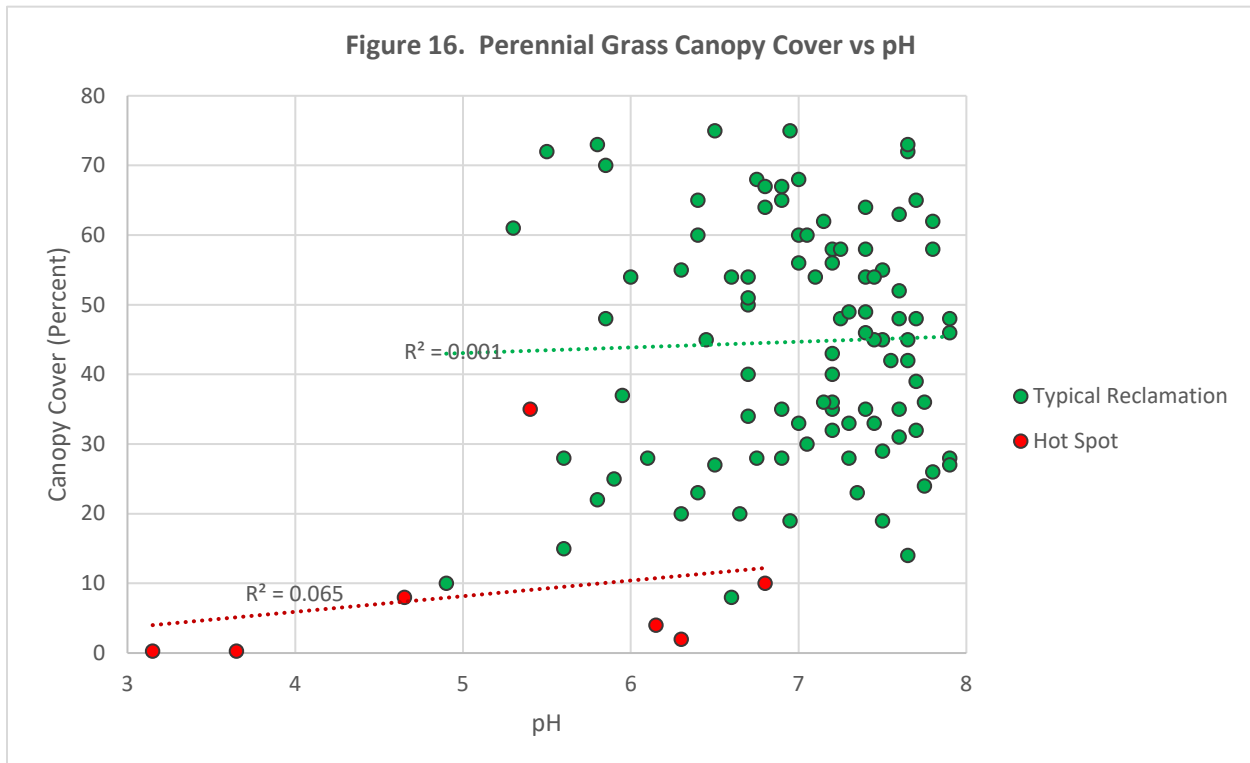
Mean coversoil pH is ≥ 5.5 in all of the sample units except the Exploration Permit (mean pH = 5.3), although mean pH is only 5.6 in Hot Spots (Figure 8). Figure 16 shows percent perennial grass cover relative to pH. Data from all sample units, including Hot Spots, are included since pH may be a limiting parameter to perennial grass cover within the Hot Spots unit. Because pH is similar between the first horizons and the total coversoil within sample unit, further analysis by horizon was not completed. Figure 16 shows no significant relationship between pH and perennial grass cover for units with typical reclamation, and only a slightly positive relationship in Hot Spots.

Figure 17 depicts mean perennial grass canopy cover by pH category and illustrates the effect of the 6 samples with pH ≤ 5.5 on the analysis shown in Figure 16. Perennial grass cover at pH ≤ 5.5 is less than in the other categories but is the same between the remaining categories. Typically, vegetation responds best at pH 6.6 to 7.0 although some tolerant plant species may do well in pH 5.6 – 6.0 (Munshower 1994). Based on Munshower's analysis, it is interesting that perennial grass canopy cover is not different among pH categories 5.5 to 7.5; this implies that grass species within reclamation at the Continental Mine are relatively tolerant of moderately acidic soils.

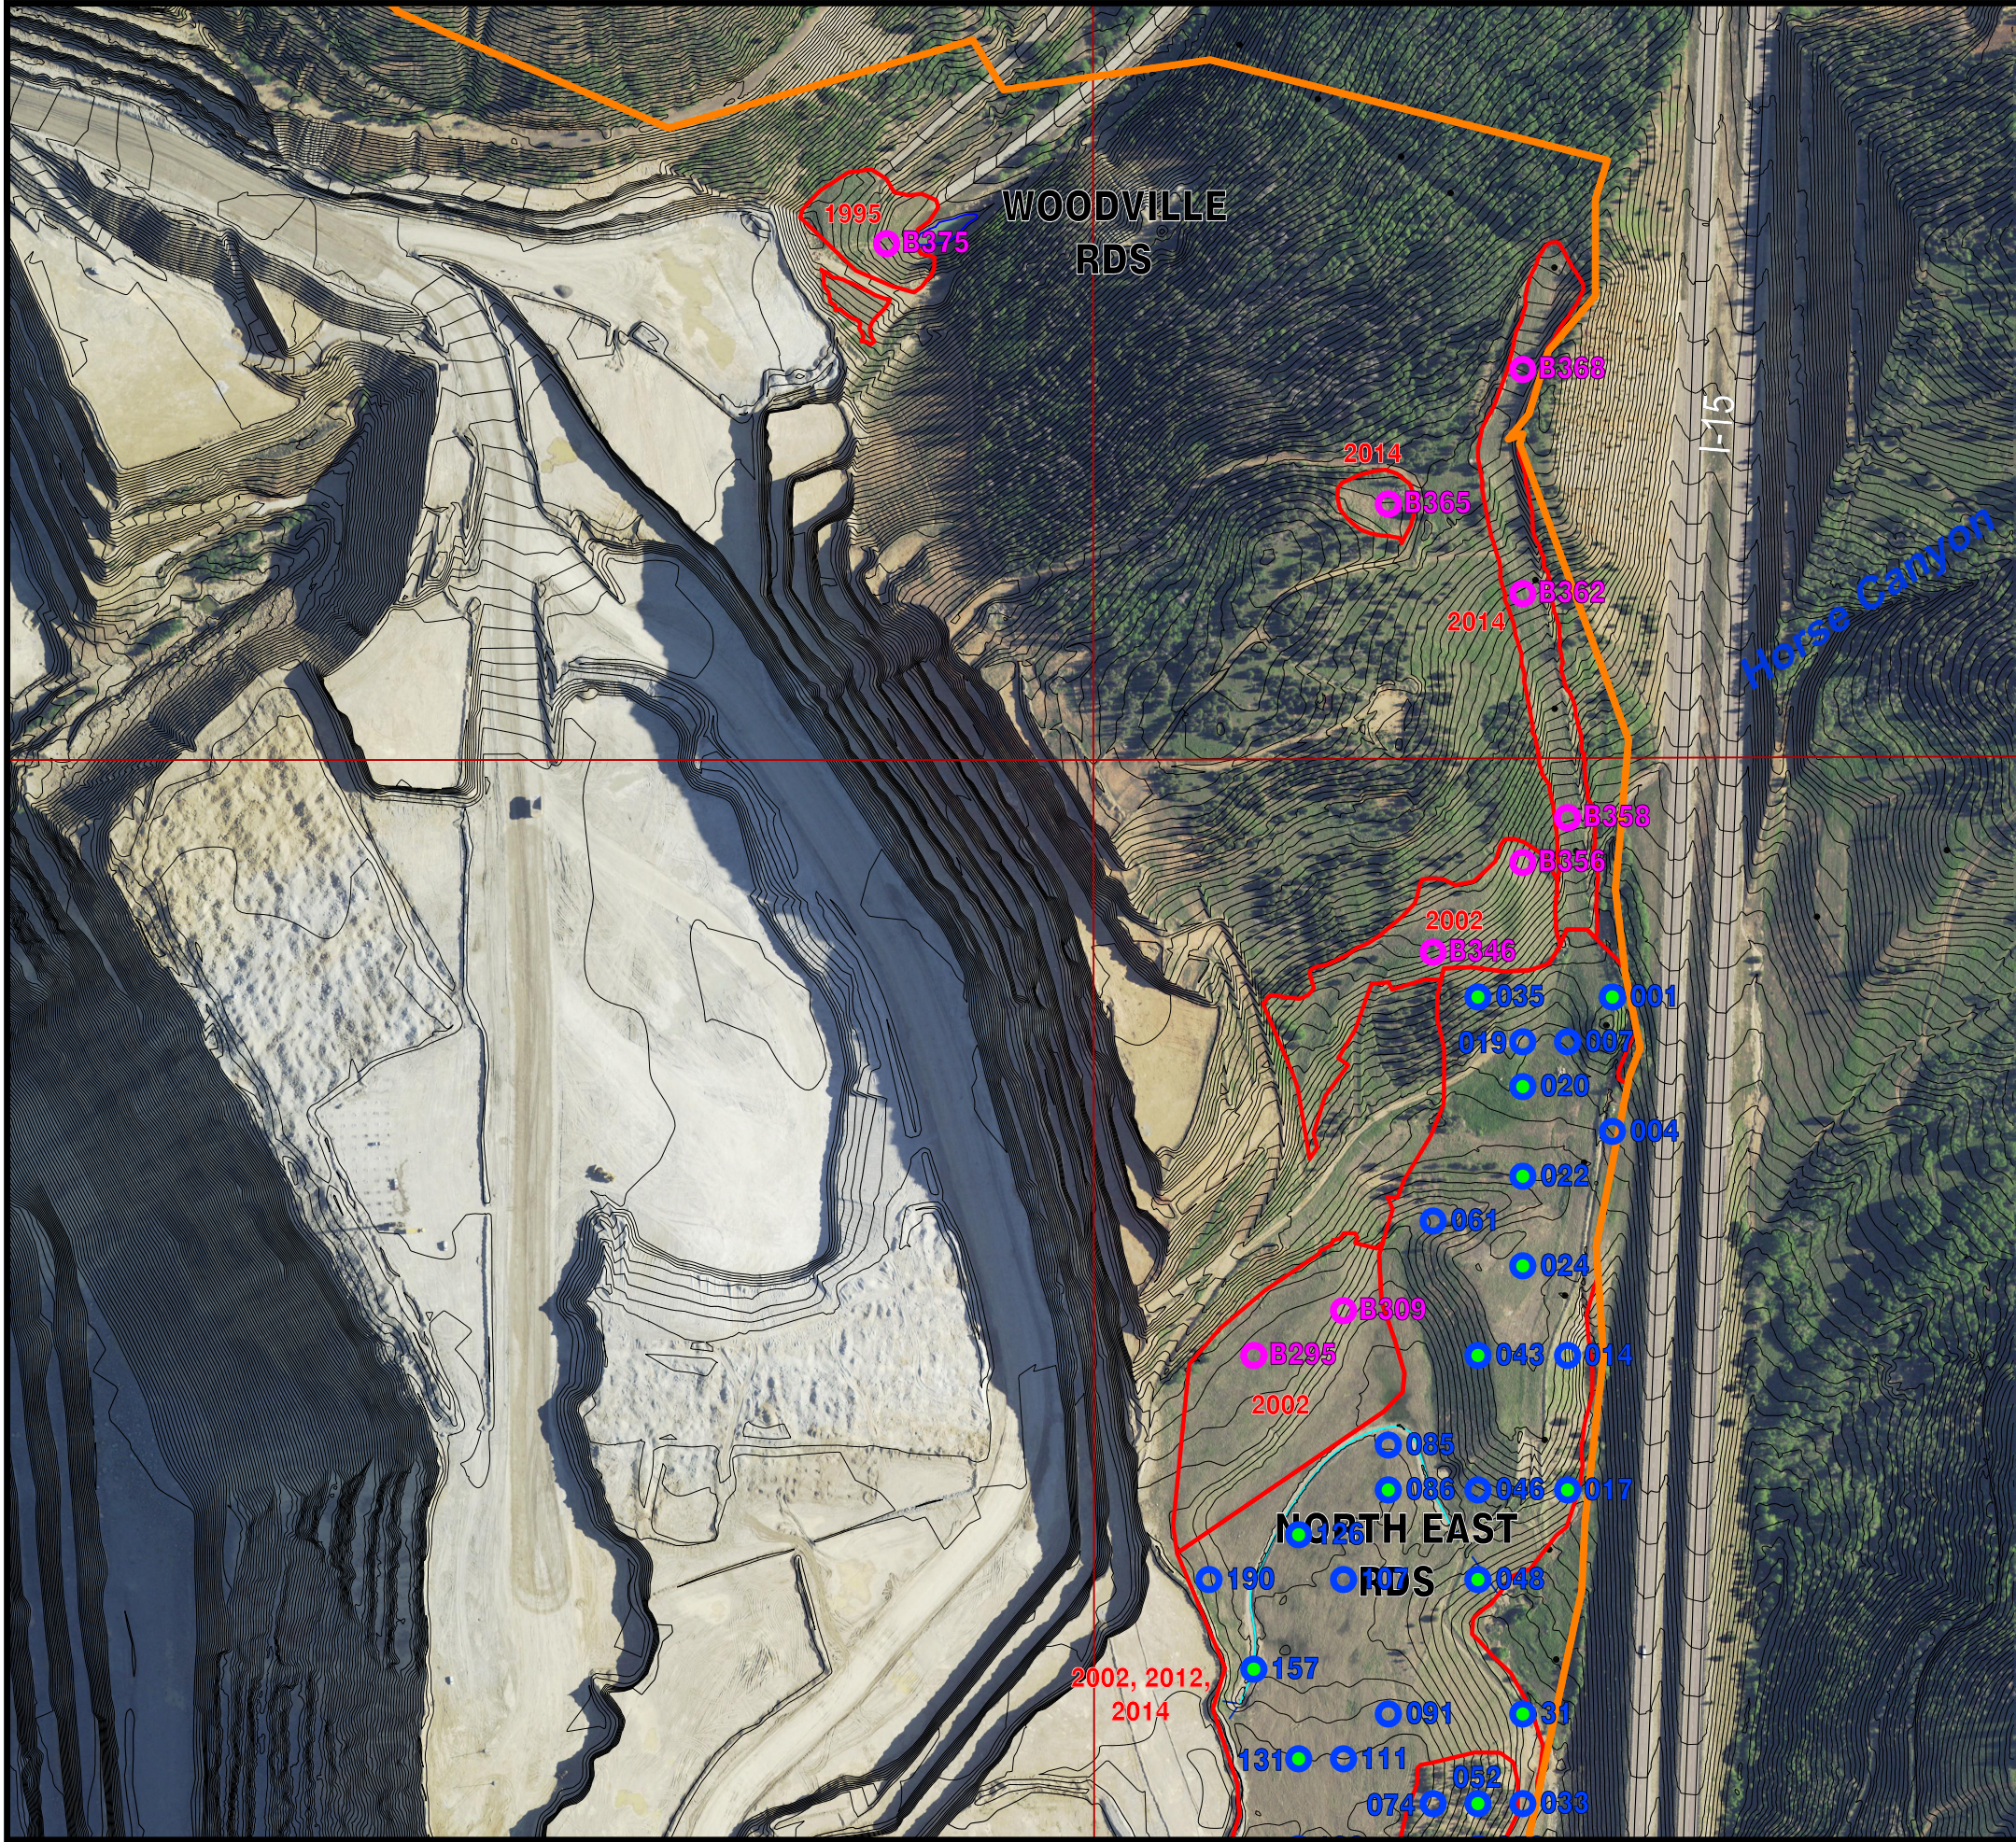
Appendix A
Reclamation Sample Units
East RDS Sites

Sample units shown on Figure 1 and detailed in Appendix A were identified based on year of seeding, slope, and coversoil depth, and included the following:

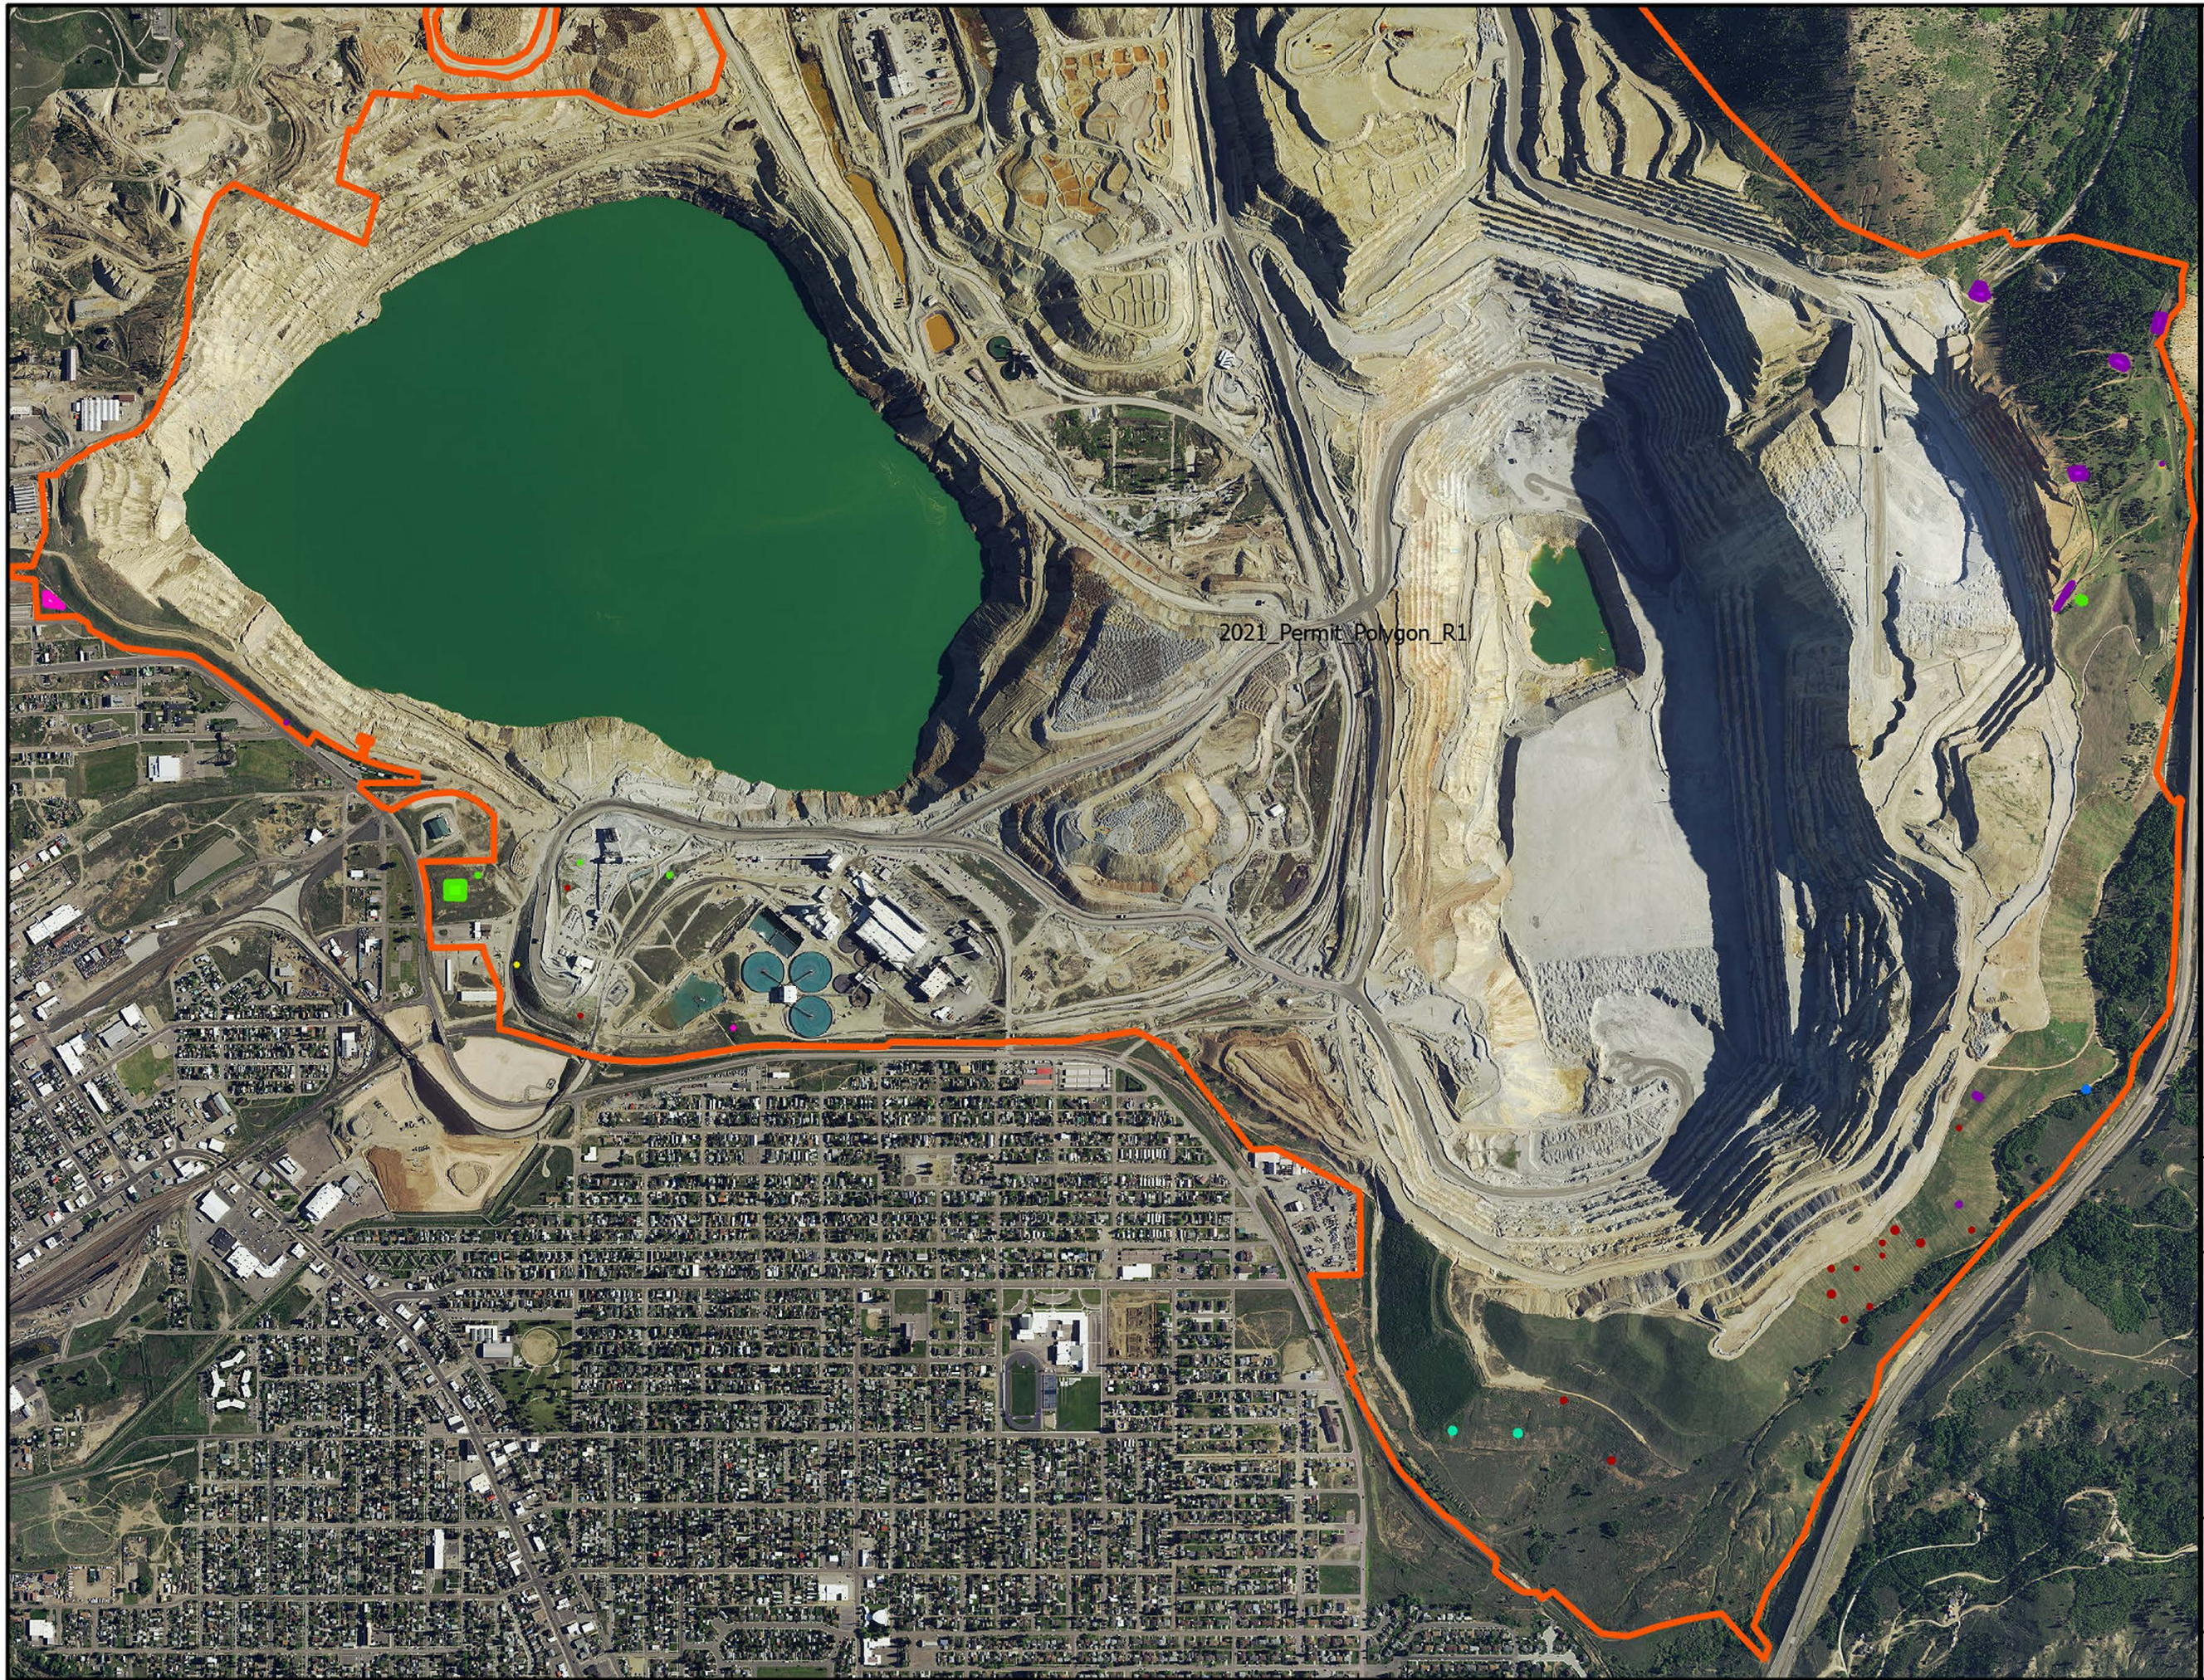
Appendix D – Noxious Weeds Recorded within Study Area

Noxious weeds were documented within sample plots. Surveyors recorded the percent cover by species within each plot and noted noxious weeds as they were observed outside of sample plots. A map of noxious weeds within the study area is included in Appendix D.

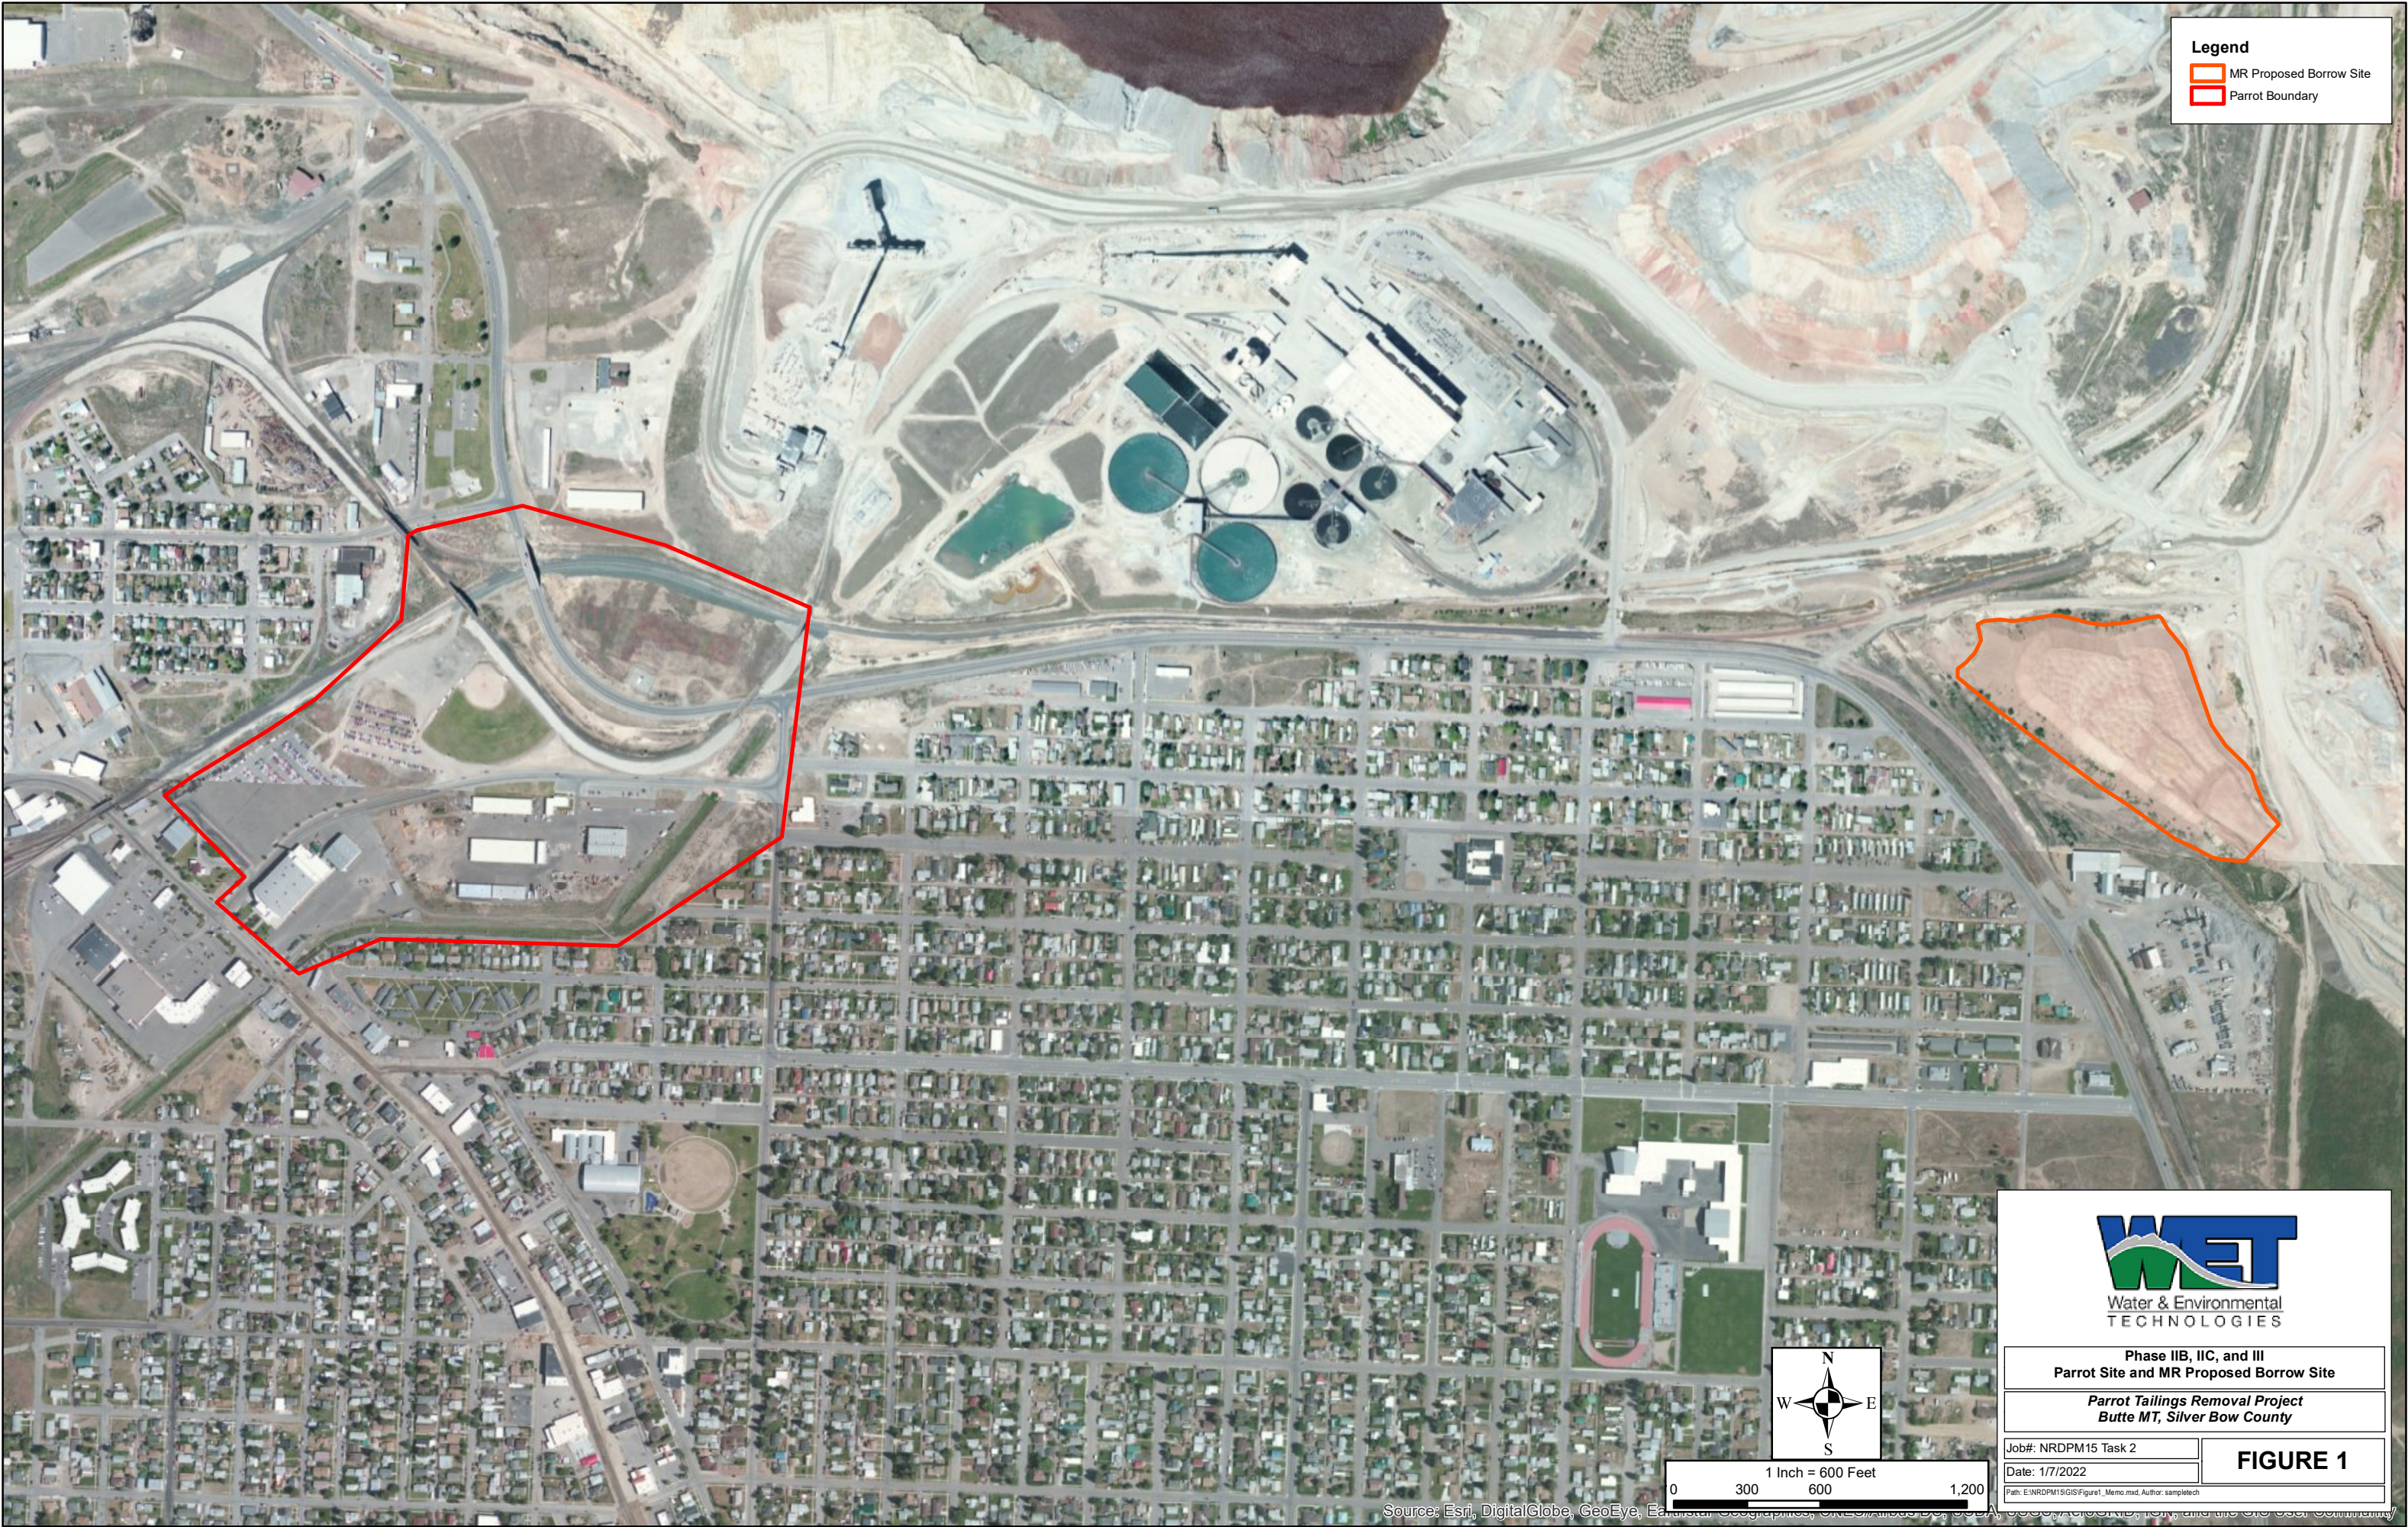
FIGURE 1

Per Montana Resources' (MR's) request, this memo summarizes sampling results from the property as shown on **Figure 1**, known as the "Lunchroom Dump". Material from this area was utilized as an alternative backfill source for the Parrot Tailings Waste Removal Project.
