VA101-126/24-7

MONTANA RESOURCES

YANKEE DOODLE TAILINGS IMPOUNDMENT - DAM BREACH INUNDATION STUDY FOR THE 6,560 AMENDMENT DESIGN DOCUMENT

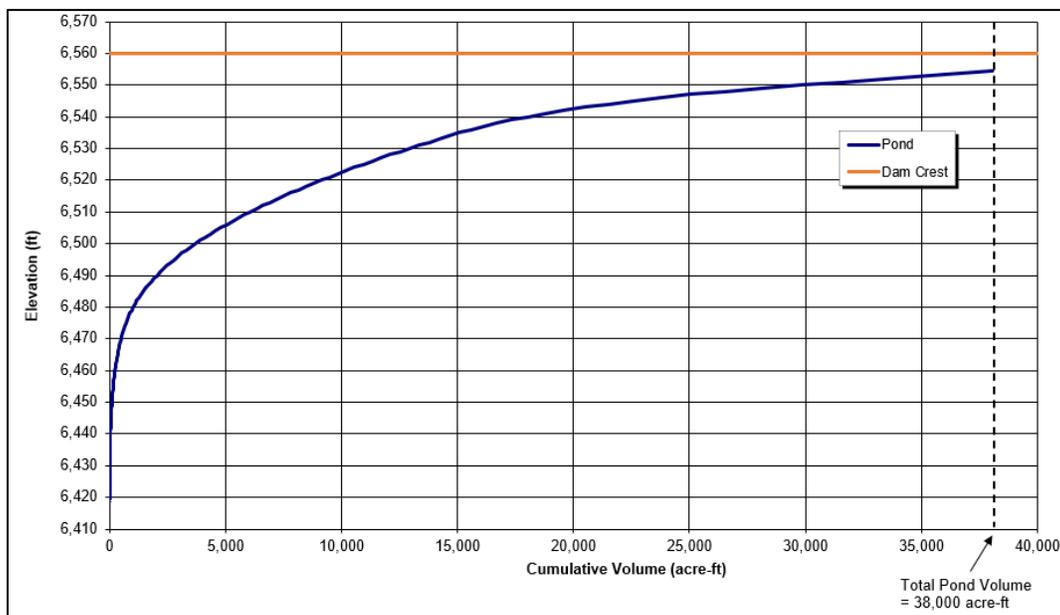
Figure 2.4 YDTI Supernatant Pond Elevation-Capacity Curve

The maximum operating pond volume is typically used as the initial pond condition for the Flood Induced scenario. According to the Design Document, the maximum normal operating pond volume for the YDTI is approximately 18,000 acre-ft (ac-ft), comprising a nominal operating pond volume of 15,000 ac-ft plus up to 3,000 ac-ft for seasonal fluctuation (KP, 2024a). The PMF volume of 20,000 ac-ft (KP, 2024a) was added to the maximum operating pond volume, corresponding to a total pond volume of 38,000 ac-ft. The YDTI is designed to safely store tailings plus this pond volume with required freeboard for wave runup. The elevation-capacity curve for the supernatant pond up to 38,000 ac-ft is shown on Figure 2.4.

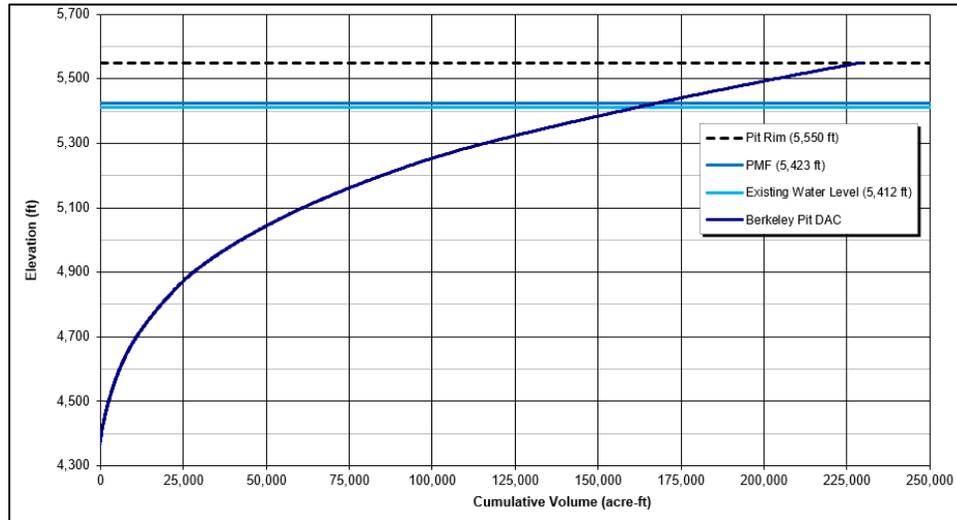
Figure 2.5 Berkeley Pit Elevation-Capacity Curve – Initial Conditions

The estimated PMF inflow volumes to Berkeley and Continental Pits are approximately 5,230 ac-ft and 10,350 ac-ft, respectively, as shown using the elevation-capacity curves on Figure 2.5 and Figure 2.6.

1. Bottom of pit is at EL. 4,370 ft.

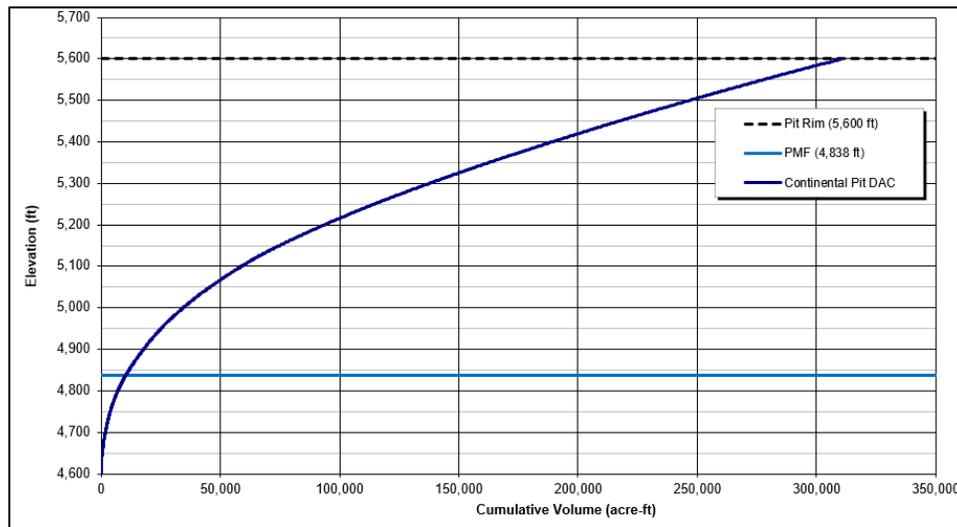
Figure 2.6 Continental Pit Elevation-Capacity Curve – Initial Conditions

1. Bottom of pit is at EL. 4,600 ft.

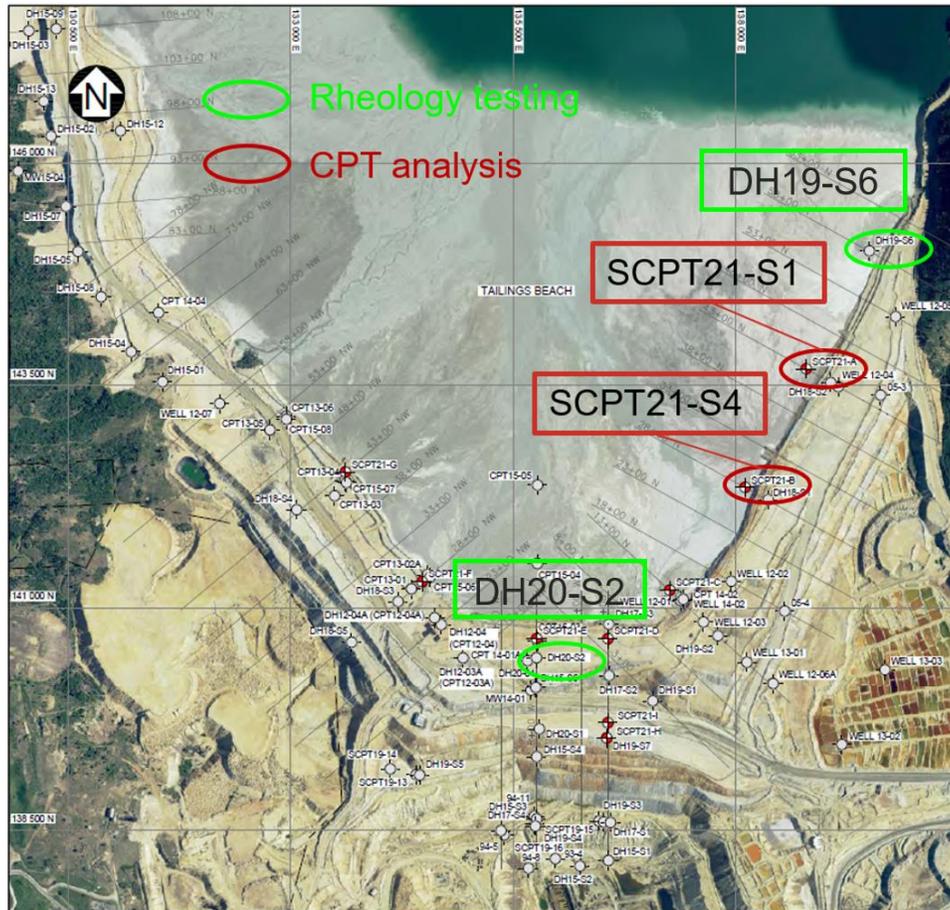
Figure 2.7 Rheology and CPT Testing Locations in the YDTI

The CPT locations used for tailings characterization (Section 2.4.2), analyzing the tailings strength relevant to the dam breach study (Section 2.4.3), and rheology testing (Section 2.4.4) are shown on Figure 2.7. The locations marked in green as “Rheology testing” were also used for tailings characterization.

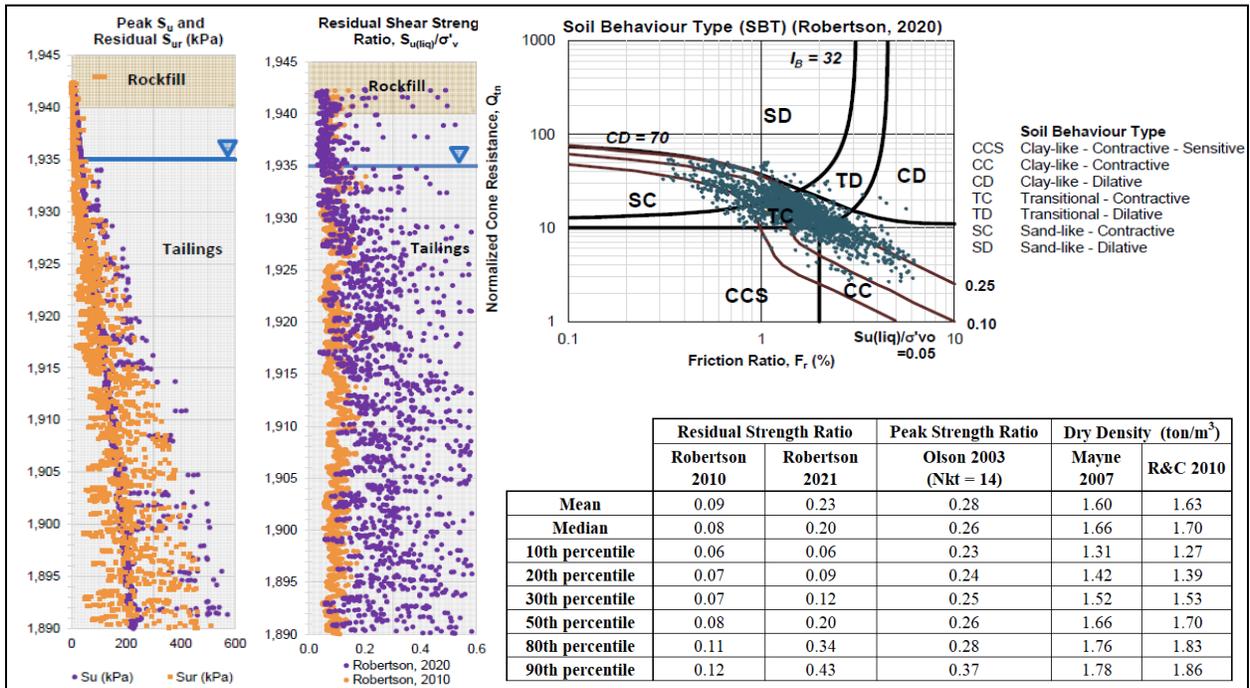
Figure 2.10 CPT Analysis for SCPT21-S1

- The depths are shown in meters, where 1,945 m = 6,381 ft

The CPT data indicate that tailings have a site-specific residual undrained shear strength ratio of 0.12 to 0.14 based on the 30th percentile using Robertson, 2021 (tables on Figure 2.10 and Figure 2.11). The estimated residual undrained shear strength ratios are in line with values observed in case histories, which ranged from 0.04 to 0.16 (Robertson, 2021).

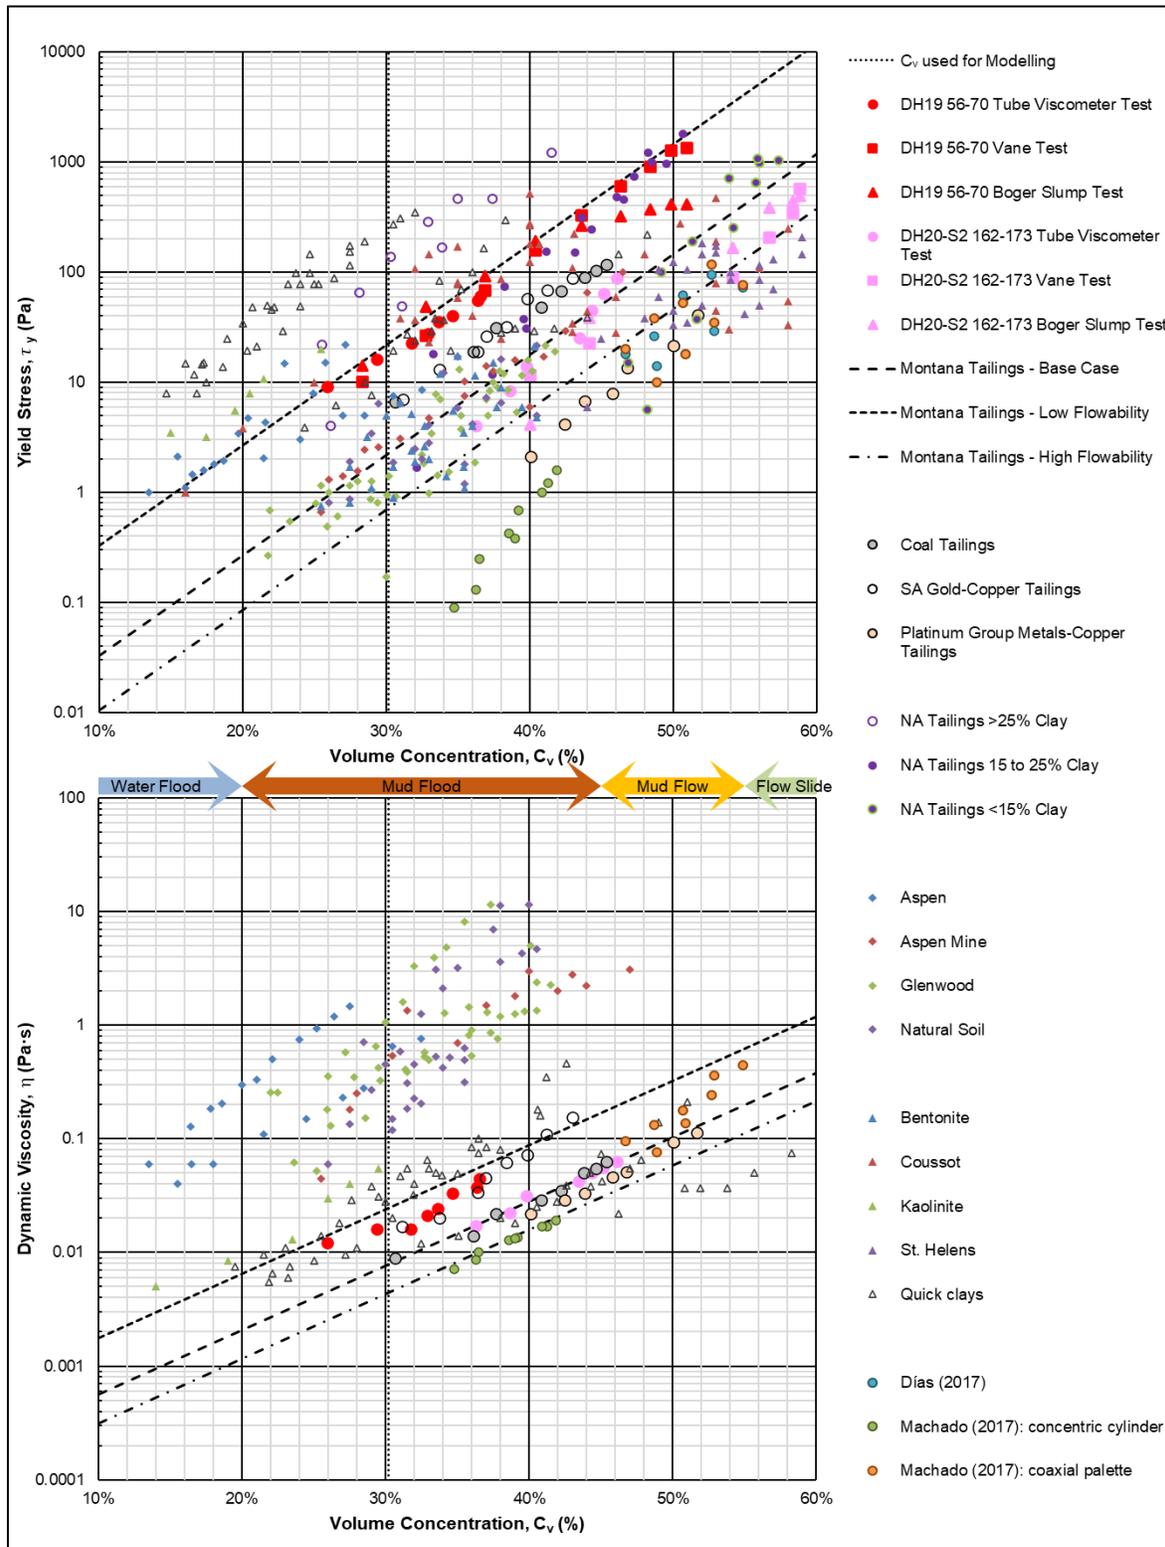
Figure 2.13 Yield Stress and Viscosity Data Comparison Based on Literature

The rheology data from the YDTI was superimposed on Figure 2.13, which includes the rheological properties of other known materials from literature. These data include mudflow samples in Colorado (Glenwood, Aspen and Natural Soil) presented in O'Brien and Julien (1988), various samples (Bentonite, Coussot, Kaolinite, St. Helens, and Quick Clays) presented in Julien (2010), NA Tailings samples from a copper / gold mine (yield stress only) presented in Adams et al. (2017), and samples from the deposited tailings runout of the Fundão failure in Brazil in 2015 presented in Días (yield stress only) (2017) and Machado (2017). Generally, more yield stress data are available in various literature than viscosity data.

Tailings from hard rock mines (e.g., copper, nickel, gold) behave differently at similar solids concentrations than tailings from soft rock mines (e.g., coal), or tailings with high content of clay sized particles. For example, NA Tailings with higher clay content (> 25%) and Quick Clays shown on Figure 2.13, have a higher yield stress at lower solids concentrations than NA Tailings with a lower clay content (< 15%), or the YDTI samples that also have a low content of clay sized particles (< 5%). Similarly, the Glenwood samples of O'Brien and Julien (1988) were coarser with lower clay content than the Aspen samples. The authors found that samples with lower percentage of clay had lower yield stress values (Glenwood), when compared to the samples with higher clay content (Aspen), but that this same trend was not observed for the viscosity.

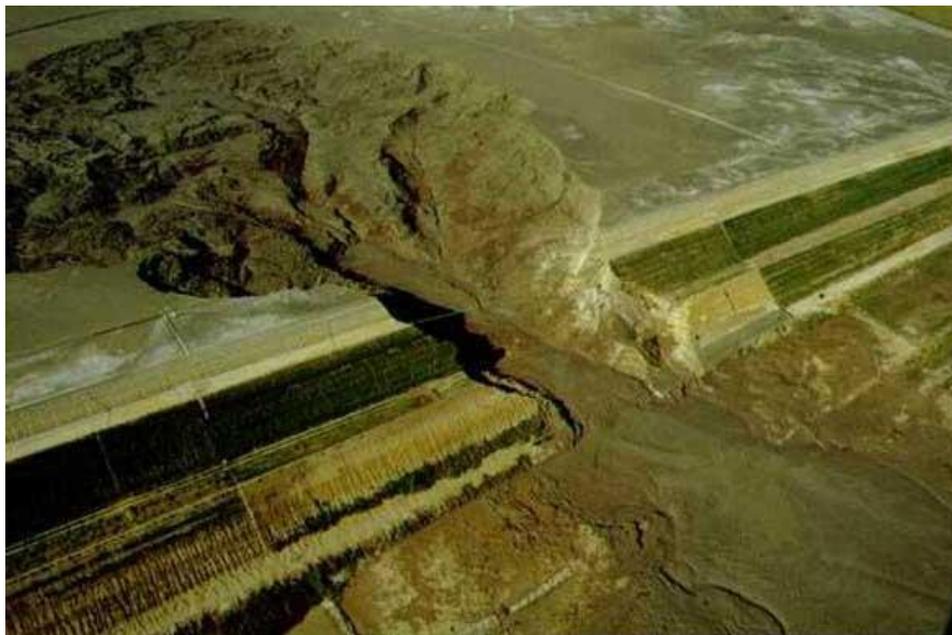
Figure 3.2 Post-Failure Cone of Depression for the Merriespruit Dam Failure (CDA, 2021)

An example of a cone of depression in a TSF following the 1994 dam failure at Merriespruit in South Africa is shown on Figure 3.2 (CDA, 2021).

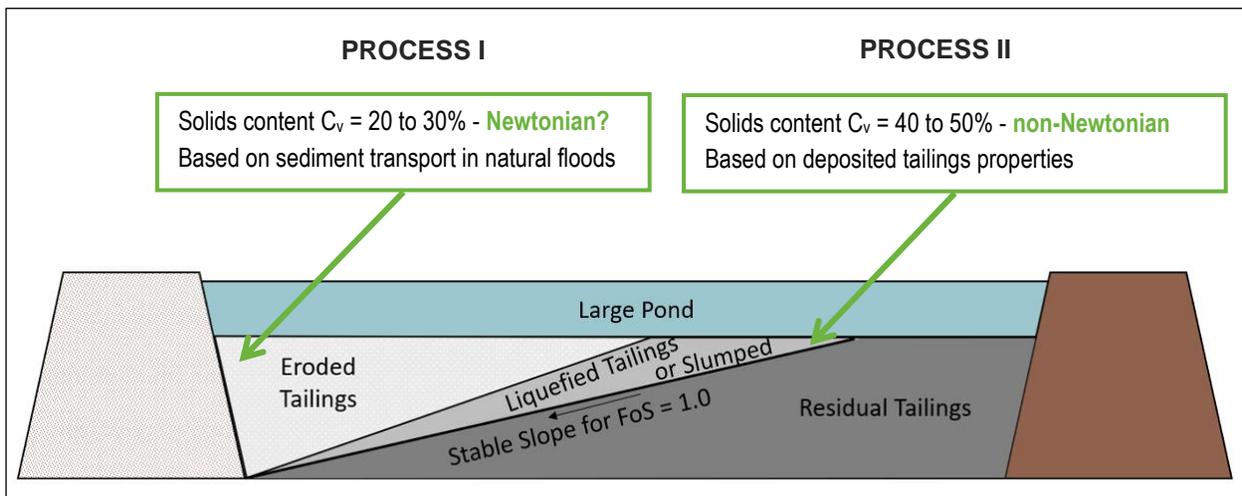
Figure 4.1 Schematic of Mobilized Materials in a Tailings Dam Breach Event

The total volume of water and tailings hypothetically released from the YDTI was estimated as the sum of released free water from the supernatant pond at the time of failure and the mobilized tailings volume through erosion and/or liquefaction. The total mobilized tailings volume was estimated as the combined volume that mobilizes through erosion (Process I) and/or static liquefaction (Process II), which is conceptually shown on Figure 4.1. The volume of total outflow in the breach and the breach size are interrelated and were determined through an iterative process. Depending on the rheological properties, Process I flows can sometimes be modeled as Newtonian fluids, whereas Process II flows are always modeled as non-Newtonian due to their yield stress and viscosity being much higher than that of water.

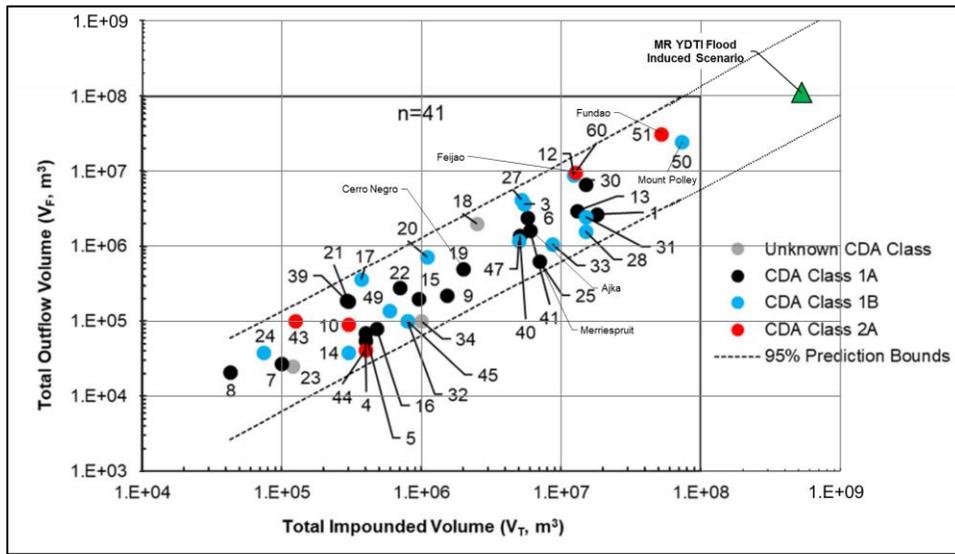
The total mobilized breach volume from the YDTI Flood Induced scenario is shown on Figure 4.3, which compares the total outflow volume to the total impounded volume for historic failures of tailings dams, using the database and statistical analysis developed by Rana et al. (2021a, 2021b). The total storage in the YDTI above the breach invert elevation of 6,300 ft is larger than the other case studies shown on Figure 4.3, hence the YDTI breach volume plots outside the range shown in Rana et al. (2021a). However, using simple extrapolation, the predicted Flood Induced breach volume would follow the trend observed in other failures.

1. The total impounded volume for the YDTI refers to the volume stored above the breach invert elevation of 6,300 ft.

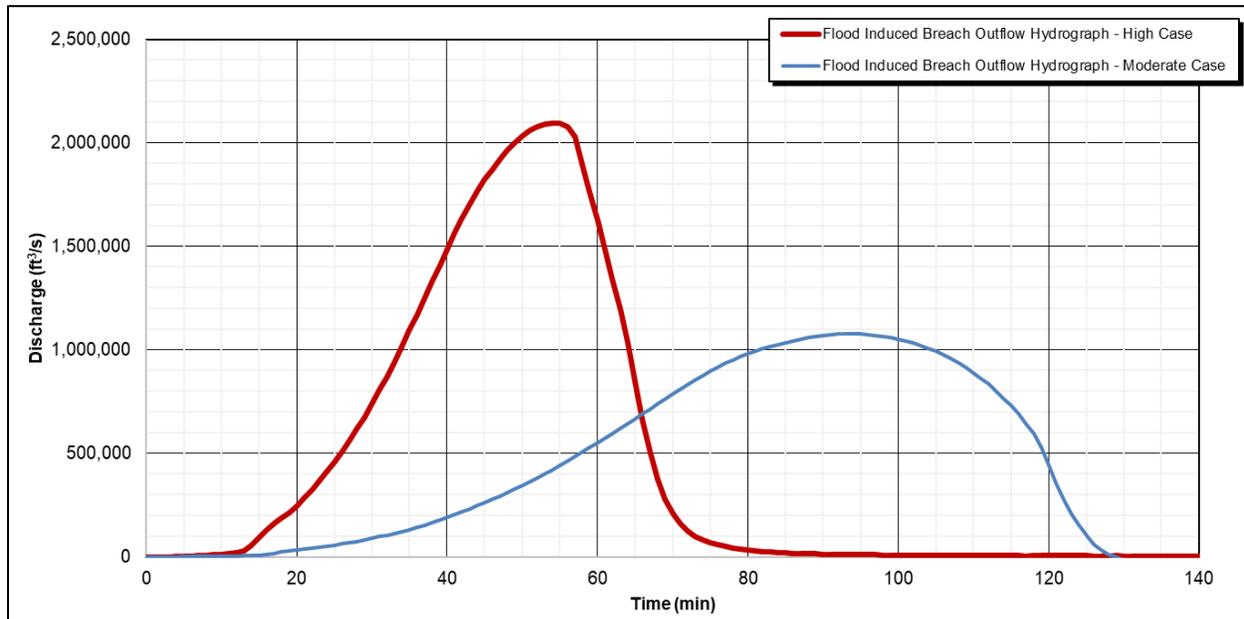
Figure 4.5 Flood Induced Breach Outflow Hydrographs

The sensitivity analysis indicates that the peak discharge is sensitive to the time of failure and the breach width, and much less sensitive to the breach side slopes. The peak of the breach hydrograph developed using average breach parameters is about 1,100,000 ft³/s. Very wide breaches with bottom widths of over 500 ft resulted in higher peak discharges of over 2,000,000 ft³/s. However, breaches of this width begin to extend into the heavily buttressed part of the dam. The times of failure of less than 1 hour resulted in similarly high peak discharges. However, given the construction materials, the buttressing, and the height of the dam, such fast failure times are less likely given that it would require downcutting rates of over 250 ft/hr.

1. The breach parameters shown in the legend represent the bottom width, time to fail, and side slopes.
2. The “Moderate Case” and the “High Case” hydrographs were selected for downstream flood routing, as discussed in the text.

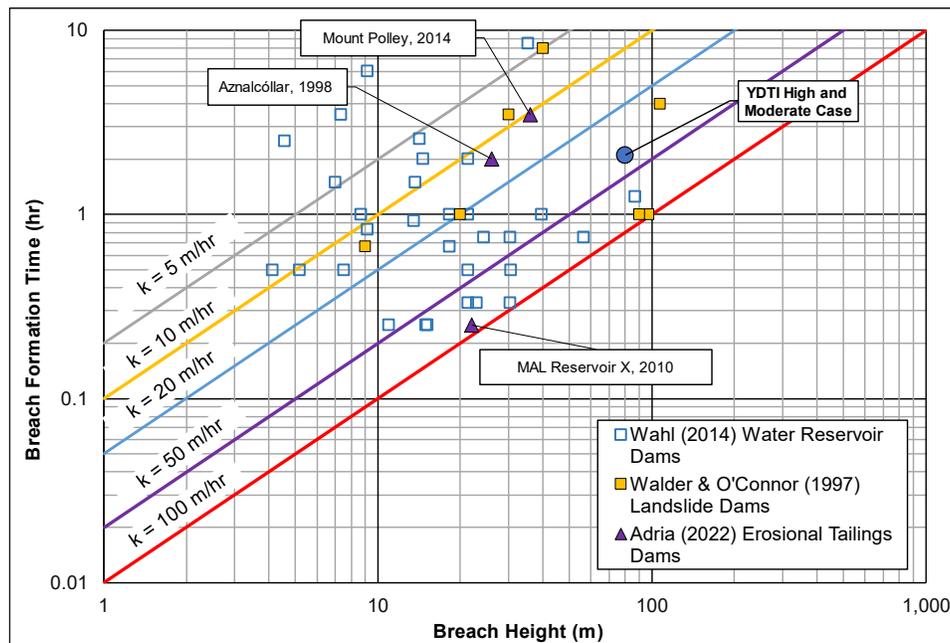
Figure 4.6 Comparison to Observed Breach Heights and Breach Formation Times for Past Failures of Water and Tailings Dams

Walder & O'Connor (1997) proposed the mean erosion rate (annotated as k on Figure 4.6) as a method to normalize formation times by the breach height, with higher mean erosion rates indicating a faster breach for a given breach height. They noted that most erosional breaches experience mean erosion rates between 10 and 100 m/hr (approximately 33 to 330 ft/hr). Several different mean erosion rates are included as colored lines on Figure 4.6 for reference. The erosion rate has a profound impact on the hydrograph shape, where higher rates result in faster time to fail, and consequently a peakier hydrograph. The impact of the hydrograph shape was further evaluated as part of the sensitivity analysis in Section 6.4.2.

Dams of all types with mean erosion rates faster than 80 m/hr (262 ft/hr) involved some additional failure mechanism, such as a structural or foundation failure, combined with the erosional type failure mechanism (Wahl, 1998; Wahl 2014). The events that failed primarily through the erosional breach mechanism typically experienced mean erosion rates of about 55 m/hr (180 ft/hr) or less. Walsh (2020) conducted physical modeling breach studies and found that the presence of a tailings beach reduced the severity and speed of a breach by 2 to 3 times compared to a failure without a tailings beach (i.e., a conventional water embankment without a core). This finding is supported by the Mount Polley (in 2010) and Aznalcóllar (also known as Los Frailes in 1998) tailings dam failures (both rockfill) exhibiting mean erosion rates of about 15 m/hr (50 ft/hr), or roughly one quarter of the typical mean erosion rate of 55 m/hr (180 ft/hr) for water dams.

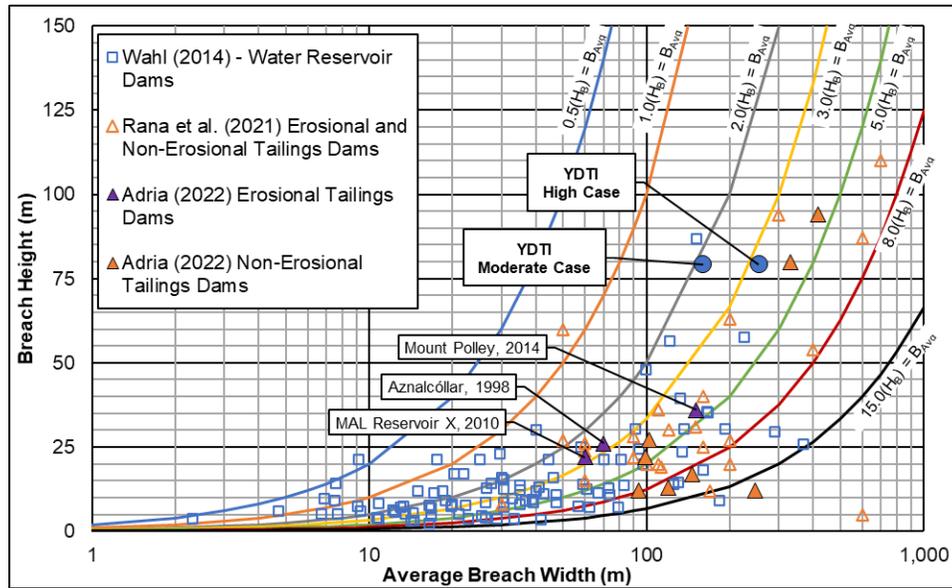
Figure 4.7 Comparison to Observed Breach Heights and Breach Widths for Past Failures of Water and Tailings Dams

The widths presented in Rana et al. (2021b) are based on past failures of tailings dams, where the width was typically measured from aerial photos. These data were not segregated to include consideration of the failure mechanism. Adria (2022) found that the widths in Rana et al. (2021b) generally correspond to the top width of the breach, and are therefore higher than the average width of the breach. The higher number of events assessed in Rana et al. (2021b) compared to Adria (2022) are still useful to consider the scatter and relative trend for tailings dams, while the data from Adria provide further insight on the impact of the failure mechanism on the breach width. Adria (2022) segregated breaches that were considered primarily erosional to those that were primarily driven by non-erosional failure mechanisms. Non-erosional tailings dam failures included those that had a combination of two or more failure mechanisms (e.g., foundation or structural combined with erosional failure mechanism), liquefaction type failures (e.g., the failures in Brazil – Fundão in 2015 and Feijão in 2019), or other failure mechanisms causing a sudden collapse.

The average breach width is generally around 3 times the breach height for water dams, typically ranging from 0.5 to 8 breach heights. The tailings dam widths reported in Rana et al. (2021b) have greater scatter in the data, but generally indicate a larger breach width for a given breach height than observed in water dams. Adria (2022) found that the erosional tailings dam breaches had average breach widths between 3 and 5 breach heights, which is generally less than the non-erosional tailings dam breach events. The breadth of the YDTI dam is much larger than the events in the databases, which would reduce the lateral erosion that could occur during a breach. The selected breach geometry for the hypothetical YDTI failure results in an average breach width of approximately 3 breach heights, which was considered a reasonable estimate for the erosional type breach associated with the assumed failure mode and failure mechanism conditions.

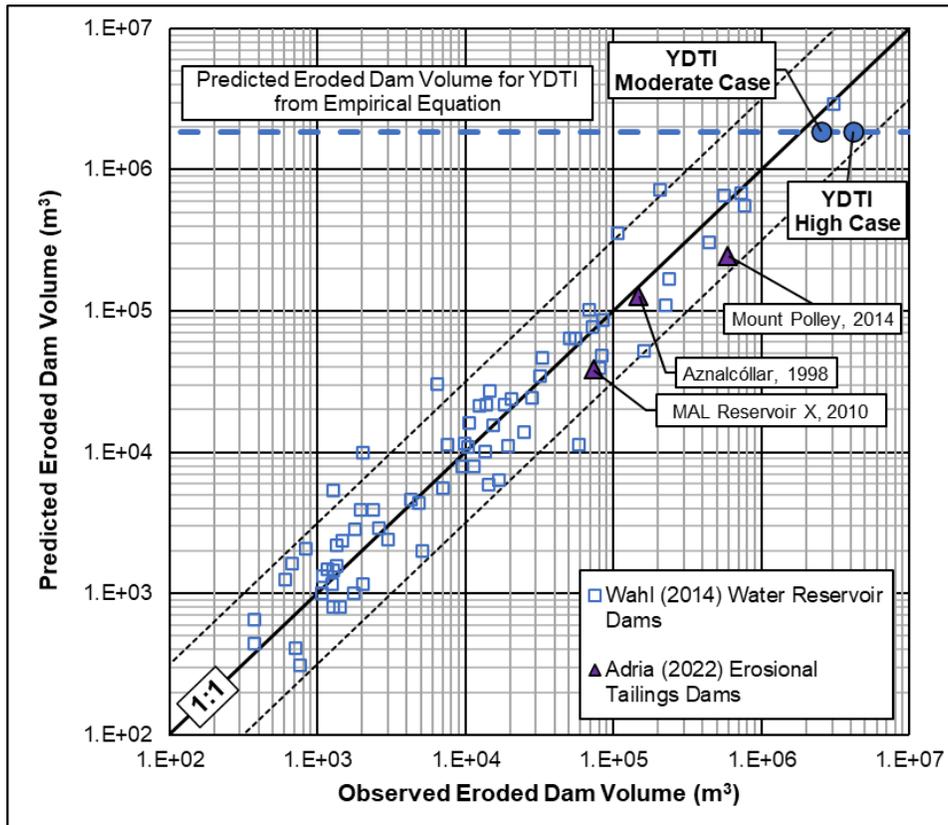
The best fit empirical equation estimates an eroded dam volume for the YDTI of 2.0 M m³ (1,600 ac-ft). The calculated eroded dam volume based on the selected breach parameters is equal to 4.2 M m³ (3,400 ac-ft) for the High Case and 2.5 M m³ (2,040 ac-ft) for the Moderate Case breach outflow hydrographs. The selected breach parameters would result in a higher eroded dam volume than would be predicted using the best fit empirical equation and fit within the observed scatter from past failures.

1. The estimated eroded dam volumes calculated using the breach parameters selected for the High Case and Moderate Case breach hydrographs (Table 4.3) were plotted as Observed Eroded Dam Volumes for the YDTI for comparison purposes.

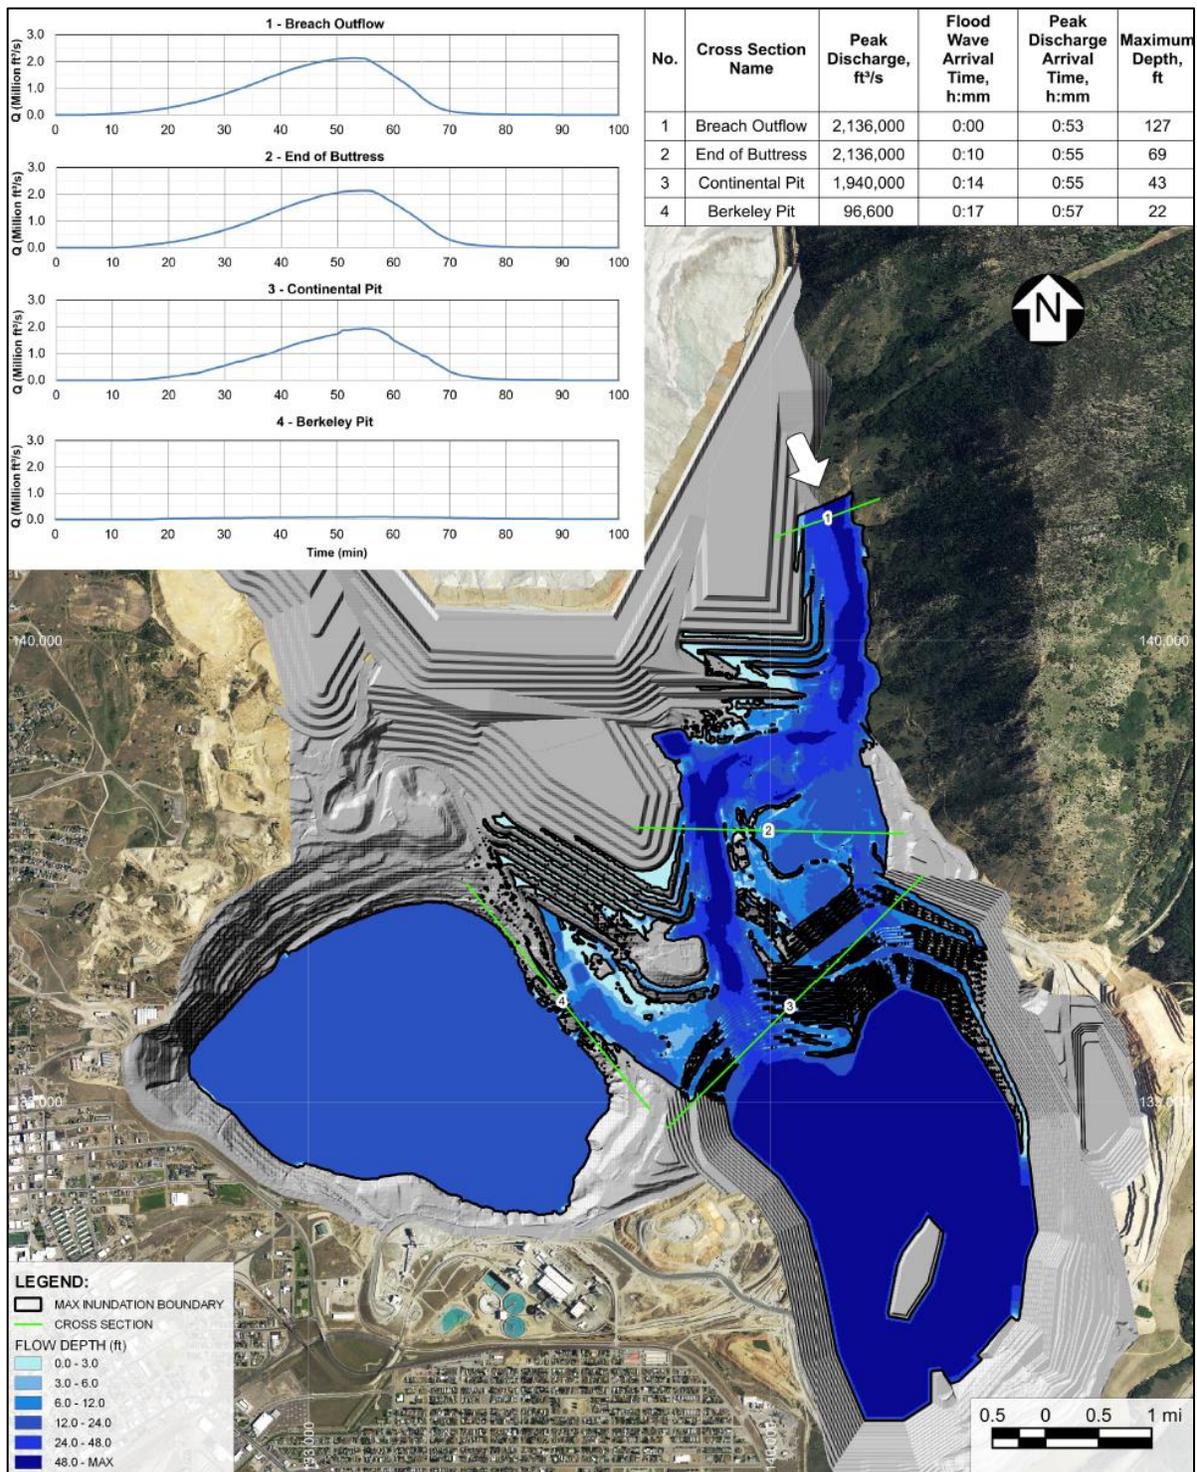
Figure 6.1 Flood Induced Scenario – Maximum Inundation and Flow Depth Map

1. Base map provided by Montana Resources, LLC on August 7, 2024.
2. Dam and rock disposal sites are projected surfaces at the time of the breach.

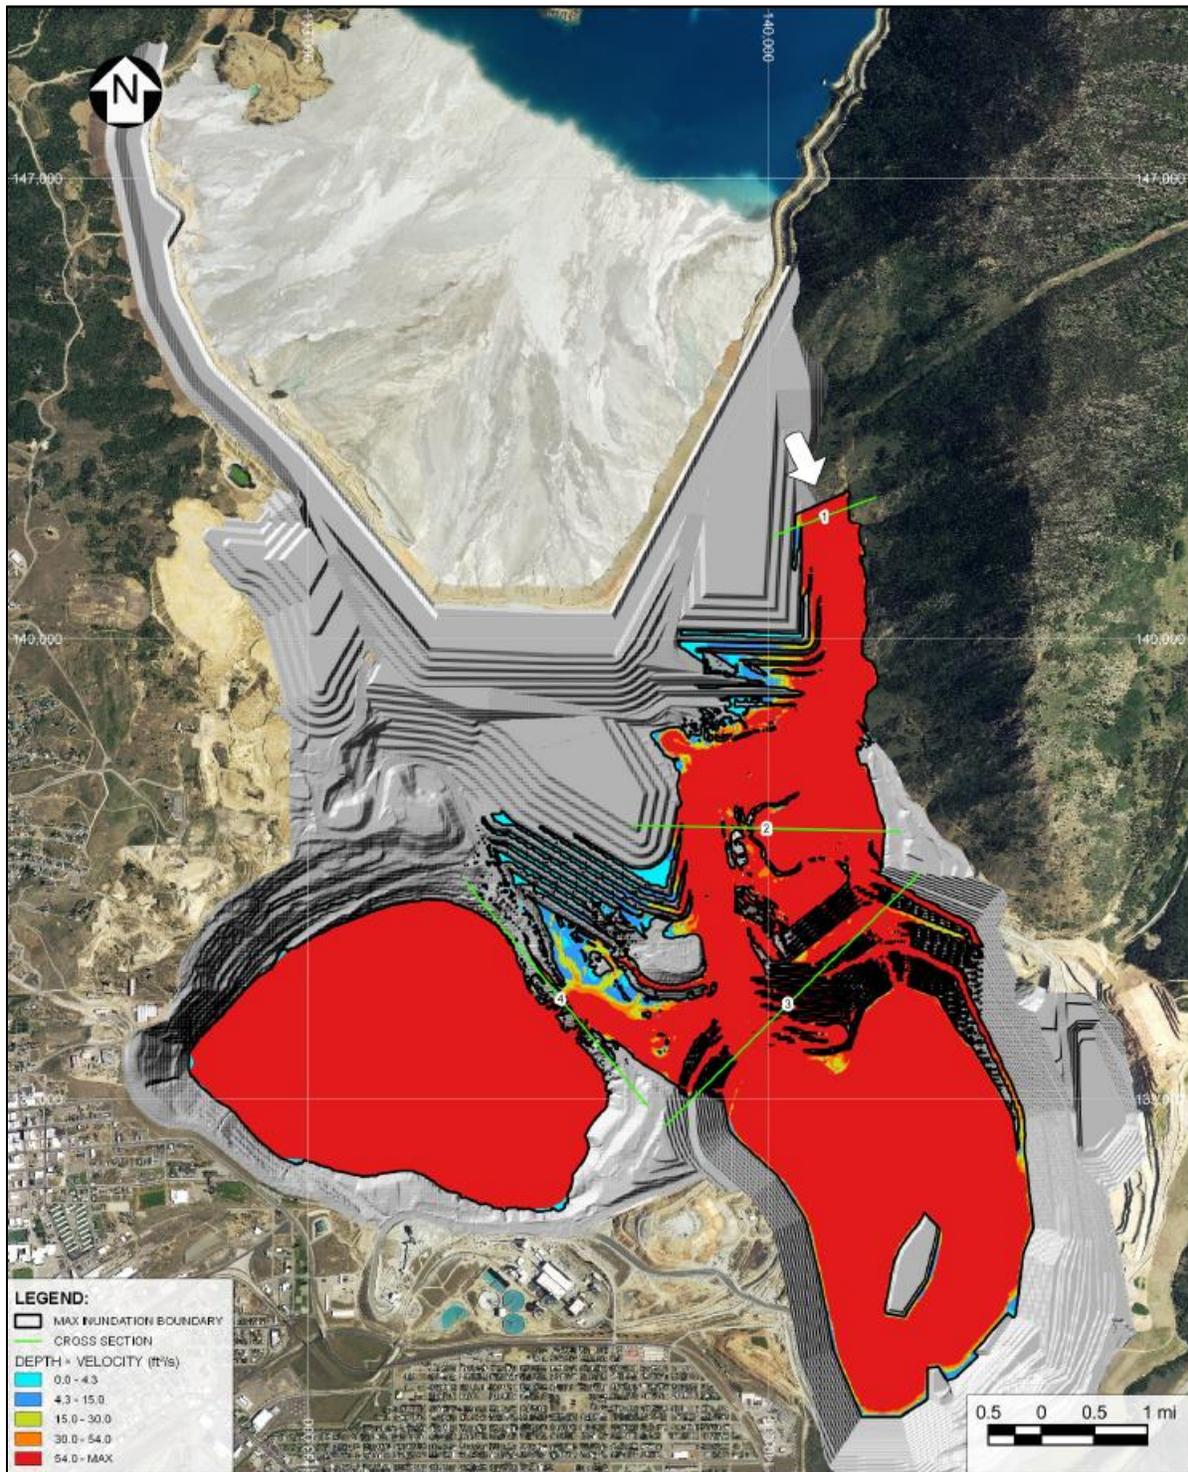
Figure 6.2 Flood Induced Scenario – Maximum DV Map

1. Base map provided by Montana Resources, LLC on August 7, 2024.
2. Dam and rock disposal sites are projected surfaces at the time of the breach.

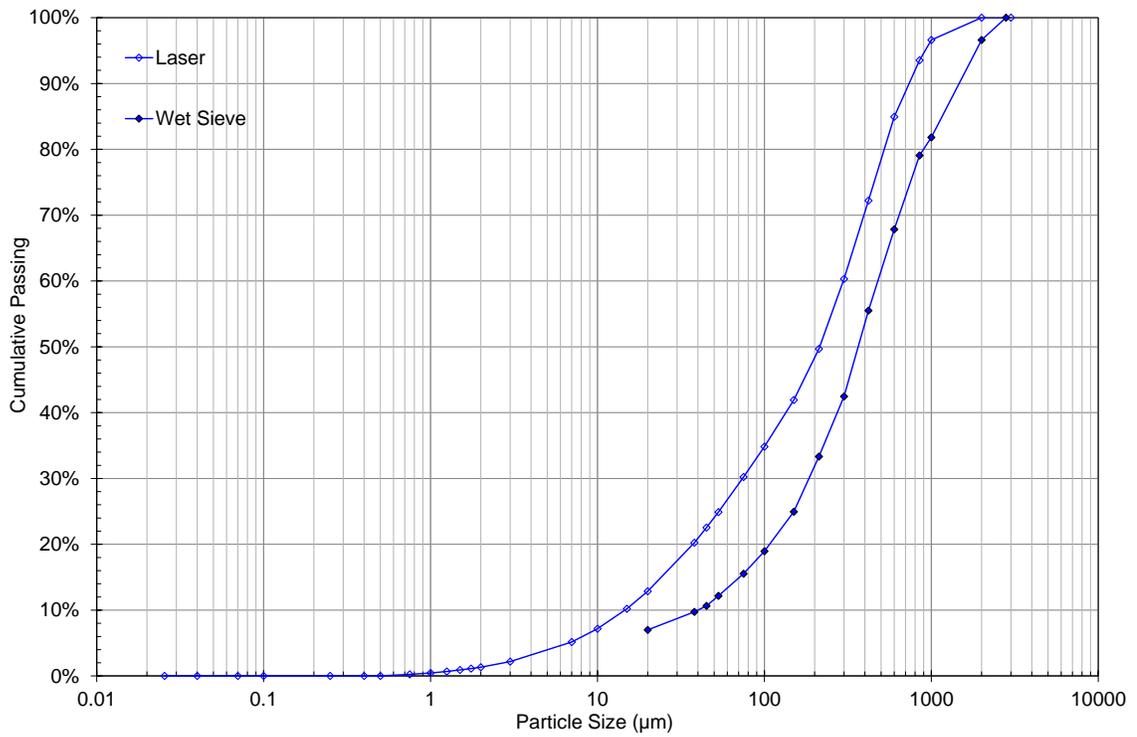
Figure 1: DH19 22-32 Particle Size Distributions

Samples DH19 22-32 and DH20-S2 83-92 had particles that were coarser than 2 mm. These particles cannot be measured using the laser particle size analyzer. The laser measurement for both samples therefore appears significantly finer than the wet sieve measurements.

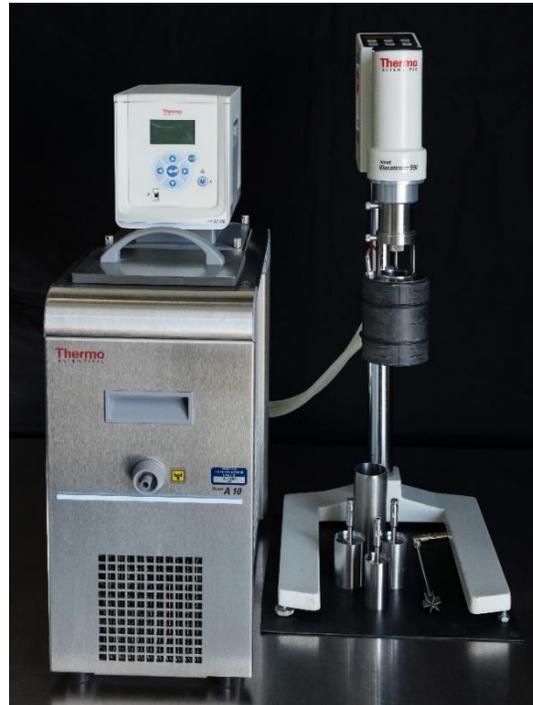
Figure 15: Haake Viscotester® 550 Rotational Viscometer

The tests were completed over a range of solids concentrations. Two vane yield stress measurements were completed at each concentration. The individual measurements at each solids concentration are presented in Appendix B. The results presented in Section 3.1.3 are an average of the two tests.

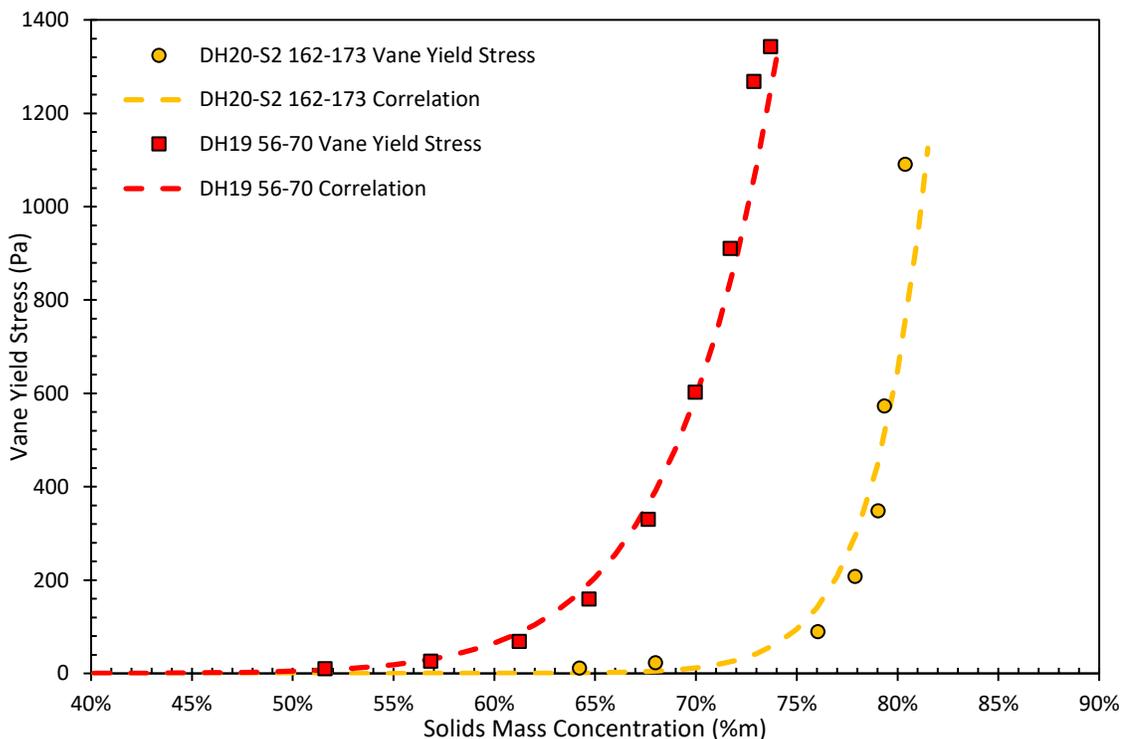
Figure 16: Vane Yield Stress Measurements

The average vane yield stress measurements are shown in Figure 16. Detailed test results are available in Appendix B. The vane yield stress correlation parameters are detailed in Table VIII.

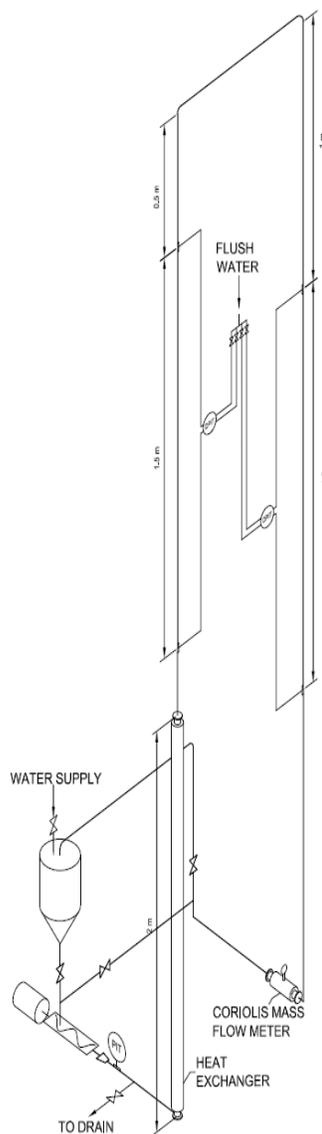
Figure 22: Isometric Sketch of P&C's $\frac{3}{4}$ inch (20 mm) Tube Viscometer

- Progressive cavity pump with a variable frequency drive
- ¾ inch (20 mm) vertical up and down stainless steel measurement tubes
- Micromotion coriolis mass flow meter
- Rosemount differential pressure transmitters
- Heat exchanger to control the slurry temperature during a test.

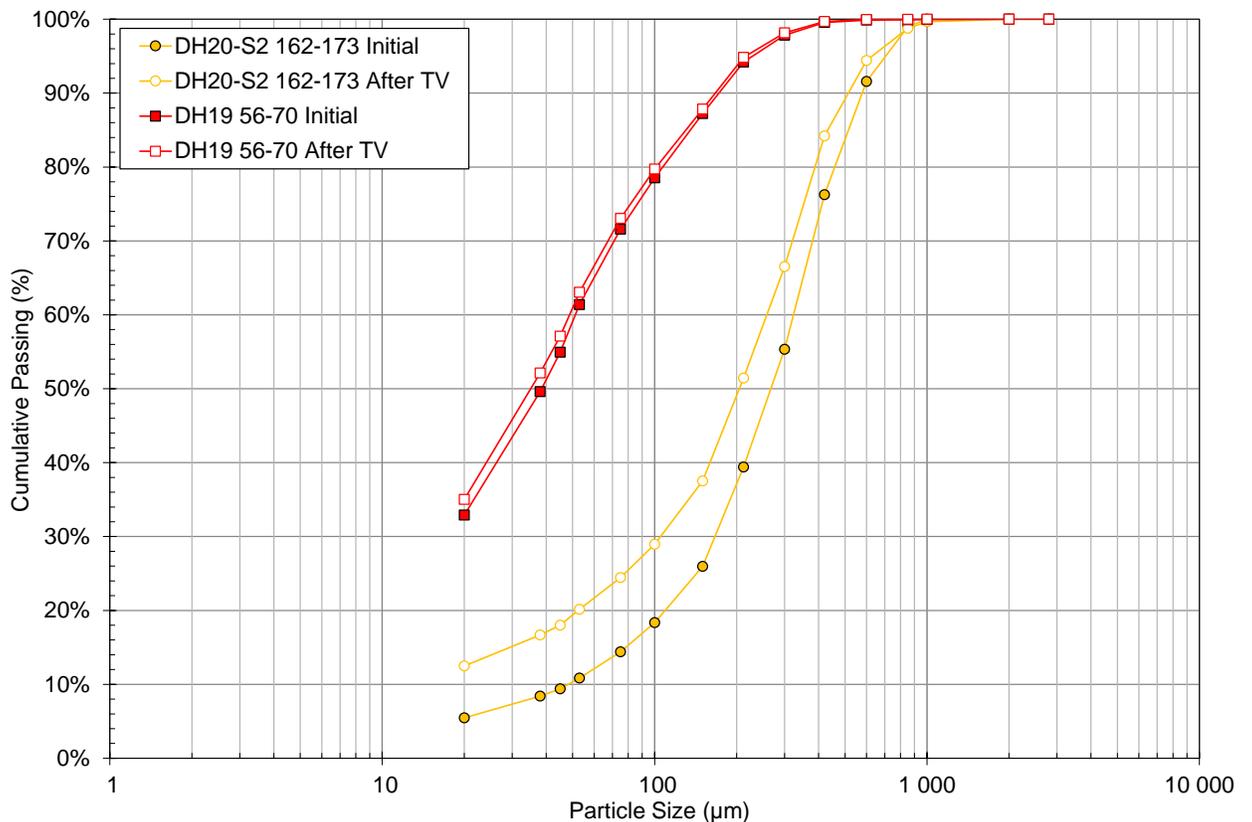
Figure 28: Wet Sieve Particle Size Distribution Before and After Tube Viscometer Test

The sample DH20-S2 162-173 was visibly sandy as received. On the first high concentration attempt, the sample sanded out and the pump seized. The second test started at low concentration and added dewatered solids to cover the tested concentration range. At the end of the test the sample visibly contained more fines. The difference shown in the initial and post test particle size distributions is notable. The higher range of concentrations will have been most impacted by the shift and have higher than initial yield stress and viscosity values.

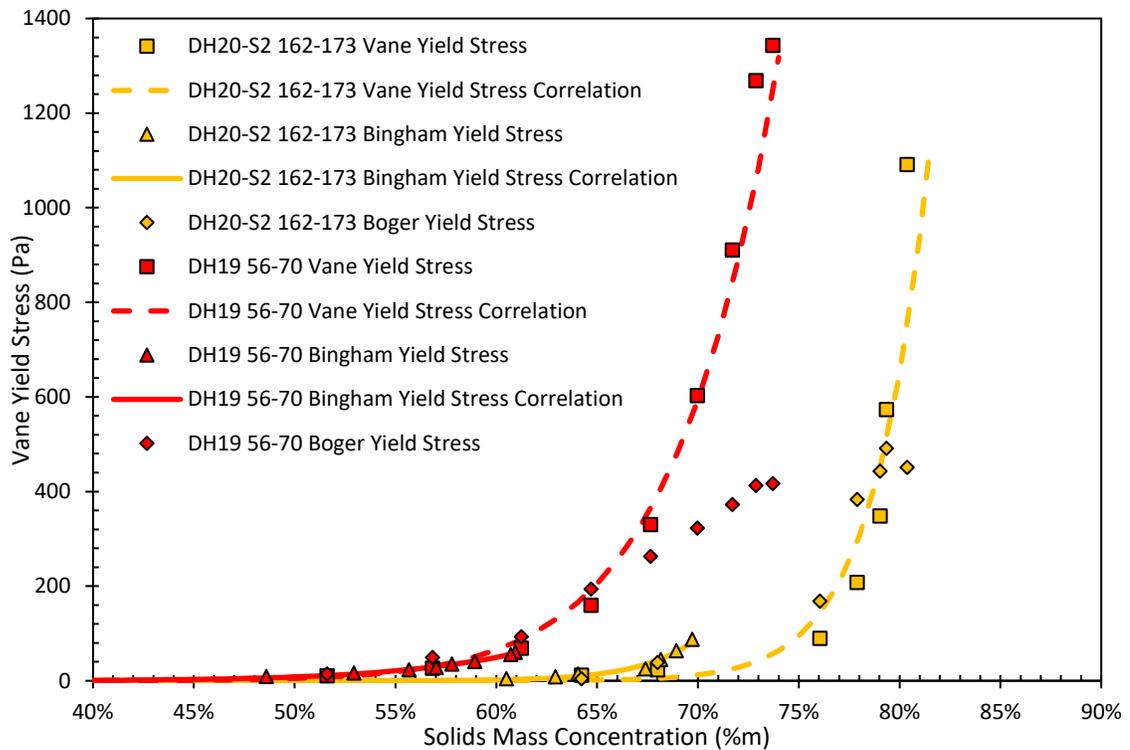
Figure 29: Vane Yield Stress, Boger Yield Stress, and Bingham Yield Stress Comparison

The 65% to 70% concentrations for DH20-S2 162-273 Bingham yield stress points were likely increased by particle attrition over the course of the test as mentioned in section 3.3.6.
