MONTANA DEPARTMENT OF ENVIRONMENTAL QUALITY
HARD ROCK MINING BUREAU
OPERATING PERMIT – FIELD INSPECTION REPORT

Operator: Montana Resources, LLP				Inspection Date: June 7, 2022			
Operating Permit #: 00030			Project: Montana Resources-Continental Mine Complex			County: Silver Bow	
Nearest City or Town(s): Butte							
DEQ Staff: Garrett Smith				Company Representative(s): Mark Thompson, Jeremy Fleege			
Agencies w/overlapping Jurisdiction:		USFS		BLM		Other	× None
Minerals: Copper, molybdenum, minor silver							
Status:		× Active		Inactive		Suspended	Other
Weather: Partly cloudy, high temp 59°F							
Type of Operation:				Purpose of Inspection:			
×	Open Pit				Initial (Pre-permitting)		
	Underground			×	Regular Compliance		
	Placer				Amendment #		
×	<i>Heap Leach- Leach pads near HSB no longer receiving solution</i>				Complaint Received		
	Vat Leach				Bond Release		
×	Mill				Other		
	Other:				NON issued

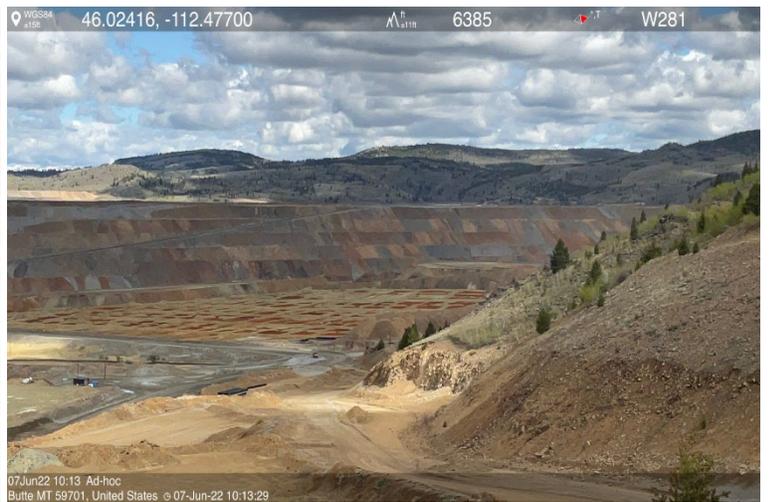
Photo 3- Mining continues within the Continental Pit (as seen from the north), dewatering occurs as needed and the inflow rates are presumed to be around 0.5 MGD. **Photo 4-** The downstream slope of the N-S Embankment (center) has been constructed in sequential lifts to support a crest elevation of 6,450 feet.
