**June 2, 2023**

Mr. Mike Harvie  
Manager of Engineering and Geology  
Montana Resources, LLC  
600 Shields Avenue  
Butte, Montana  
USA, 59701

**Knight Piésold Ltd.**

**RE: Q1 2023 – YDTI Quarterly Piezometric and Deformation Monitoring Update**

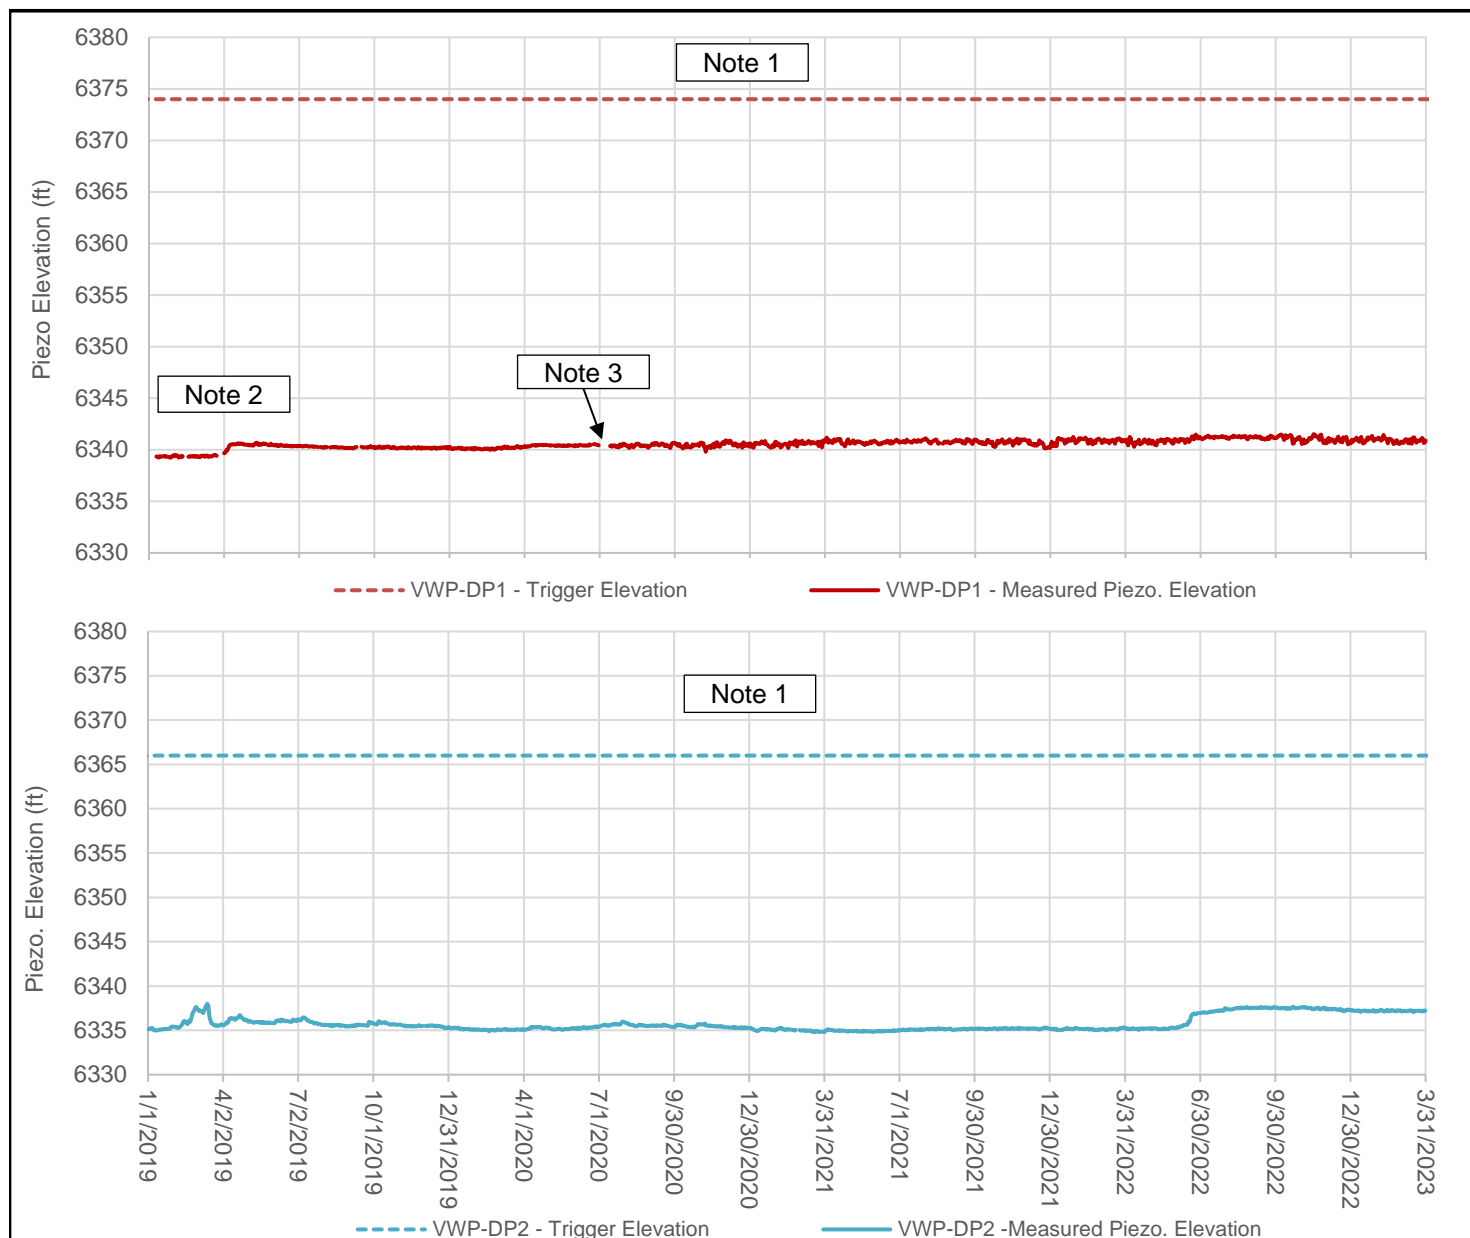
P/A NO. VA101-126/29	REF NO. VA23-00701
<div style="display: flex; justify-content: space-between;"> <div> <p><b>FIGURE 7</b></p> </div> <div> <p>RE 0</p> </div> </div>

No piezometric trigger elevation exceedances were observed at QPP monitoring sites during Q1 2023. A high-level summary of QPP piezometric data and instrumentation status is provided in Table 1. Piezometric data recorded at QPP sites within the East-West, North-South, and West Embankments are shown relative to the trigger elevations on Figure 2 through 6. Piezometric conditions and quarterly change in piezometric elevation along Section 8+00W of the East-West Embankment are presented graphically on Figure 7.

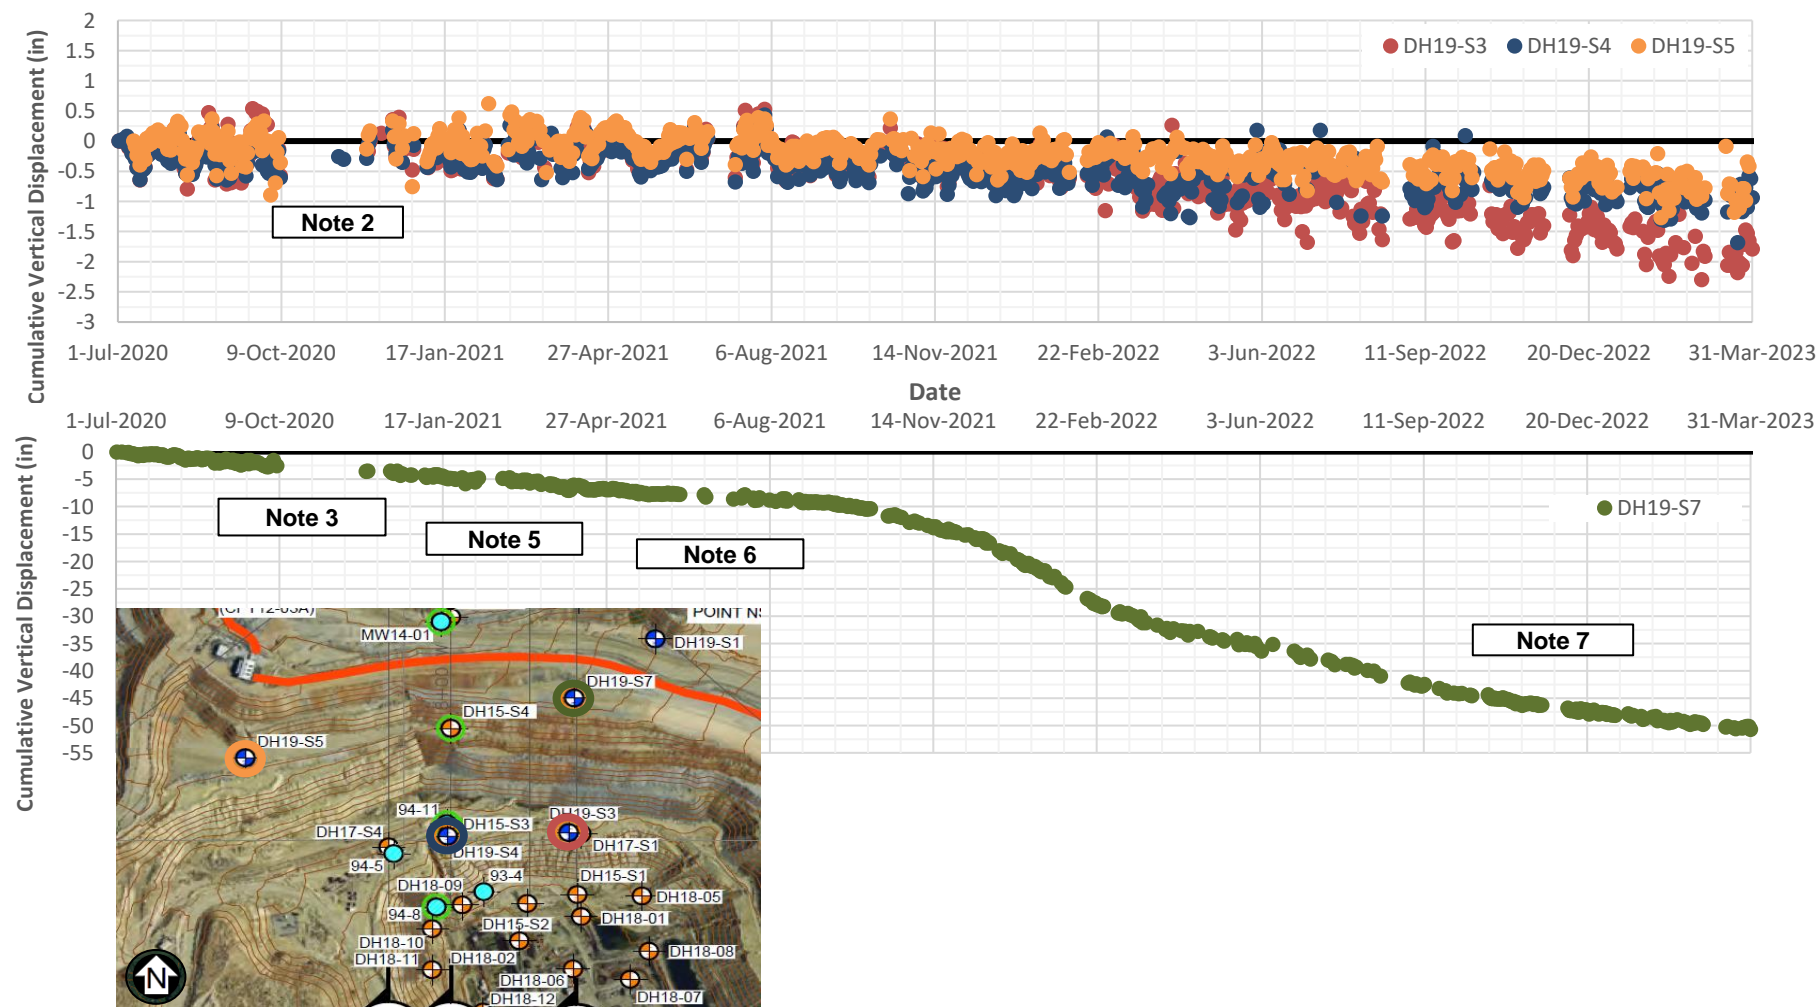
MONTANA RESOURCES LLC.			
YANKEE DOODLE TAILINGS IMPOUNDMENT			
CUMULATIVE VERTICAL DISPLACEMENTS MONITORED AT DH19-S3 (JULY 1, 2020 THROUGH MARCH 31, 2023)			
	P/A NO. VA101-00126/29		REF. NO. VA23-00701
	FIGURE A.1		REV 0

- Survey-monuments (GNSS DH19-S3, GNSS DH19-S4, SB-1, SB-2, and SB-3) installed along the Seep 10 Bench have previously observed slightly elevated surface deformation rates interpreted to signify influence from construction. Monitoring during Q1 2023 continued to indicate slightly slowing deformation rates.

1. CUMULATIVE VERTICAL DISPLACEMENTS ARE CALCULATED RELATIVE TO JULY 1, 2020.
2. NO DATA WERE COLLECTED FROM DH19-S2 AND DH19-S5 BETWEEN OCTOBER 7 TO DECEMBER 2, 2020 DUE TO A POWER MANAGEMENT SCHEDULE ISSUE AT THE GNSS REFERENCE STATION (DH16-04).
3. NO DATA WERE COLLECTED FROM DH19-S3 AND DH19-S7 BETWEEN OCTOBER 7 TO NOVEMBER 13, 2020 DUE TO A POWER MANAGEMENT SCHEDULE ISSUE AT THE GNSS REFERENCE STATION (DH16-04).
4. NEGATIVE VERTICAL DISPLACEMENTS INDICATE DOWNWARD DISPLACEMENT.
5. NO DATA WERE COLLECTED FROM FEBRUARY 9 TO 21, 2021 DUE TO A DEPLETED DATA LOGGER BATTERY.
6. NO DATA WERE COLLECTED FROM JUNE 12 TO JULY 15, 2021 DUE TO A TELEMETRY HARDWARE OUTAGE.
7. NO DATA WERE COLLECTED FROM AUGUST 16 TO SEPTEMBER 2, 2022, NOVEMBER 23 TO DECEMBER 10, 2022, AND MARCH 2 TO 16, 2023 DUE TO A HARDWARE ISSUE.

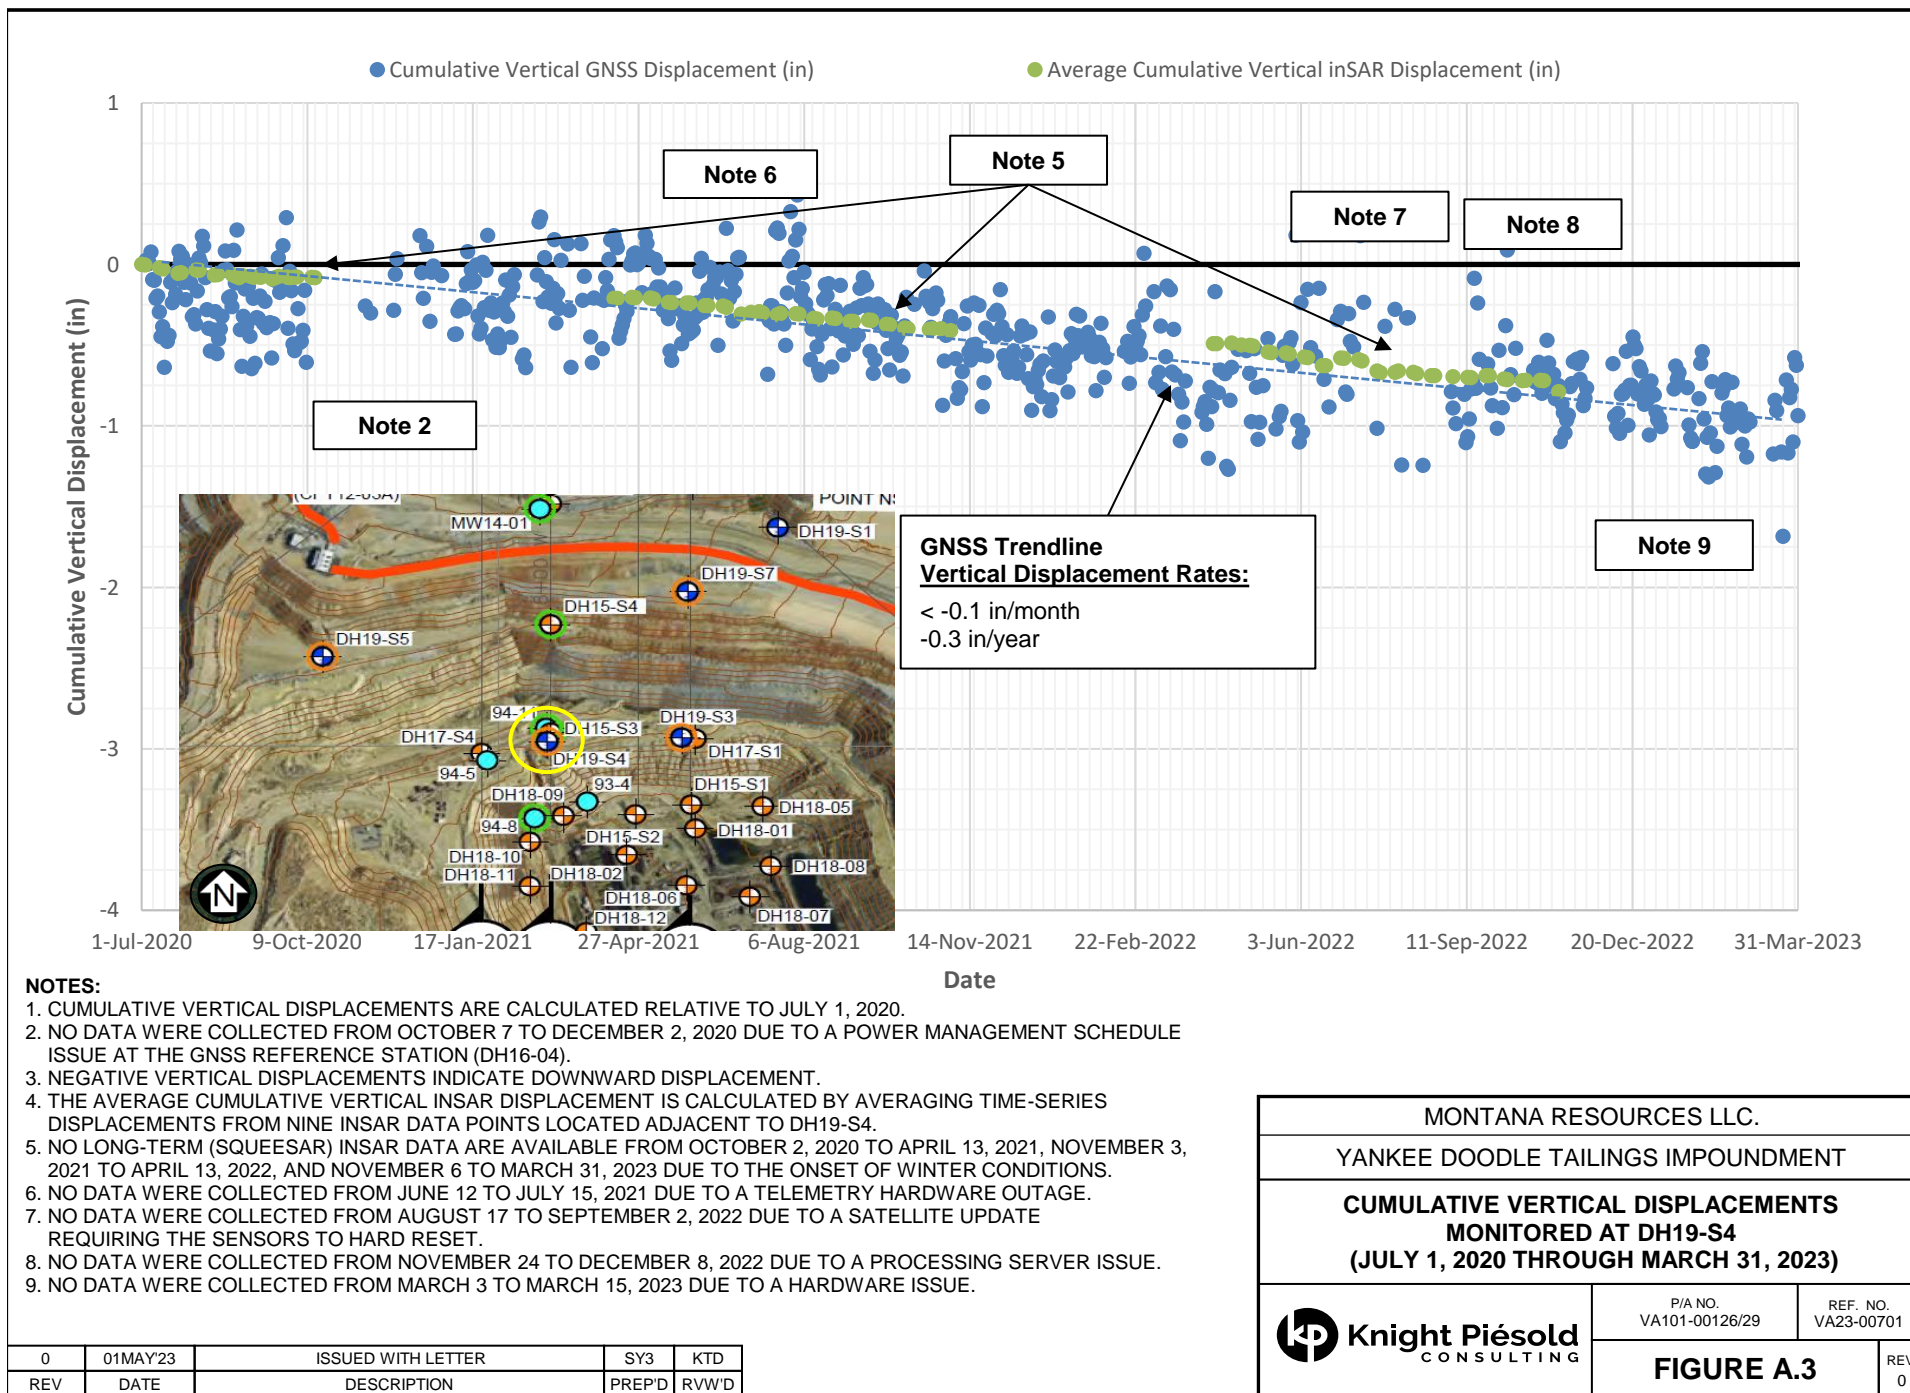
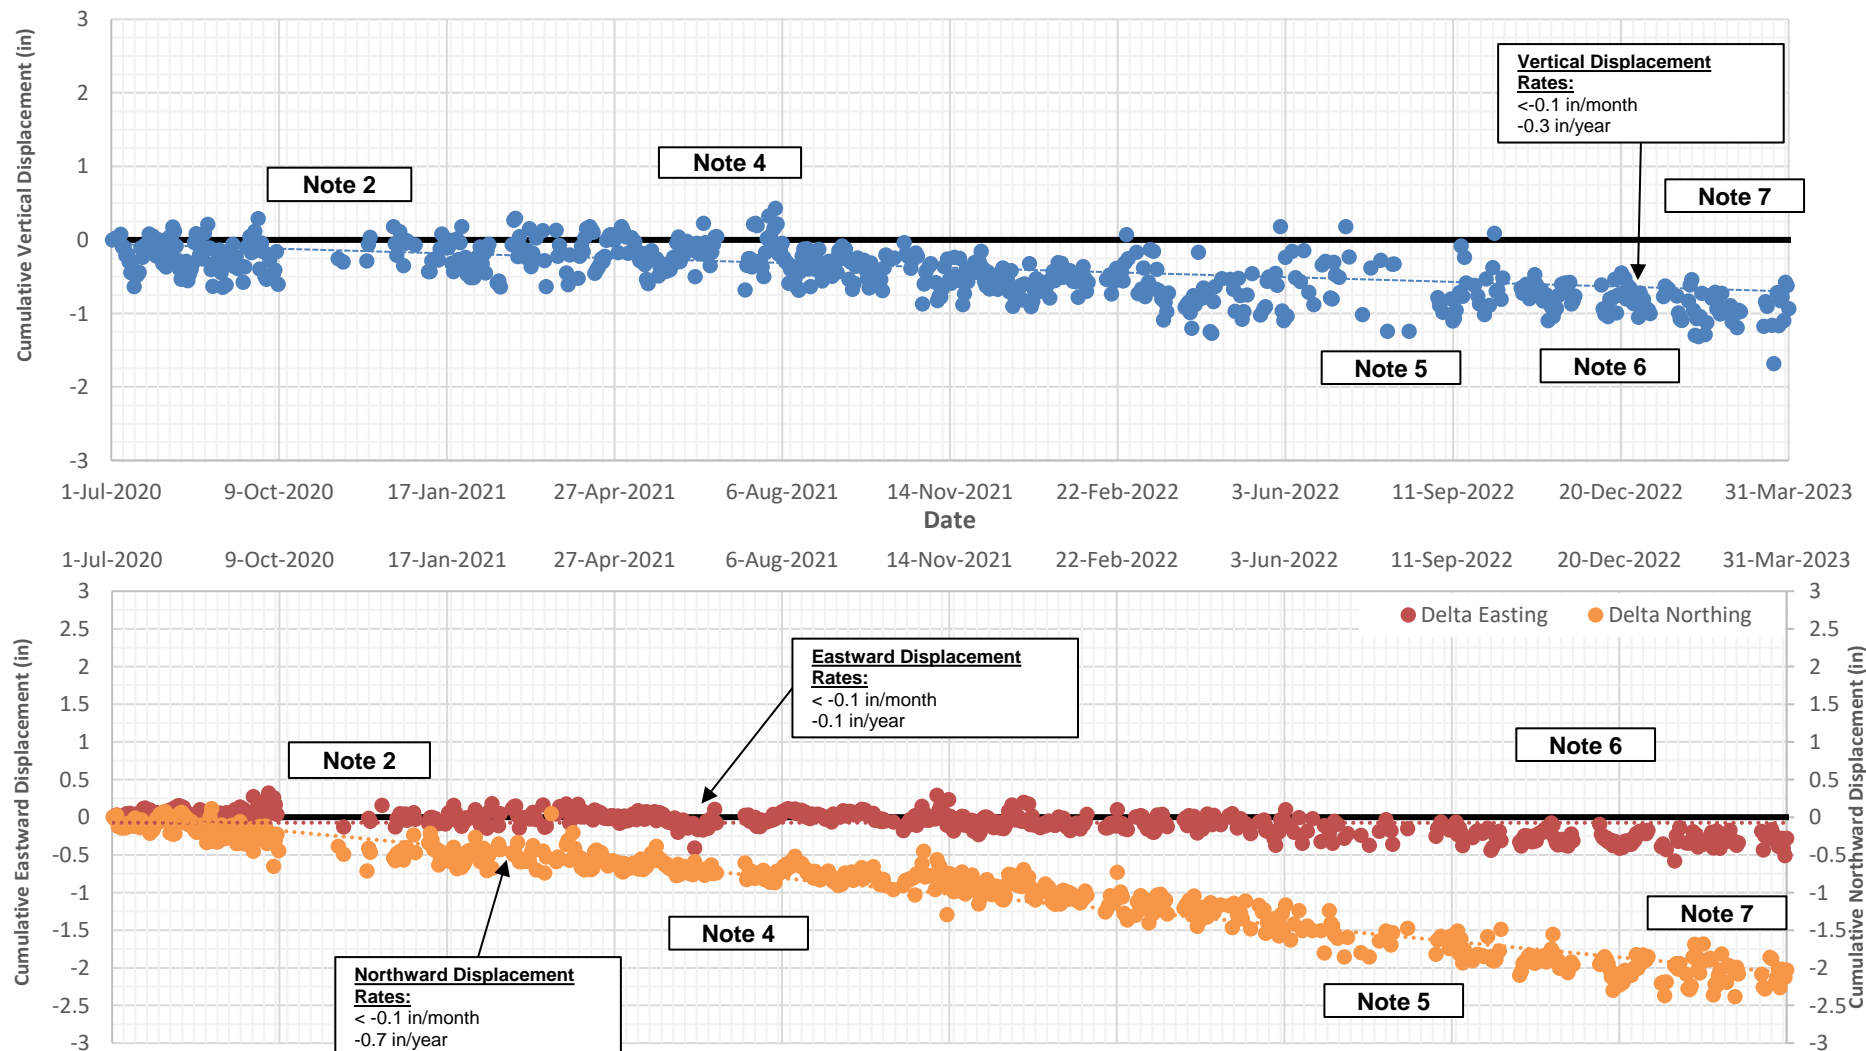
MONTANA RESOURCES LLC.	
YANKEE DOODLE TAILINGS IMPOUNDMENT	
CUMULATIVE VERTICAL & LATERAL DISPLACEMENTS MONITORED AT DH19-S4 (JULY 1, 2020 THROUGH MARCH 31, 2023)	
	P/A NO. VA101-00126/29
	REF. NO. VA23-00701
FIGURE A.4	
REV 0

- Seep 10 Bench inclinometers DH19-S3 and DH19-S4 (Sections 0+00 and 8+00W, respectively) have previously observed slightly elevated subsurface deformation rates since June 2022, that are interpreted to be influenced by embankment lift construction upstream. Deformation rates have generally remained consistent or slowed slightly since mid-2022 (following El. 6,400 ft lift construction), with very minor rate and directional fluctuations interpreted to result from continuing settlement.
