**April 29, 2024**

**Knight Piésold Ltd.**  
Suite 1400 - 750 West Pender Street  
Vancouver, British Columbia  
Canada, V6C 2T8  
T +1 604 685 0543  
E [vancouver@knightpiesold.com](mailto:vancouver@knightpiesold.com)  
[www.knightpiesold.com](http://www.knightpiesold.com)

## **RE: Q4 2023 – YDTI Quarterly Piezometric and Deformation Monitoring Update**

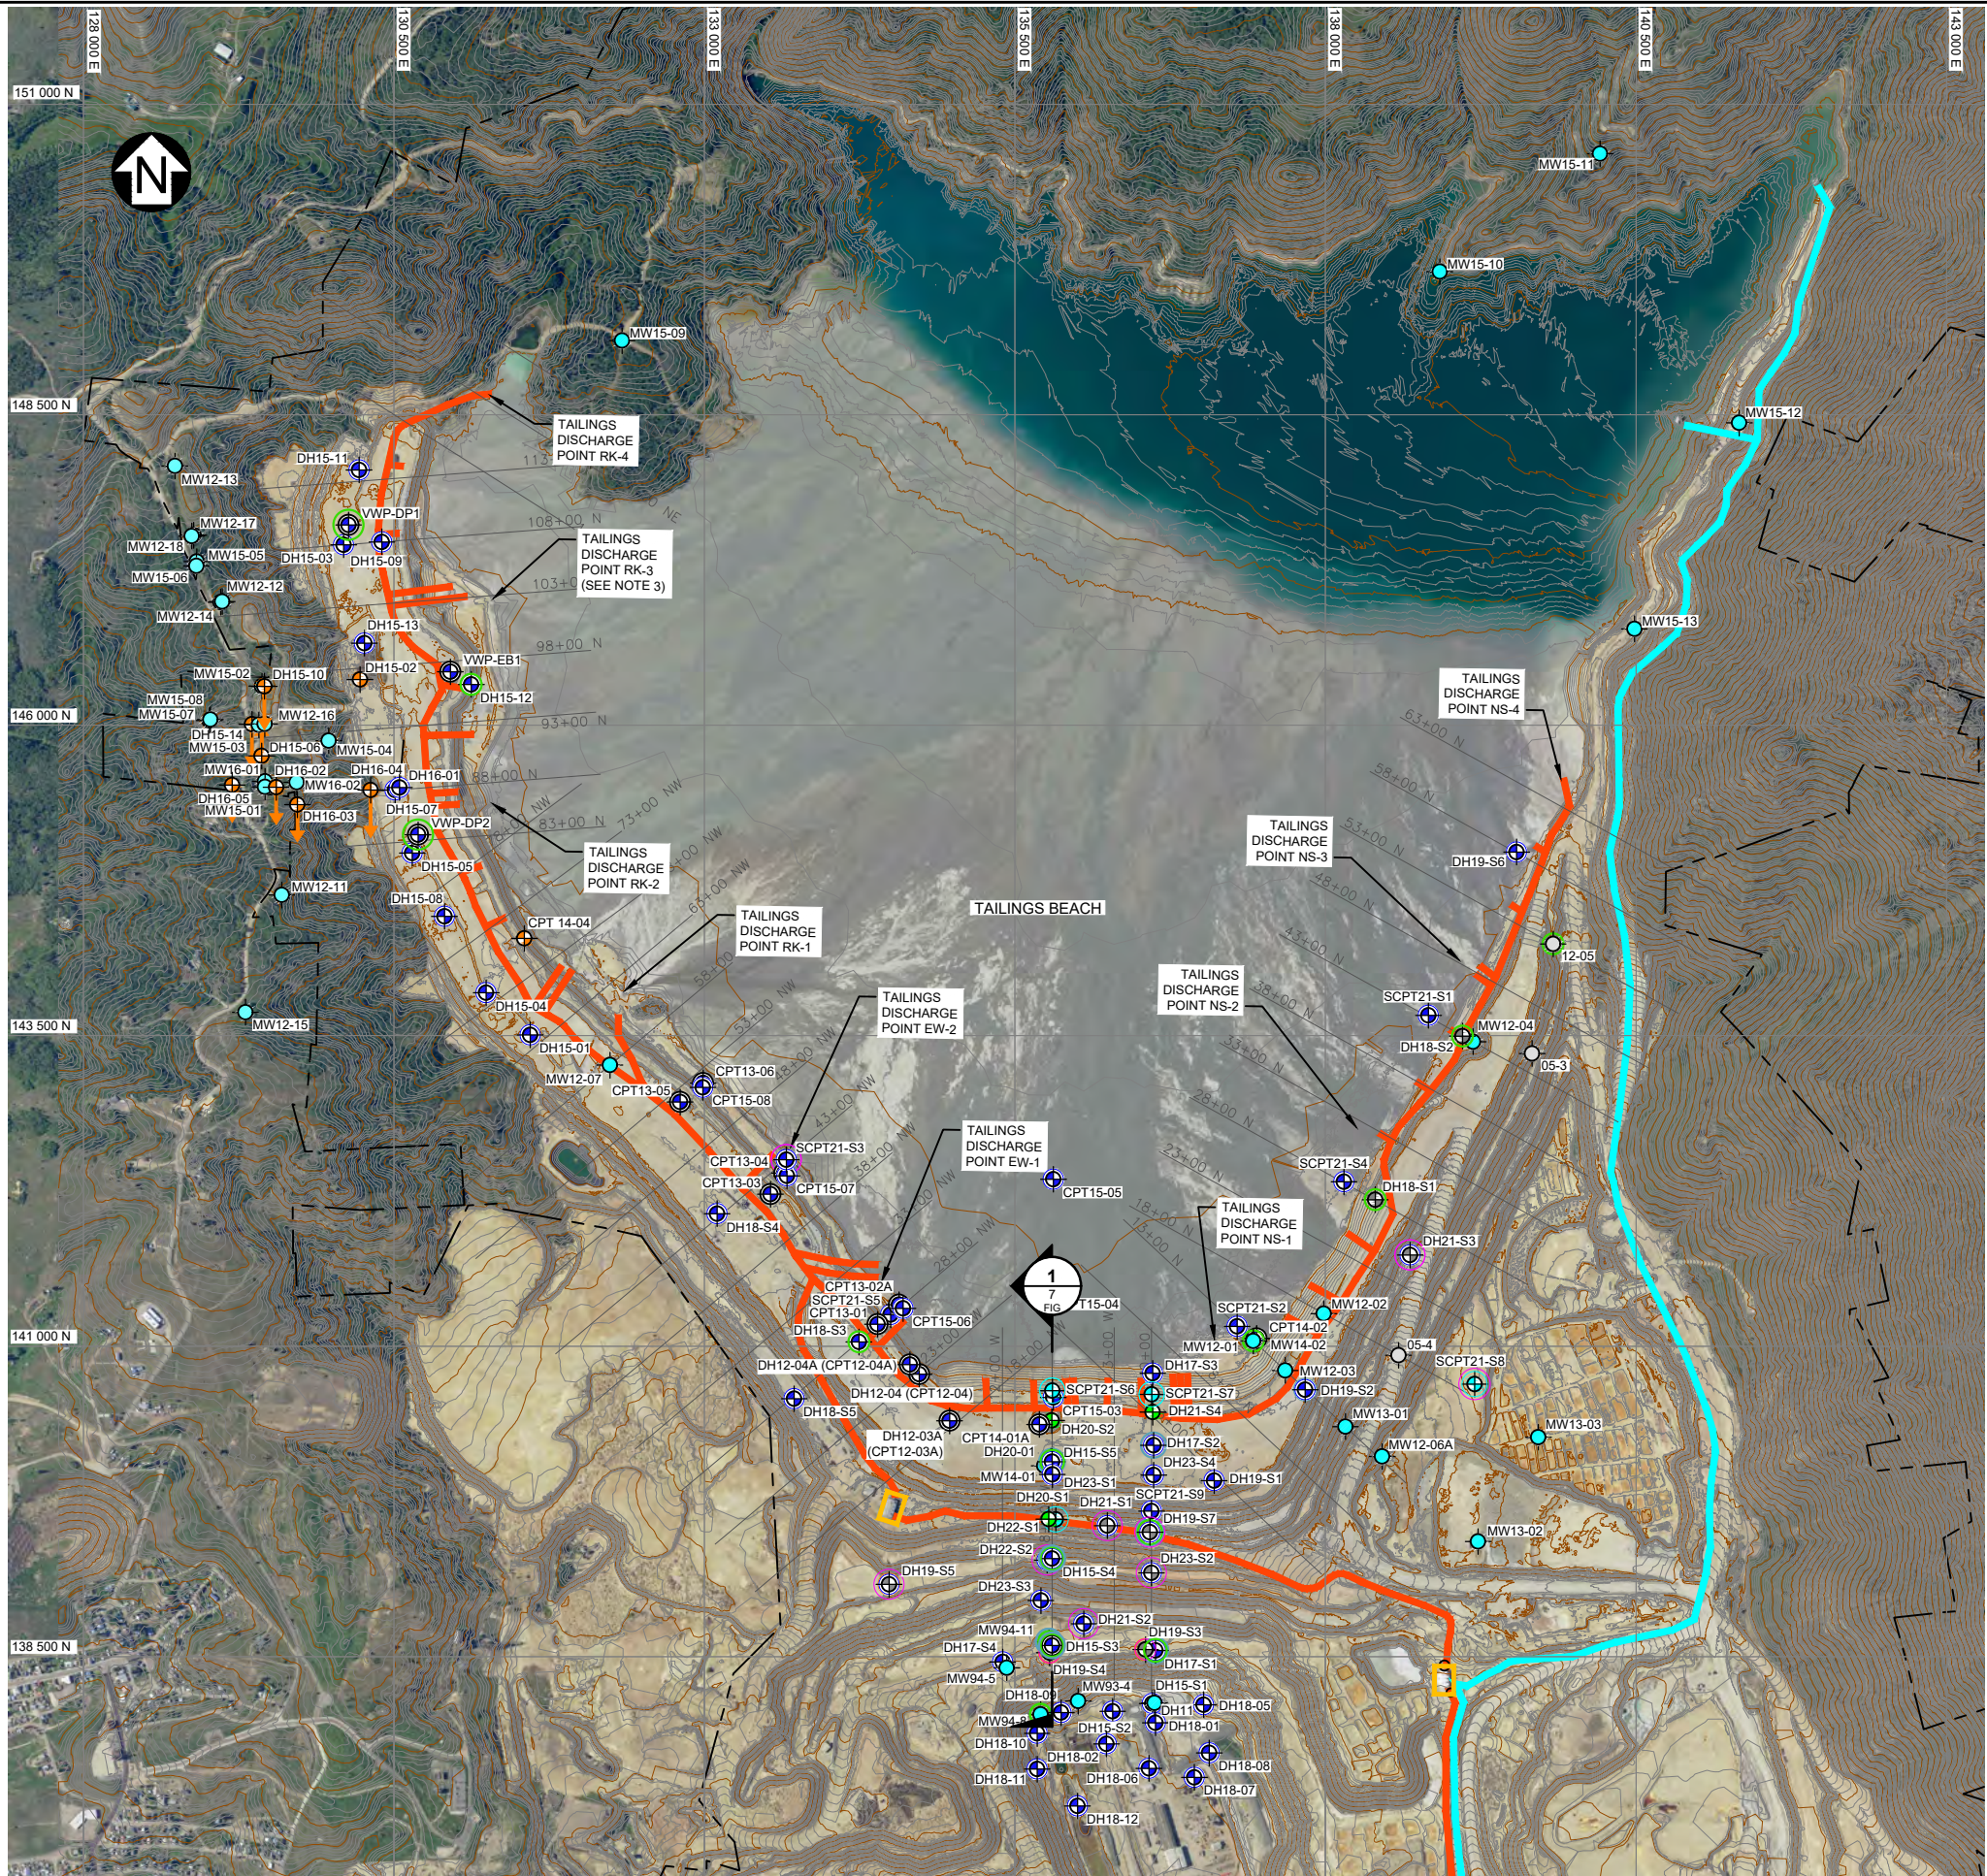
MONTANA RESOURCES, LLC		
MONTANA RESOURCES		
YANKEE DOODLE TAILINGS IMPOUNDMENT ACTIVE PIEZOMETRIC INSTRUMENTATION AND MONITORING SITES		
	P/A NO. VA101-126/29	REF NO. VA24-00030
	FIGURE 1	
		REV 0

- COORDINATE SYSTEM AND ELEVATIONS BASED ON ANACONDA MINE GRID.
- QPP MONITORING SITES = QUANTITATIVE PERFORMANCE PARAMETER  
CPP MONITORING SITES = CONSTRUCTION PERFORMANCE PARAMETER.
- RK-3 TAILINGS DISCHARGE POINT WAS RELOCATED NORTH IN OCTOBER 2017.
- THE AERIAL PHOTO SHOWN IS FROM JULY, 2023.
- SEPTEMBER 2023 TOPOGRAPHY PROVIDED BY MONTANA RESOURCES, LLC.
- NO PORE WATER PRESSURE DATA ARE AVAILABLE FROM DH20-S1 AND DH22-S1 AS THE INSTRUMENTS ARE NOT FUNCTIONAL.

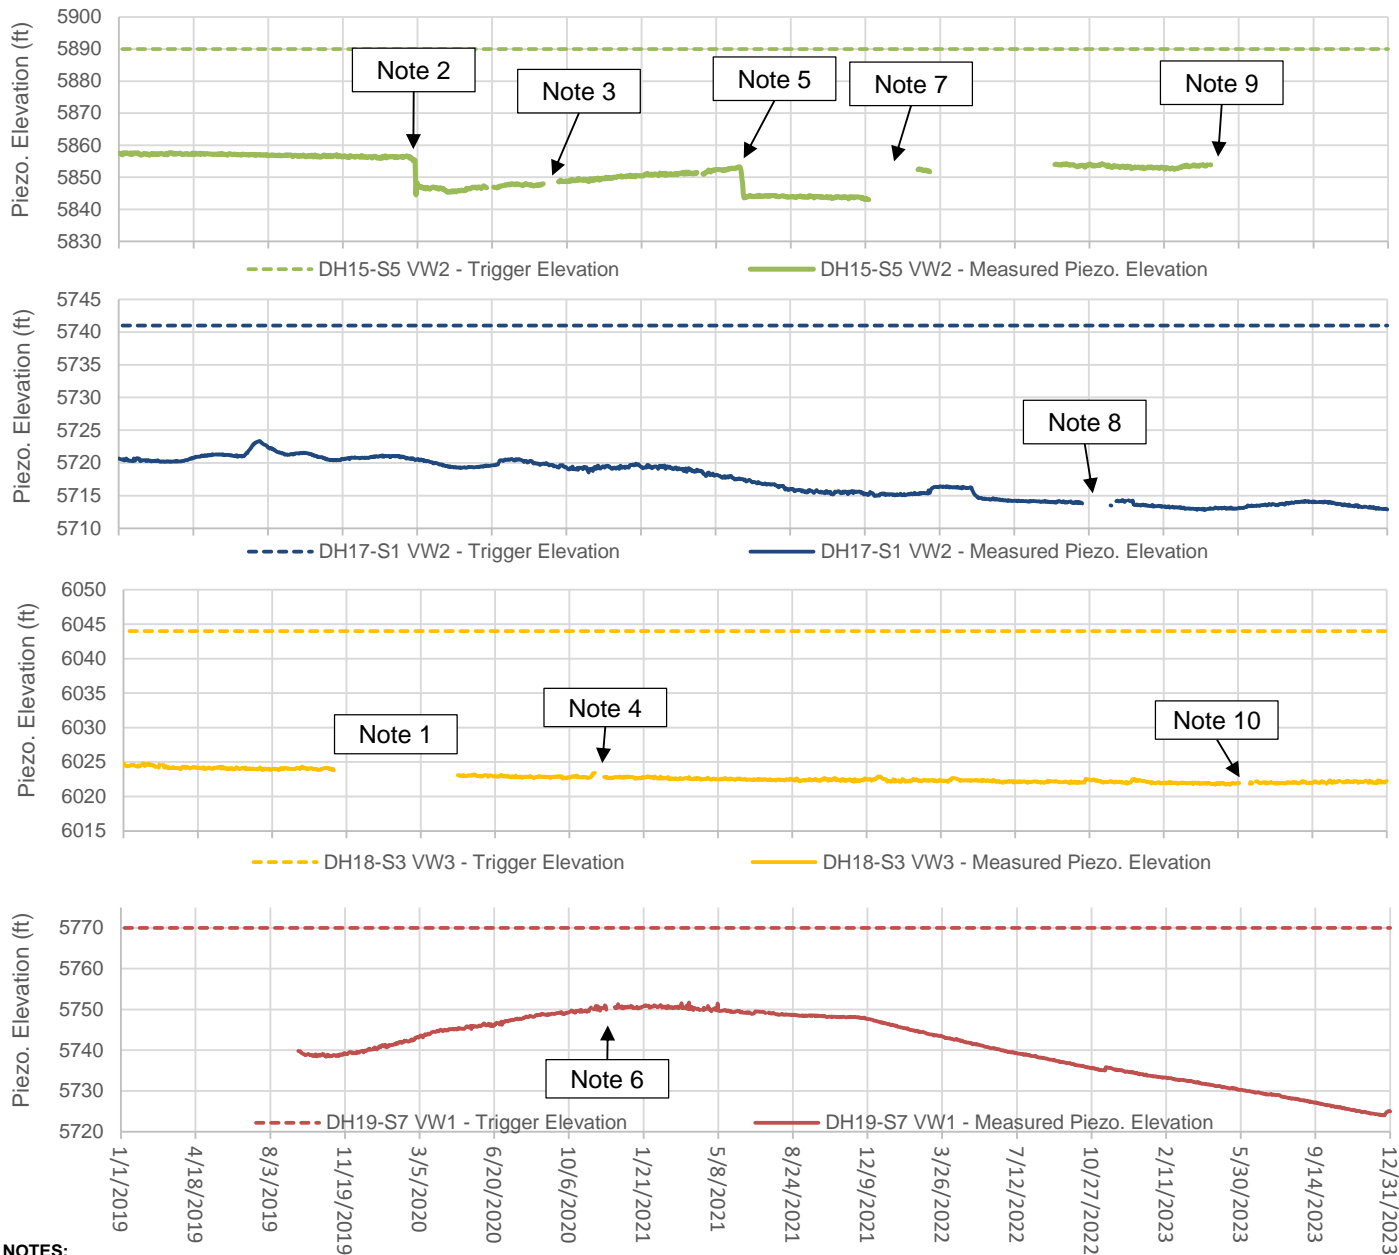
1. NO DATA WERE COLLECTED BY DH18-S3 VW1 FROM NOVEMBER 1, 2019 TO FEBRUARY 3, 2020 AND FEBRUARY 4 TO APRIL 30, 2020 DUE TO SUSPECTED HARDWARE DAMAGE.
2. NO DATA WERE COLLECTED BY DH15-S5 VW2 DUE TO LOGGER POWER SUPPLY ISSUES FROM JUNE 13 TO 23, 2020.

3. NO DATA WERE COLLECTED BY DH15-S5 VW2 DUE TO WATER DAMAGED LOGGER FROM SEPTEMBER 2 TO 24, 2020. THE LOGGER WAS SUBSEQUENTLY REPLACED.
4. NO DATA WERE COLLECTED BY DH18-S3 VW3 DUE TO A DEPLETED DATA LOGGER BATTERY FROM NOVEMBER 12 TO 25, 2020.

8. THE DATA LOGGER AT DH17-S1 WAS DAMAGED AND NO DATA WERE RECORDED BETWEEN OCTOBER 18, 2022 AND DECEMBER 9, 2022. FUNCTIONALITY HAS SUBSEQUENTLY BEEN RESTORED.

9. SENSOR DH15-S5 VW2 HAS COLLECTED ERRONEOUS DATA SINCE APRIL 15, 2023 DUE TO SUSPECTED CABLE DAMAGE. THE SENSOR WAS SUBSEQUENTLY ABANDONED AND WILL BE REPLACED WITH SENSOR(S) FROM DH23-S1.

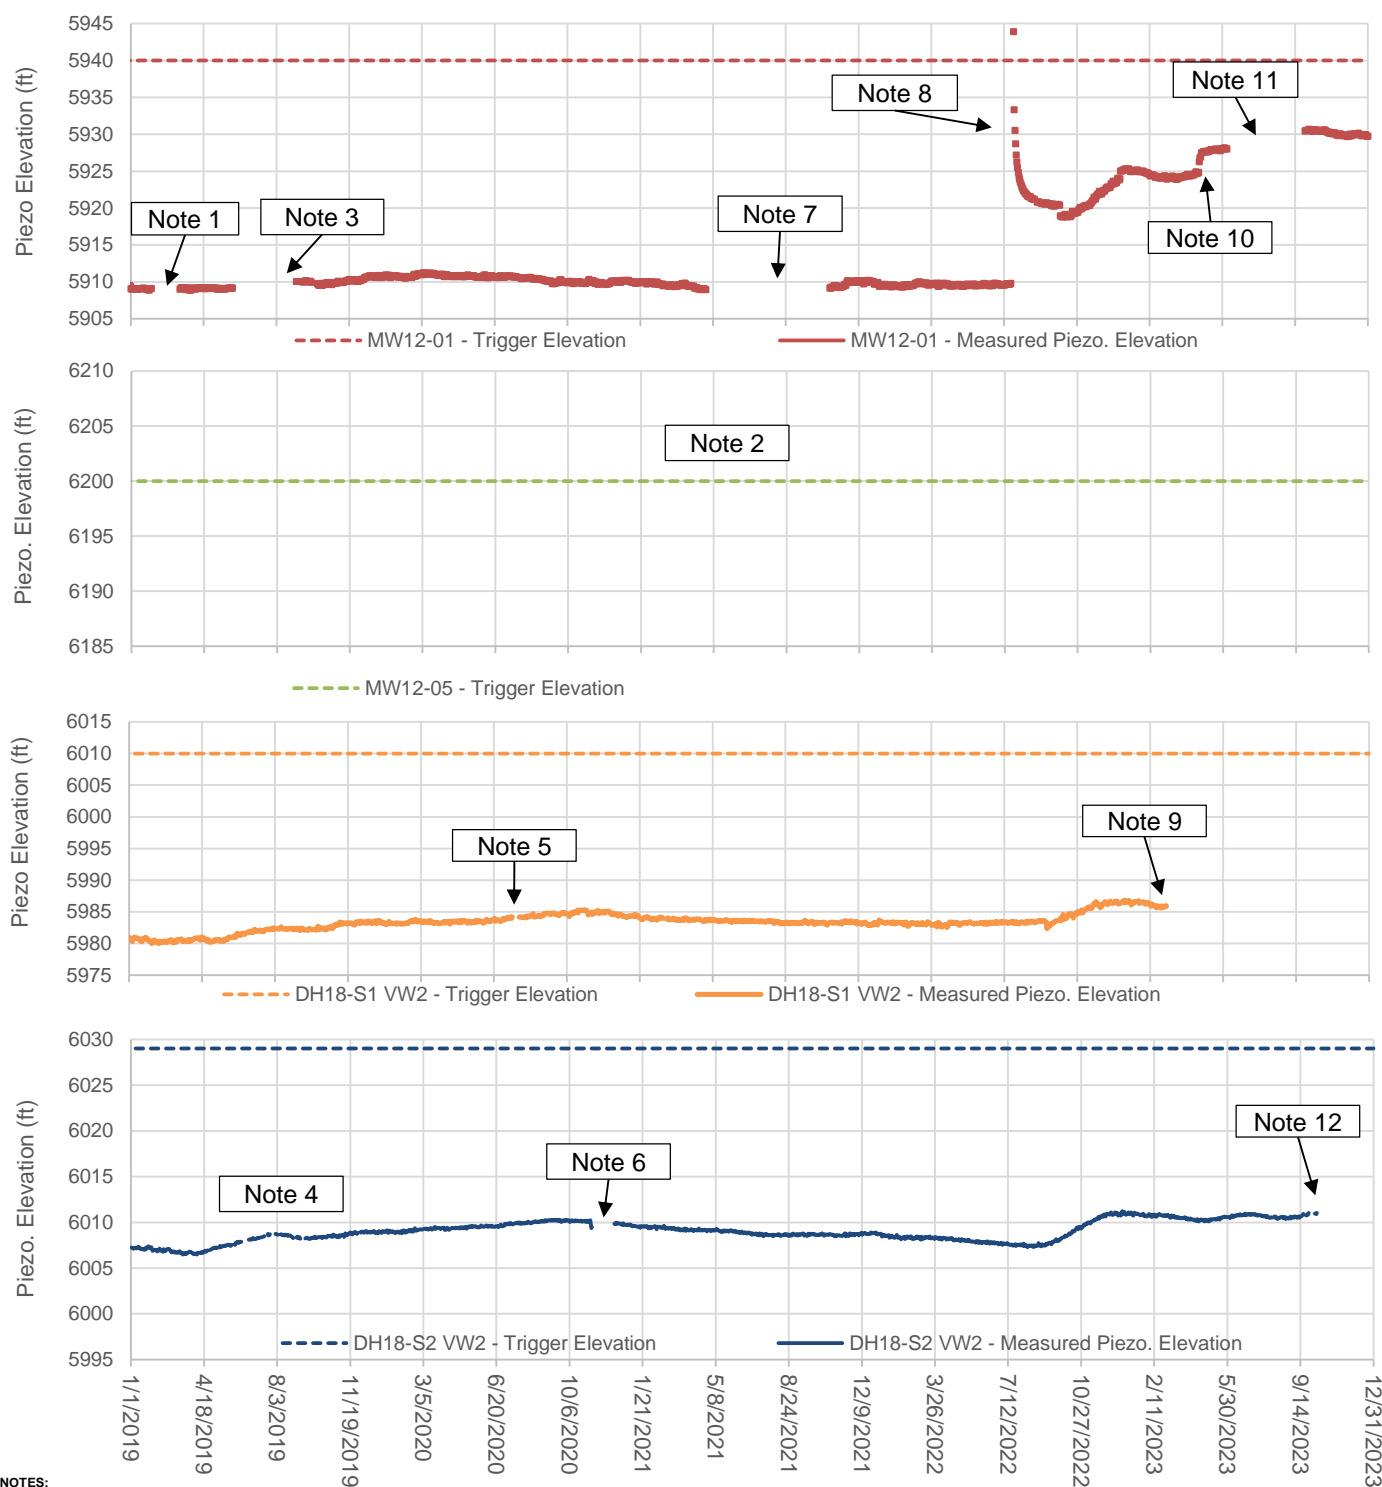
- MW12-01 BECAME UNSATURATED FROM FEBRUARY 1 TO MARCH 13, 2019.
- NO DATA WERE COLLECTED BY MW12-05. THE STANDPIPE WAS UNSATURATED (DRY) UNTIL IT BECAME DAMAGED ON MARCH 8, 2023 BY CONSTRUCTION.

- NO DATA WERE COLLECTED BY MW12-01 FROM MAY 31 TO SEPTEMBER 11, 2019 DUE TO DATA LOGGER FAILURE.
- ERRONEOUS NOISE WAS RECORDED IN THE DATA BY DH18-S2 VW2. THESE DATA HAVE BEEN OMITTED FOR CLARITY.

- SENSOR DH18-S1 VW2 WAS DISCONNECTED IN PREPARATION FOR EL. 6,450 FT LIFT CONSTRUCTION (ON MARCH 8, 2023) BUT WAS SUBSEQUENTLY DAMAGED AND IS PLANNED TO BE REPLACED IN 2024.

- DH18-S2 VW2 STOPPED COLLECTING DATA ON OCTOBER 10, 2023. TO BE REPLACED IN 2024.

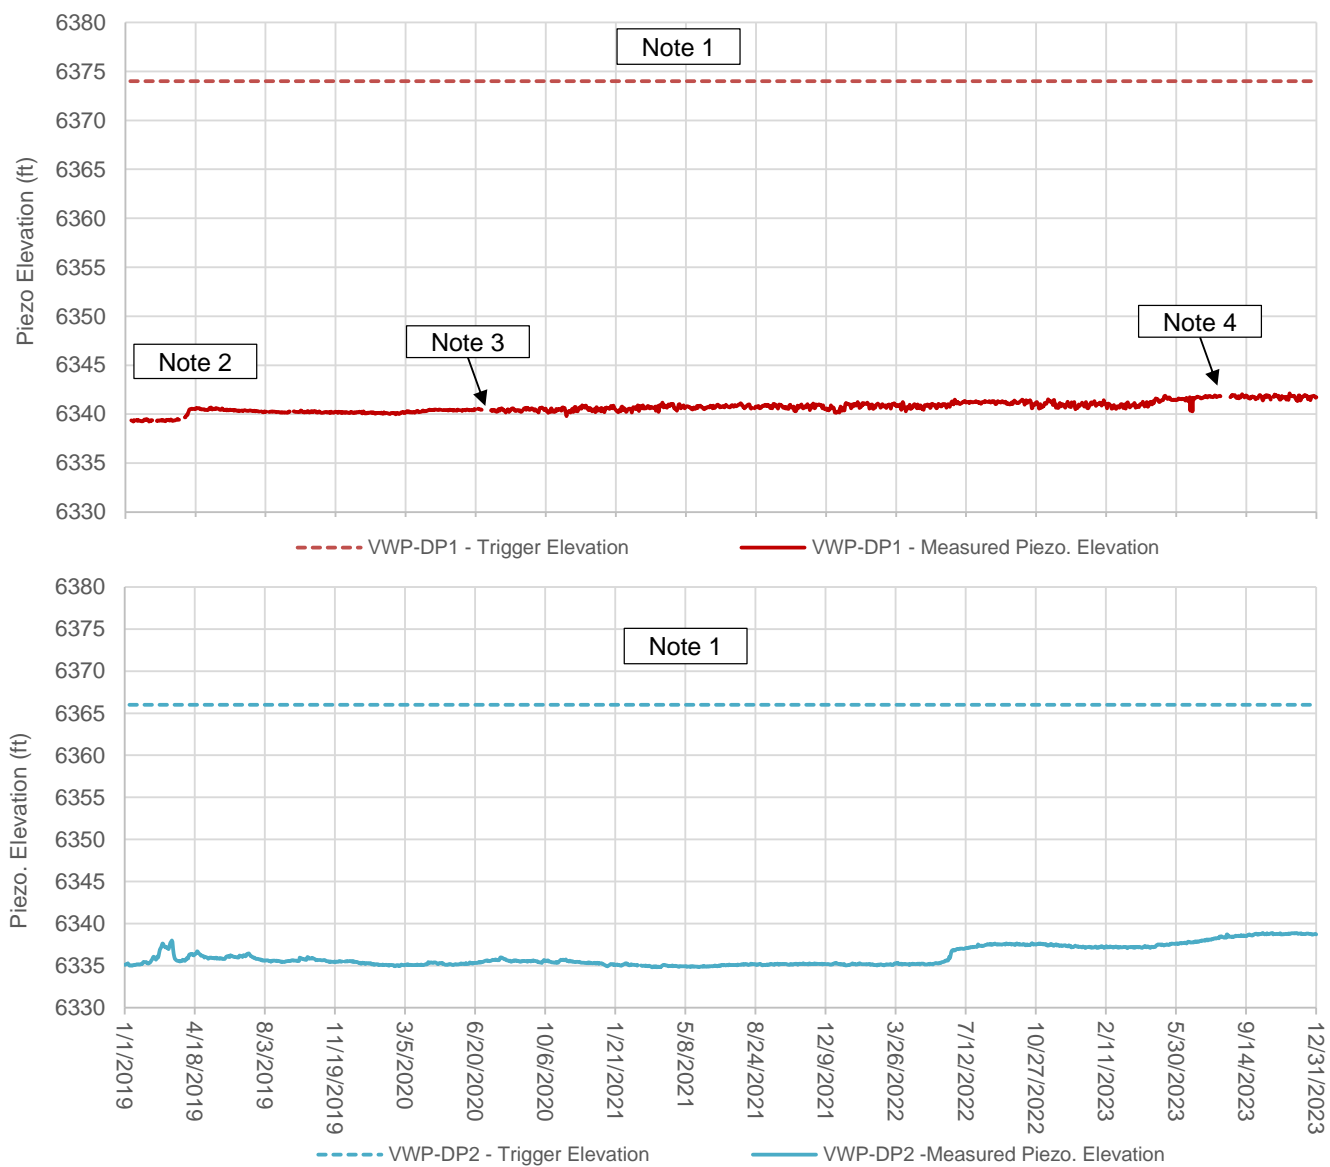
MONTANA RESOURCES, LLC	
MONTANA RESOURCES	
SUMMARY OF MEASURED VS. QPP TRIGGER PIEZOMETRIC ELEVATIONS WEST EMBANKMENT

- NOTES:**
- 1. TRIGGER ELEVATIONS FOR SENSORS INSTALLED IN THE DRAIN PODS HAVE BEEN SPECIFIED AT THE ALLOWABLE HYDRAULIC GRADE LINE.
  - 2. PERIODIC OUTAGES OCCURRED AT VWP-DP1 DUE TO INTERMITTENT BATTERY VOLTAGE ISSUES.
  - 3. NO DATA WERE RECORDED BY VWP-DP1 FROM JULY 1 TO 14, 2020 DUE TO A DATALOGGER ISSUE. A REPLACEMENT DATALOGGER WAS SUBSEQUENTLY INSTALLED TO RESOLVE THE ISSUE.
  - 4. NO DATA WERE RECORDED BY VWP-DP1 FROM AUGUST 7 TO 20, 2023 DUE TO A CONNECTIVITY ISSUE.

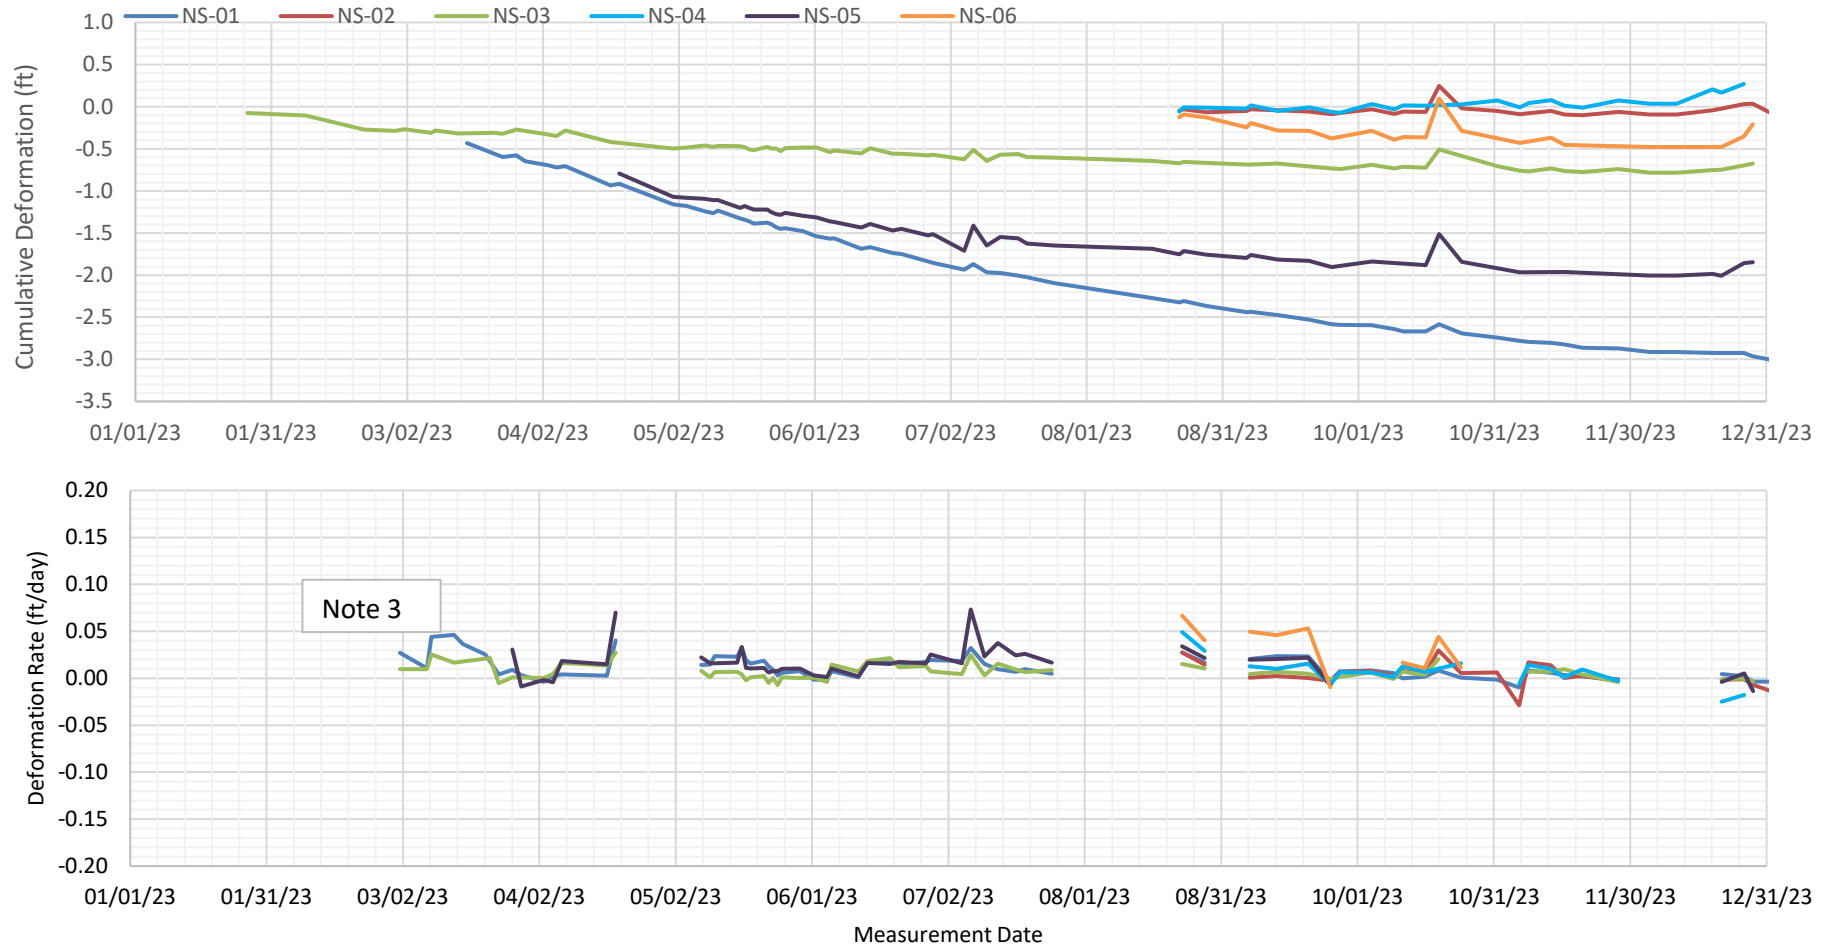
P/A NO. VA101-126/29		REF. NO. VA24-00030
	FIGURE A.21		REV 0

- Manual survey-monuments installed along the North-South Embankment (NS-01, NS-02, NS-03, NS-04, NS-05, and NS-06) indicate slightly elevated, generally slowing deformation rates following the substantial conclusion of EL. 6,450 ft lift construction. The highest Q4 2023 displacement rates were observed near Section 0+00 (at monument NS-01) at the corner of the North-South Embankment, where several lifts were placed and continue to settle. It is anticipated that rates will continue to slow in Q1 2024.

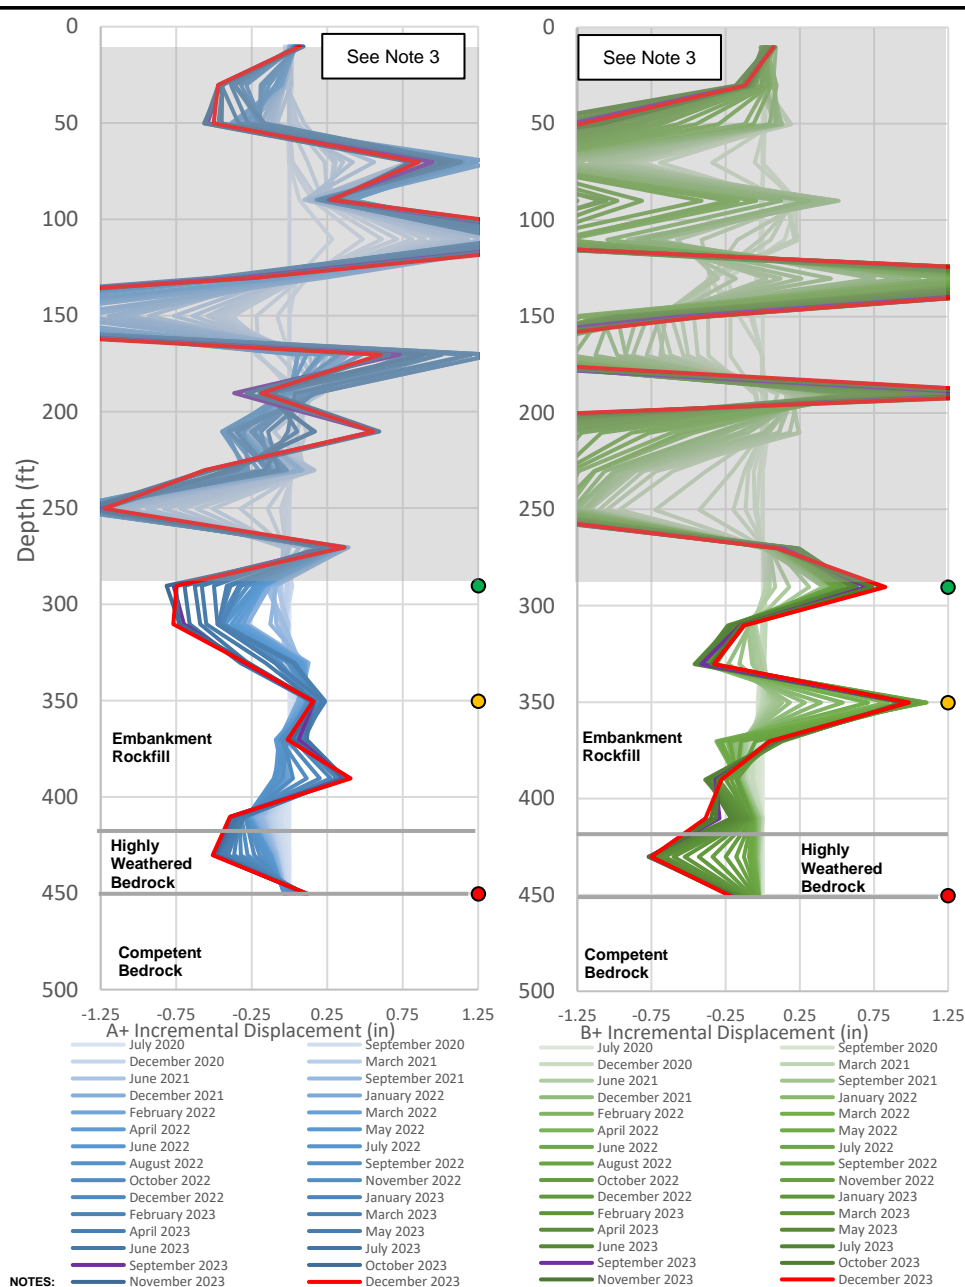
**FIGURE B.7**REV  
0

1. INCREMENTAL DEFORMATION MAGNITUDES AND RATES ARE PRESENTED AS MONTHLY AVERAGES.
2. POSITIVE A+ AND B+ DEFORMATIONS INDICATE SOUTHWARD AND WESTWARD DISPLACEMENTS, RESPECTIVELY.
3. DEFORMATION DATA WITHIN THE UPPER 275 FTBG ARE INTERPRETED TO RESULT PREDOMINANTLY FROM SETTLEMENT-DERIVED CASING DISTORTION WITHIN HISTORICALLY LEACHED ROCKFILL.

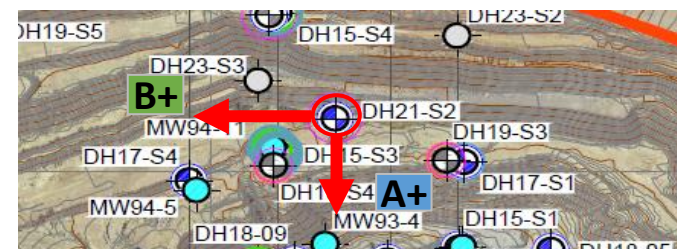
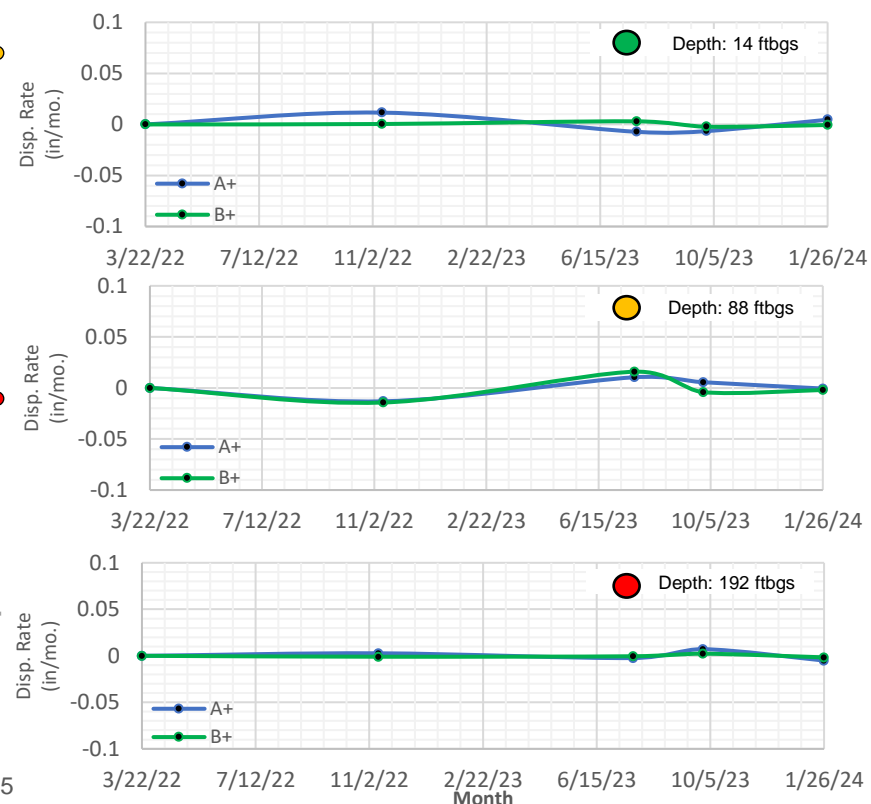
<b>Knight Piésold</b> CONSULTING	P/A NO. VA101-126/29	REF. NO. VA24-00030	
	<b>FIGURE B.11</b>		RE 0

1. INCREMENTAL DEFORMATION MAGNITUDES AND RATES ARE PRESENTED AS MONTHLY AVERAGES WHERE DATA IS AVAILABLE.
2. POSITIVE A+ AND B+ DEFORMATIONS INDICATE SOUTHWARD AND WESTWARD DISPLACEMENTS, RESPECTIVELY.
3. LIMITED DATA ARE AVAILABLE DUE TO LIMITED SURVEY STAFF AVAILABILITY.

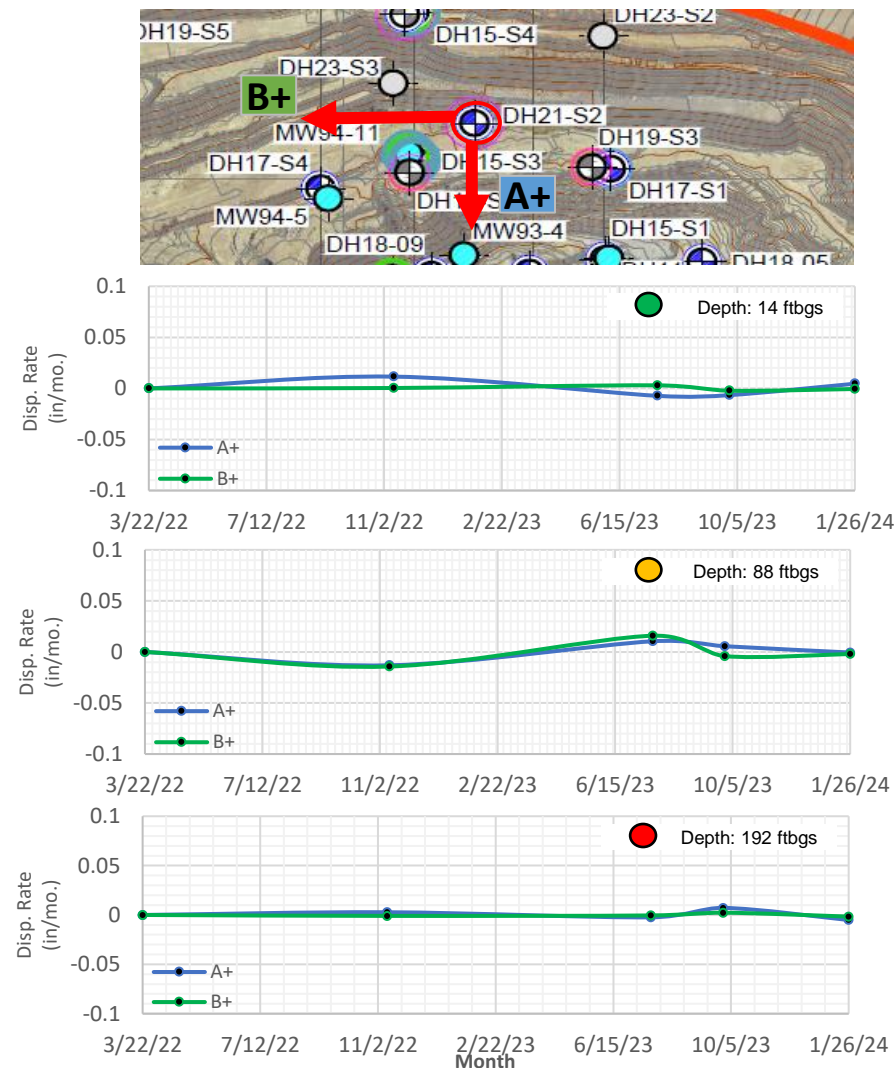
<b>Knight Piésold</b> CONSULTING	P/A NO. VA101-126/29		REF. NO. VA24-00030
	<b>FIGURE B.12</b>		RE 0

1. INCREMENTAL DEFORMATION MAGNITUDES AND RATES ARE PRESENTED AS MONTHLY AVERAGES WHERE DATA IS AVAILABLE.
2. POSITIVE A+ AND B+ DEFORMATIONS INDICATE SOUTHWARD AND WESTWARD DISPLACEMENTS, RESPECTIVELY.
3. LIMITED DATA ARE AVAILABLE DUE TO LIMITED SURVEY STAFF AVAILABILITY.

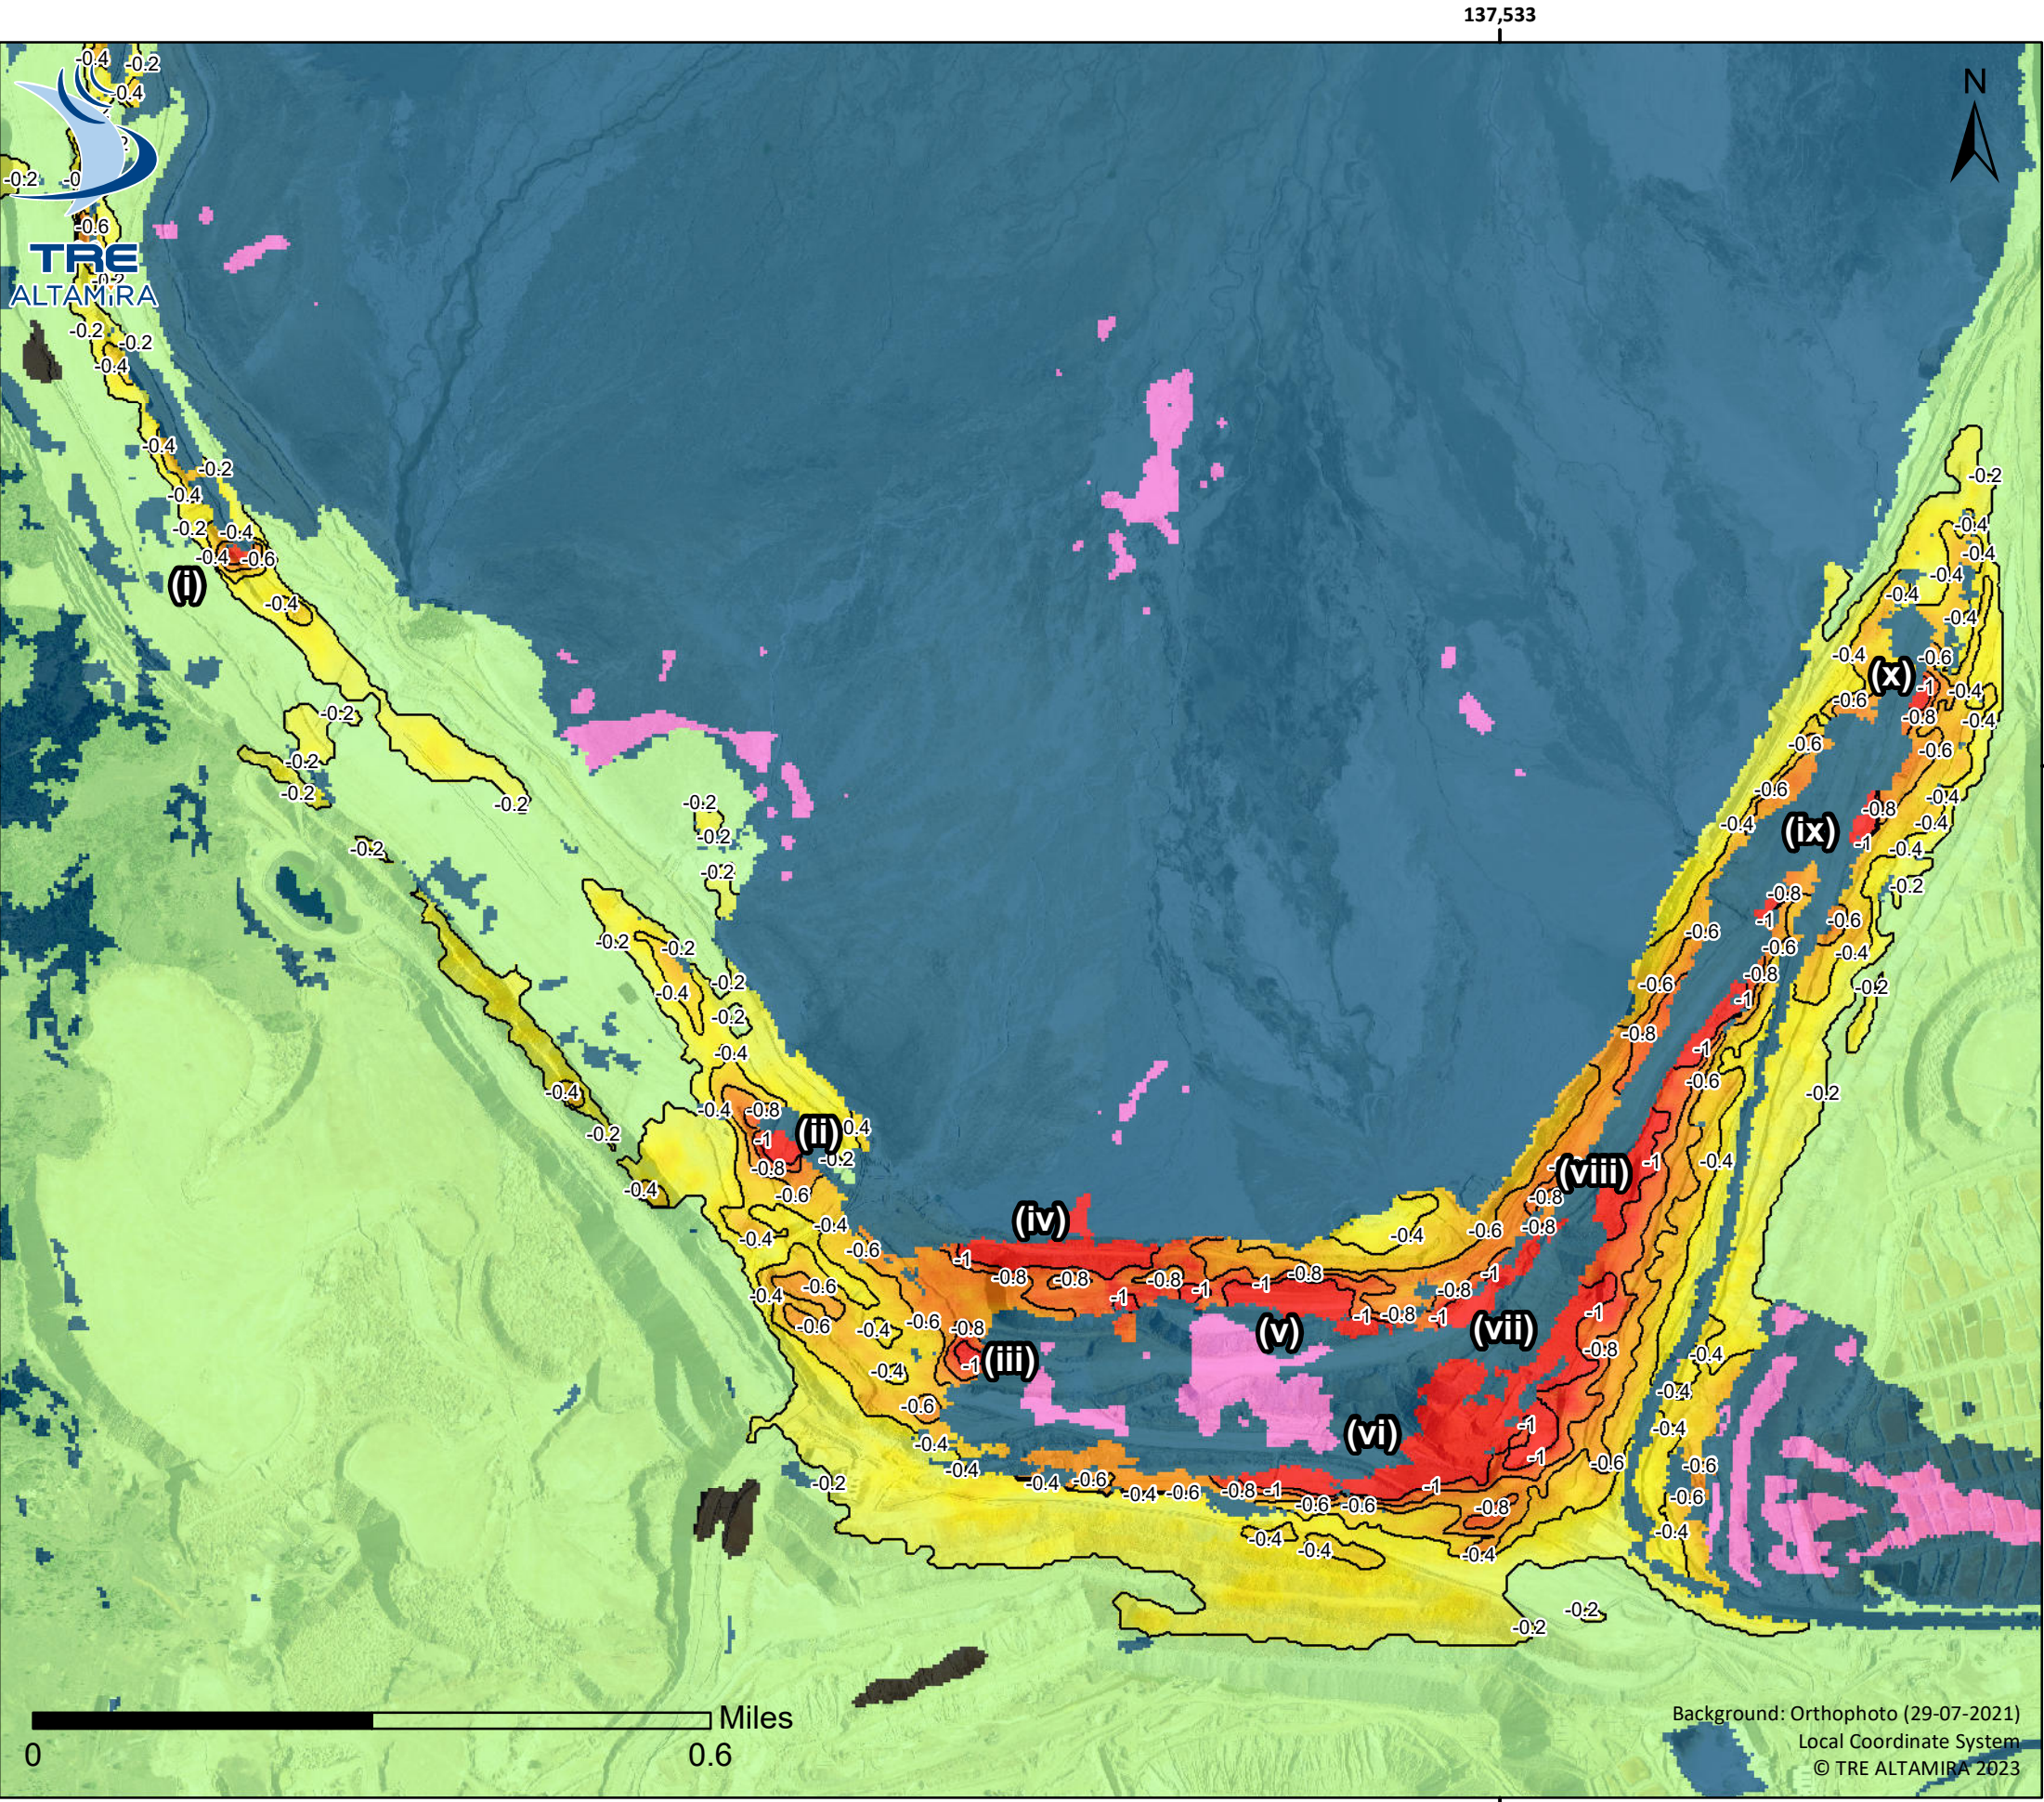
21 Sep 2023 - 13 Oct 2023

Further possible motion observed
